## Thor Motor Coach Technical Service Bulletin

| TSB # | <b>TSB 22-09</b> | | |
| Description/Title: | Rize/Scope A/C install | | |
| Affected Product Line(s): | Certain model year<br>2022 – 2023 Rize & Scope | | |

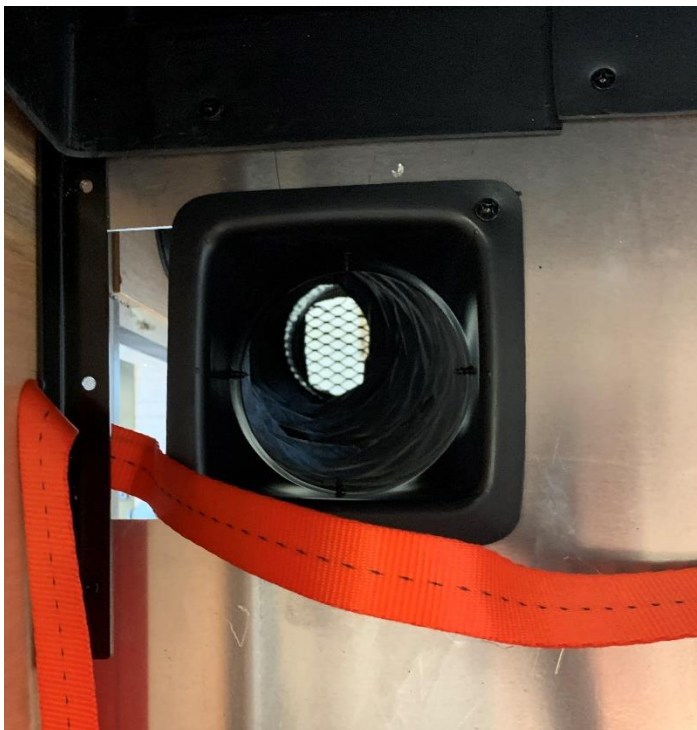
4. A/C exhaust plenum #16 on the TIP0425 print is not lined up with the air exhaust opening. The screws need to be removed and the plenum slide rearward.

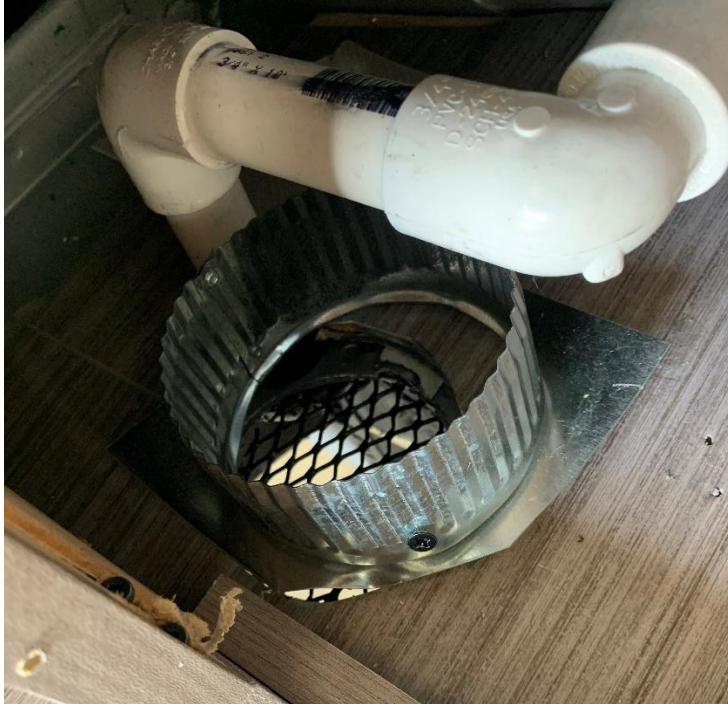
5. Exhaust flange at the floor is not lined up with the hole in the floor and the floor hole is too small. (hole in floor is 3.5" and should be 4")

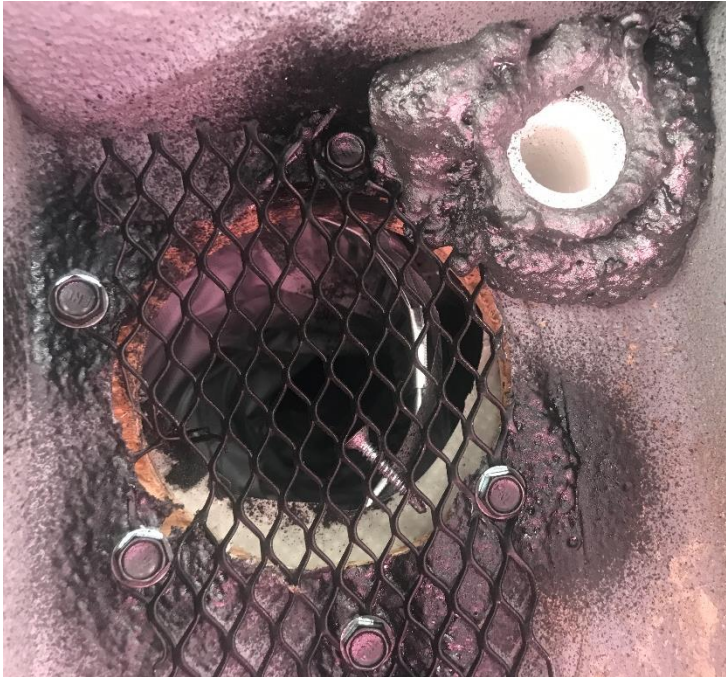
6. Mesh cover not installed properly & wrong size, should be a larger piece and needs secured to bottom of frame rail. TFM7703

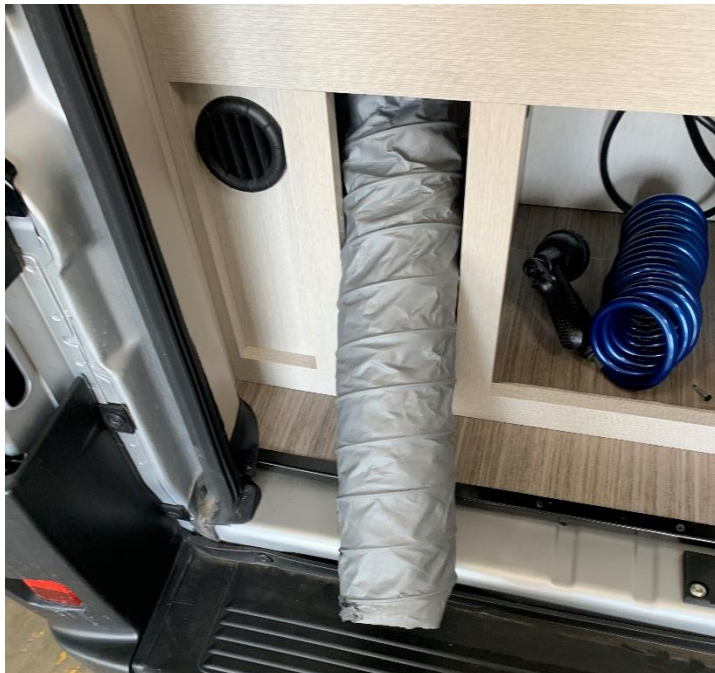
7. Exhaust hose may be too long and should have the excess cut off to keep the hose from kinking.
