SERVICE ACTION

Service Action
Number: N576v2

Coolant Level Sensor Loose	Subject:
	Publication No.: N576v2
	Model: Defender (LE)
	Model Year: 2020
	Date of Issue: 13 June 2022
	Expiry Date: 30 September 2023

SERVICE INSTRUCTION - N576V2

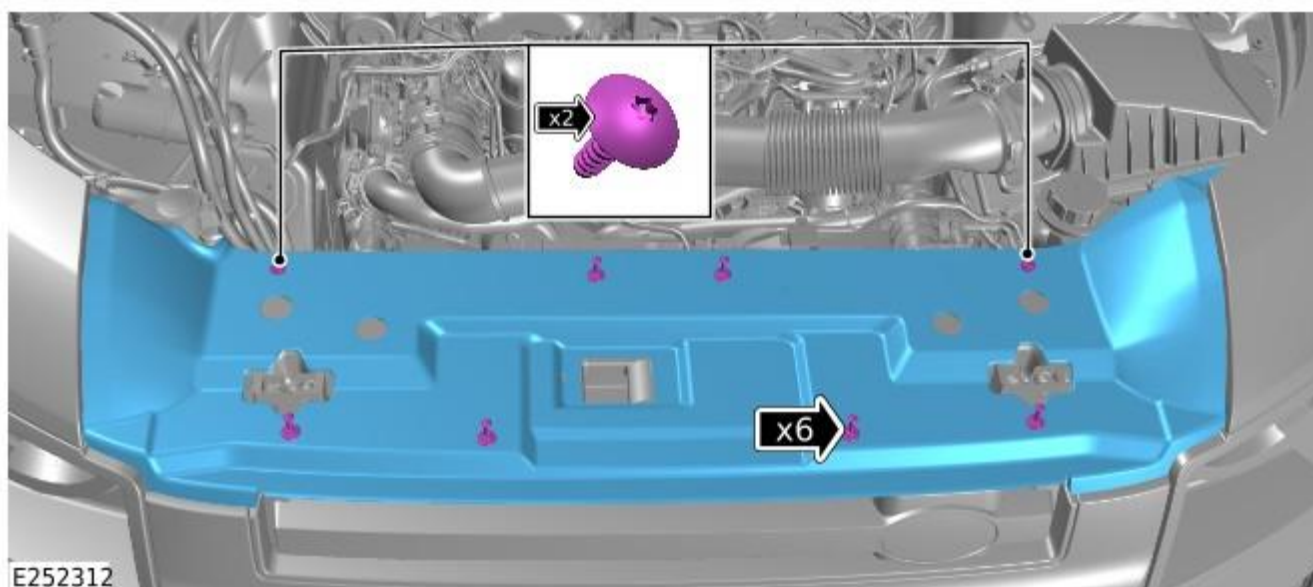
1. Remove the upper radiator grille panel.

- Remove the 2 bolts.
 - Torque: **5 Nm**
- Remove the 6 clips.

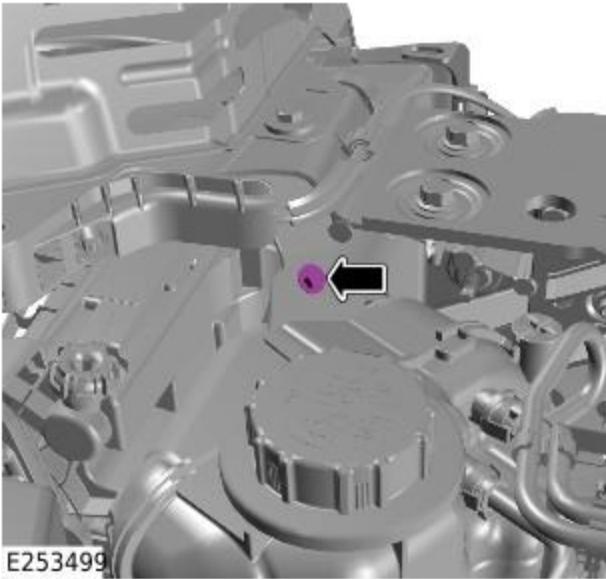
2. Remove the bolt from the coolant expansion tank bracket.

- Torque: **2.8 Nm**

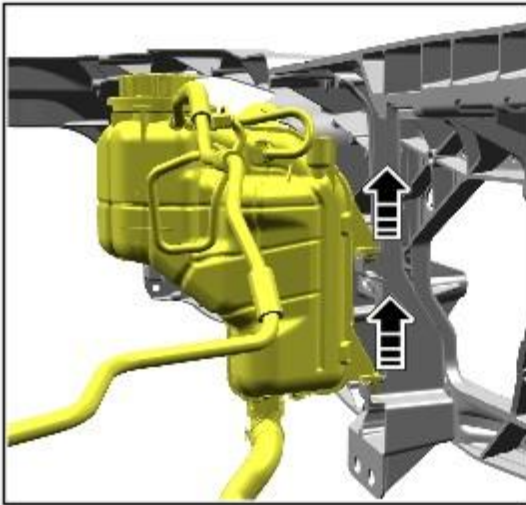
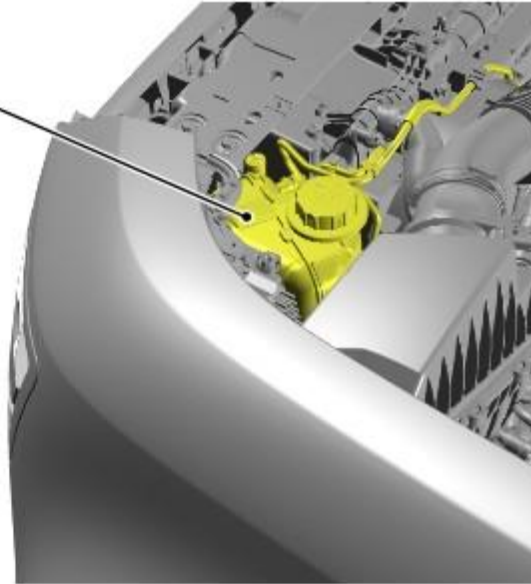
E253500

NOTE: The coolant expansion tank part number is located on the opposite side of the expansion tank to the Min/Max markings.

Release the coolant expansion tank and reposition upwards so the part number is visible.

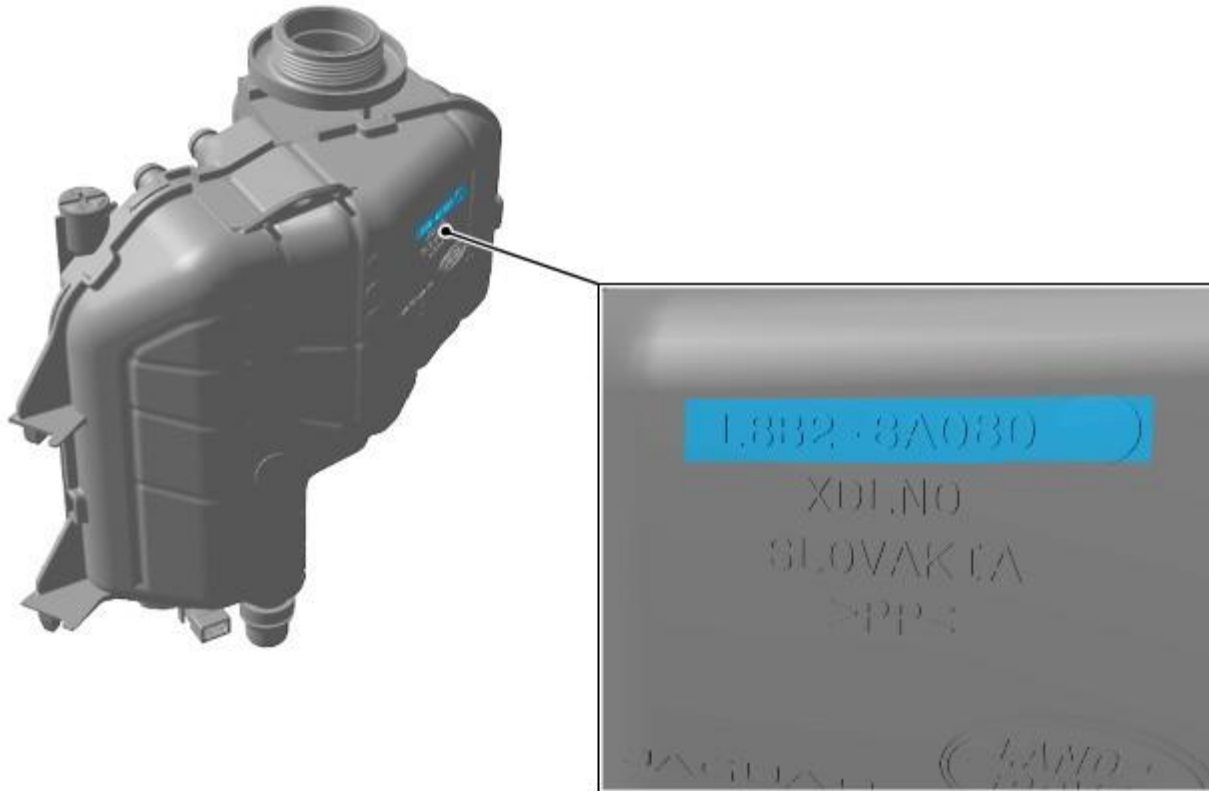
E283547

4. Inspect the coolant expansion tank part number.

- If the coolant expansion tank part number is **L8B2-8A080-AF** or **L8B2-8A080-AG**, reverse steps 1 to 3 and release the vehicle.
- If the coolant expansion tank part number is not **L8B2-8A080-AF** or **L8B2-8A080-AG**, continue to the Service Instruction.
