Technical Service Bulletin

| SUBJECT: | | No: TSB-21-42A-011REV2 | |
| MODIFIED HOOD FOR HOOD FLUTTER - 2022 OUTLANDER - REVISED | | DATE: June 2022 | |
| | | MODEL: 2022 Outlander | |

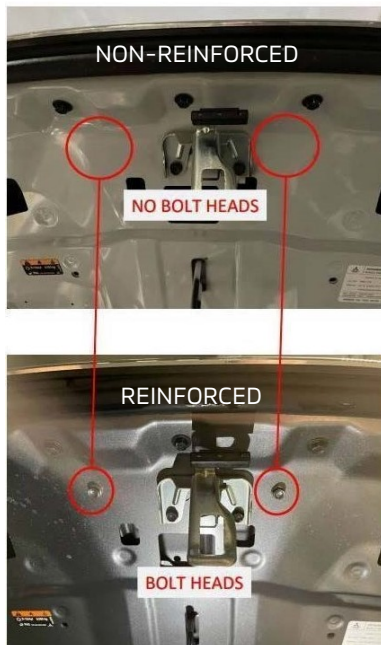
Method to determine if hood is reinforced (bolt heads) or non-reinforced (no bolt heads):
