Technical product information

Topic	HV battery will not charge - DTC's stored in address 19 (C11C5F2) and address C6 (P0D6D00) for the High Voltage System
Market area	Bentley: worldwide (2WBE)
Brand	Bentley
Transaction No.	2067185/1
Level	EH
Status	Approval
Release date

New Flying Spur Hybrid

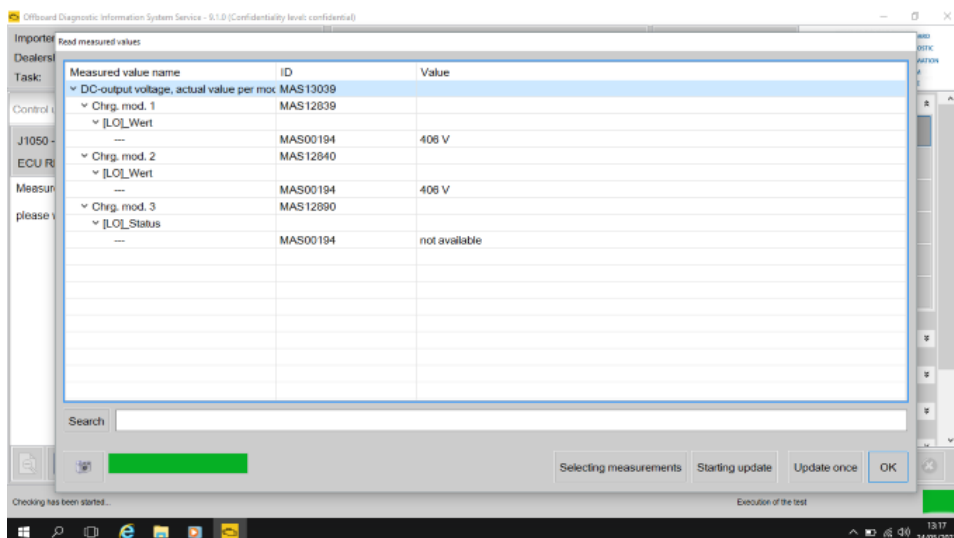
Internal harness failure of the High Voltage cable between the HV battery and the On-board charger

Select – 'MAS 13039 DC–Output voltage, actual value per module'

If both values read 0V then the High Voltage cable between the HV battery and the On-Board Charger must be replaced

4) Replace the High Voltage cable between the HV battery and the On-Board Charger

7) Repeat step 2, the voltages should now read HV Battery Voltage (approximately 400V)
