Technical Service Bulletin

22-ST-005H-1

JUNE 2022

SUBJECT: C-MDPS WORM SHAFT BEARING NOISE

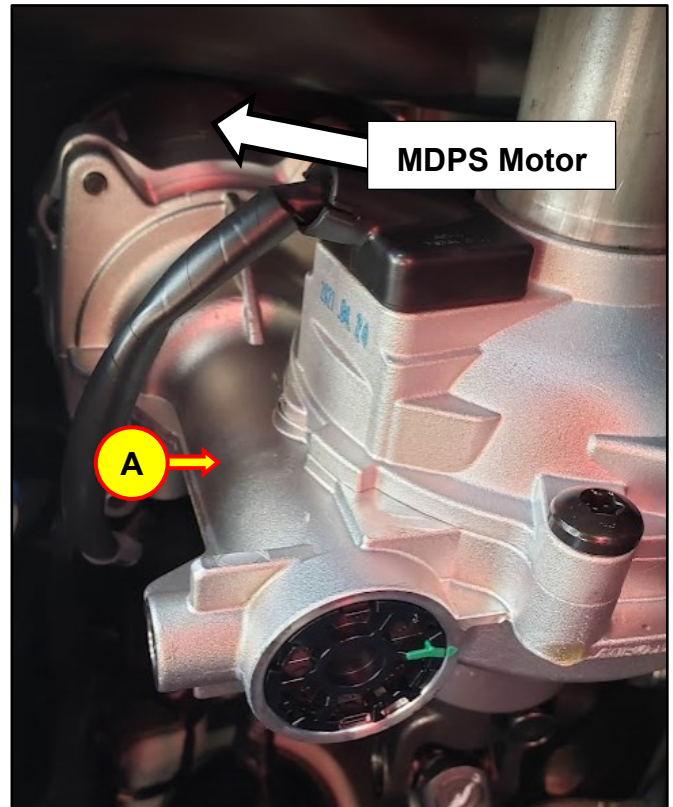
1. Determine if bearing noise comes from the MDPS column and housing.
 - Start the engine and turn the steering wheel left and right.
 - Listen for the bearing noise occurring from the worm shaft housing (A). This noise will be located near the C-MDPS motor on the steering column.
 - To hear an example of the bearing noise, refer to the link or QR code below.
<https://youtu.be/22Pl3hAEfnk>

2. Replace the worm shaft small bearing if noise is heard.

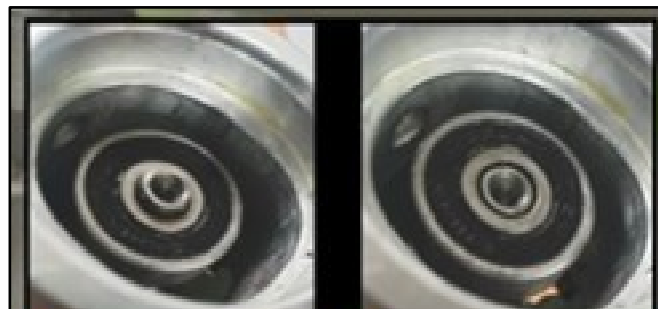
Ensure the bearing is fully seated and the end of the worm shaft is protruding approximately 1.2mm (0.047 inch).

OK
Bearing is seated properly. The end of the worm shaft is protruding.

Not OK
Bearing is not seated properly. The end of the worm shaft is flush with the bearing.

If the bearing did not seat as shown in the photo, increase the torque setting on the torque wrench and continue to slowly seat the bearing.
