HYUNDAI Technical Service Bulletin	GROUP AUTOMATIC TRANSMISSION	NUMBER 22-AT-008H
	DATE JUNE, 2022	MODEL SONATA HYBRID (DN8 HEV) SANTA FE HYBRID (TM HEV/PHEV) TUCSON HYBRID (NX4 HEV/PHEV)
SUBJECT: AUTOMATIC TRANSAXLE SOLENOID DTC P074800, P075300, P075800, P076300, P076800, P077300, P177800 & P270900

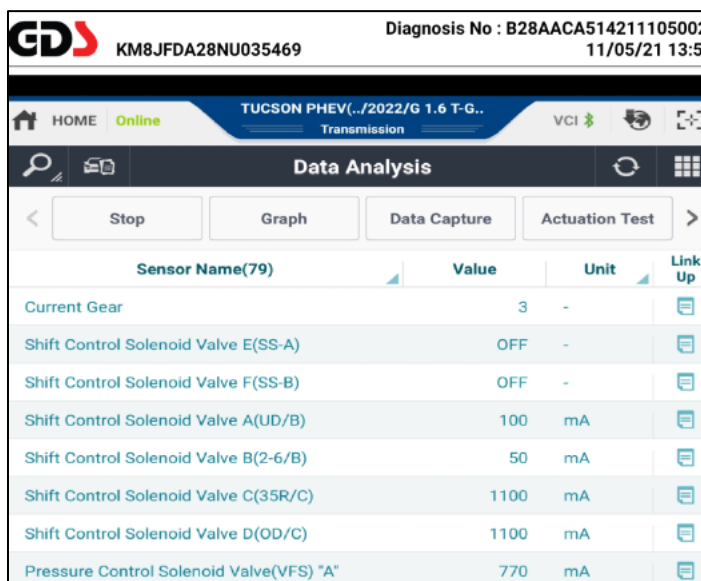
1. Attach a GDS and select **DTC Analysis** and **A/T** menu. Record the DTC and description. Delete the DTC.
2. From the GDS home screen, select **Data Analysis** and **A/T** menu and the parameters shown below. If the parameters show:
 - Continuous and changing output while driving, the wiring **currently** has no open/short circuits. Go to Step 4.
 - No continuous and changing output, go to Step 3.

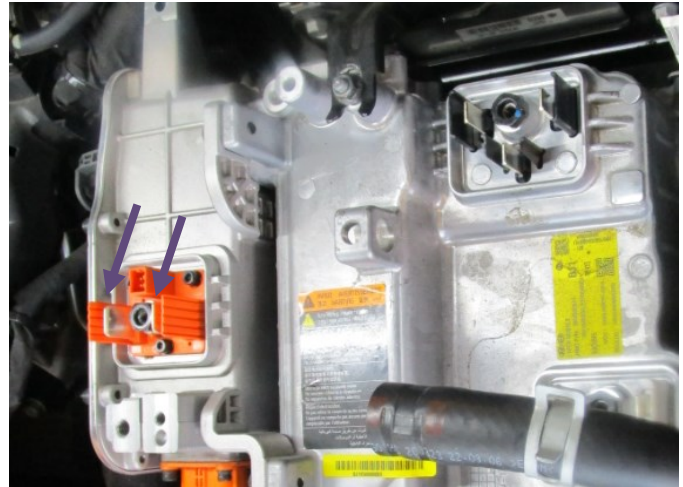
If more than **30V**, there is a fault on the high voltage circuit and the vehicle is not safe to work on.

8. Wait more than **3 minutes** so the capacitor in the high voltage system can be discharged.

Measure the voltage between the **inverter (+ terminal)** and **(-) terminal**.

If the voltage is below **30V**, the high voltage circuit has been disconnected.

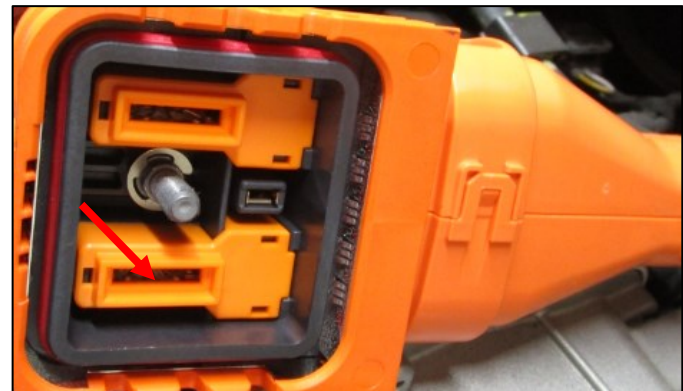
If more than **30V**, there is a fault on the high voltage circuit and the vehicle is not safe to work on.

11. Measure the voltage between the power cable **(-) terminal)** and **chassis ground**.

If the voltage is below 30V, the high voltage circuit has been disconnected.

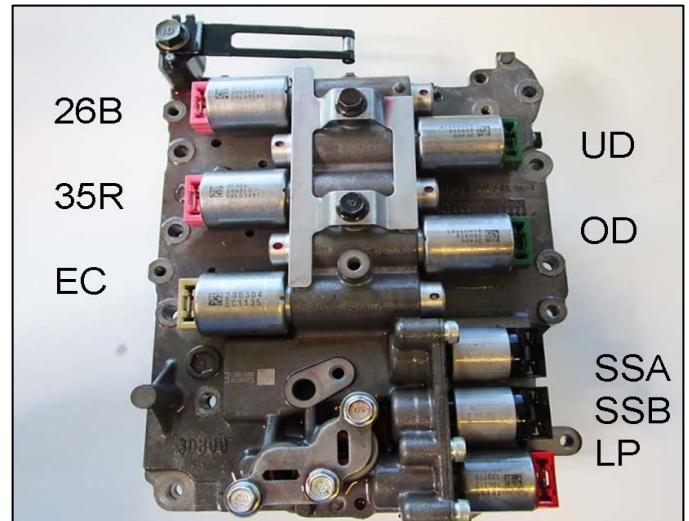
DTC	SOLENOID	
P075300	UD	Shift solenoid A
P076800	OD	Shift solenoid D
P077300	SSA	Shift control solenoid E
P270900	SSB	Shift control solenoid F
P074800	LP	Pressure control solenoid
P075800	26B	Shift control solenoid B
P076300	35R	Shift solenoid C
P177800	EC	Engine clutch solenoid

28. Refer to the DTC recorded in Step 1 and replace the related solenoid.

Reinstall the roller pin and/or support.
