Service Bulletin

Bulletin No.: 19-NA-076

Subject: Blue or Black Screen and Service Rear Vision System Message on Radio Display Shifting into Reverse

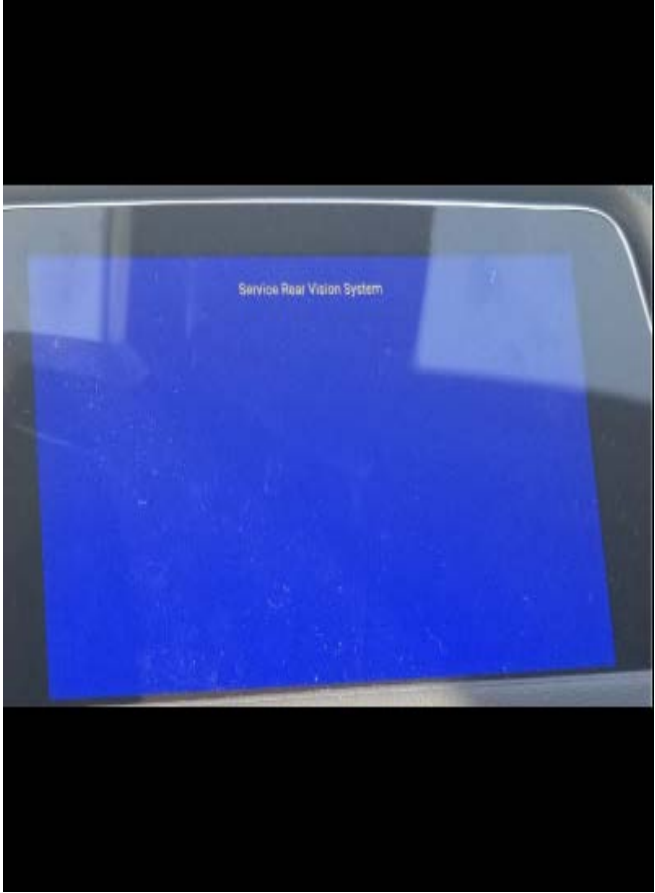
<p style="text-align: right;">5733397</p>

Blue Screen

If the **blue** or **black** screen condition exists, it will occur every time the rear view is displayed to the customer within the same power cycle and may return to normal functionality on the next power cycle after the A11 radio enters and exits a sleep cycle. A DTC of B395A Symptom Byte 08, 72 and 3A will be stored as history together in the A11 Radio.

<p>Cause</p>	<p>The cause of the condition may be software anomalies in the Video Processing Module (VPM) or rear camera.</p>
<p>Correction</p>	<ul style="list-style-type: none"> • Vehicles with UV2/UVI/UVS — reprogram the Video Processing Module (VPM). • Vehicles with UVB — replace the rearview camera.
