# Service Bulletin

Bulletin No.: 20-NA-104

**Subject:** Malfunction Indicator Lamp (MIL) Illuminated – 5V Reference, Reduced Power, Extended Crank, Body Harness to Fuel Tank Damage

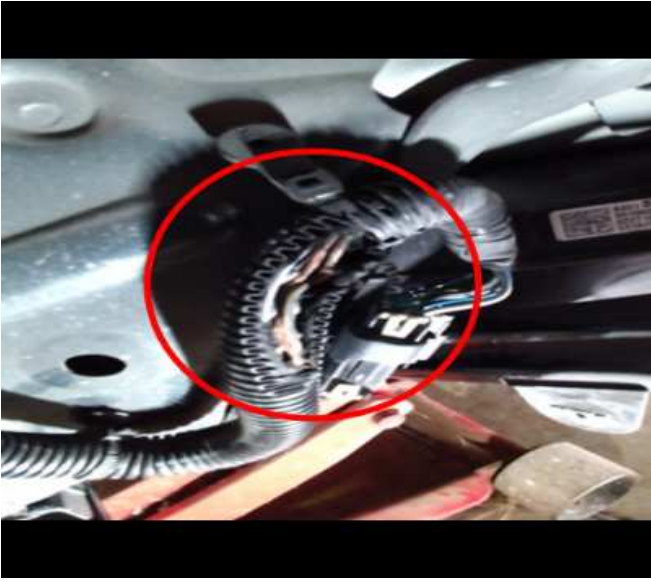
| <b>Cause</b> | <p style="text-align: right;">5599085</p> <p>This concern may be caused by a damaged body to fuel pump harness.</p> |

| <p><b>Correction</b></p> | <p style="text-align: right; font-size: small;">5599088</p> <p>Inspect the left rear wheelhouse liner for a rub through condition due to incorrect tire size.</p> |
