Service Bulletin

Bulletin No.: 21-NA-026

Subject: Information on Accessory All-Weather Floor Liners and Flat Mats Warped or Mis-shapen

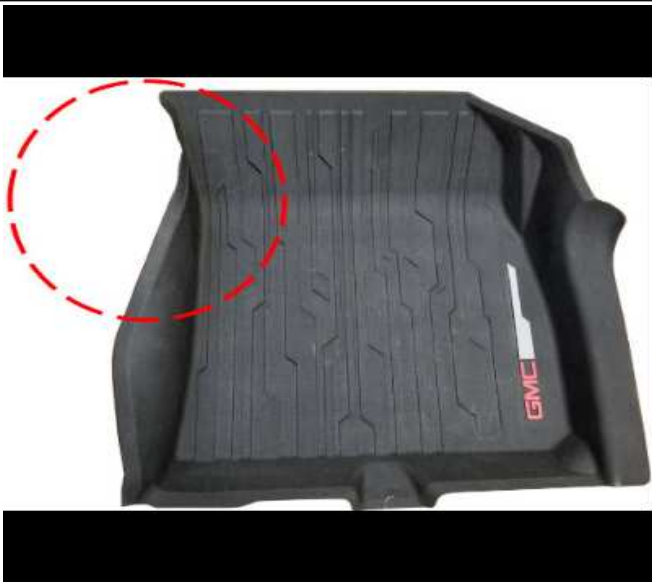
<p>5721505</p> <p>Note: An example of a warped part is shown in the graphic above.</p> <p>Dealership personnel/customers may comment that the accessory all-weather floor liners/flat mats appear to be warped and do not fit the vehicle as intended.</p>
Cause	The cause of the warped part(s) is the result of the packaging and the shipping process. Excess handling and extreme conditions may result in deformed parts.
Correction	<p>Attempt to reshape the all-weather floor liner/flat mats following the steps in the Service Procedure below.</p> <p>In cases where the part reshaping is not successful, re-order and return the warped parts to ADI (U.S.). In Canada, submit a claim through Parts Workbench and return as "New Defective (Impedes normal function)."</p>
