Service Bulletin

Bulletin No.: 21-NA-188

Subject: Radio Software Version V158 Update

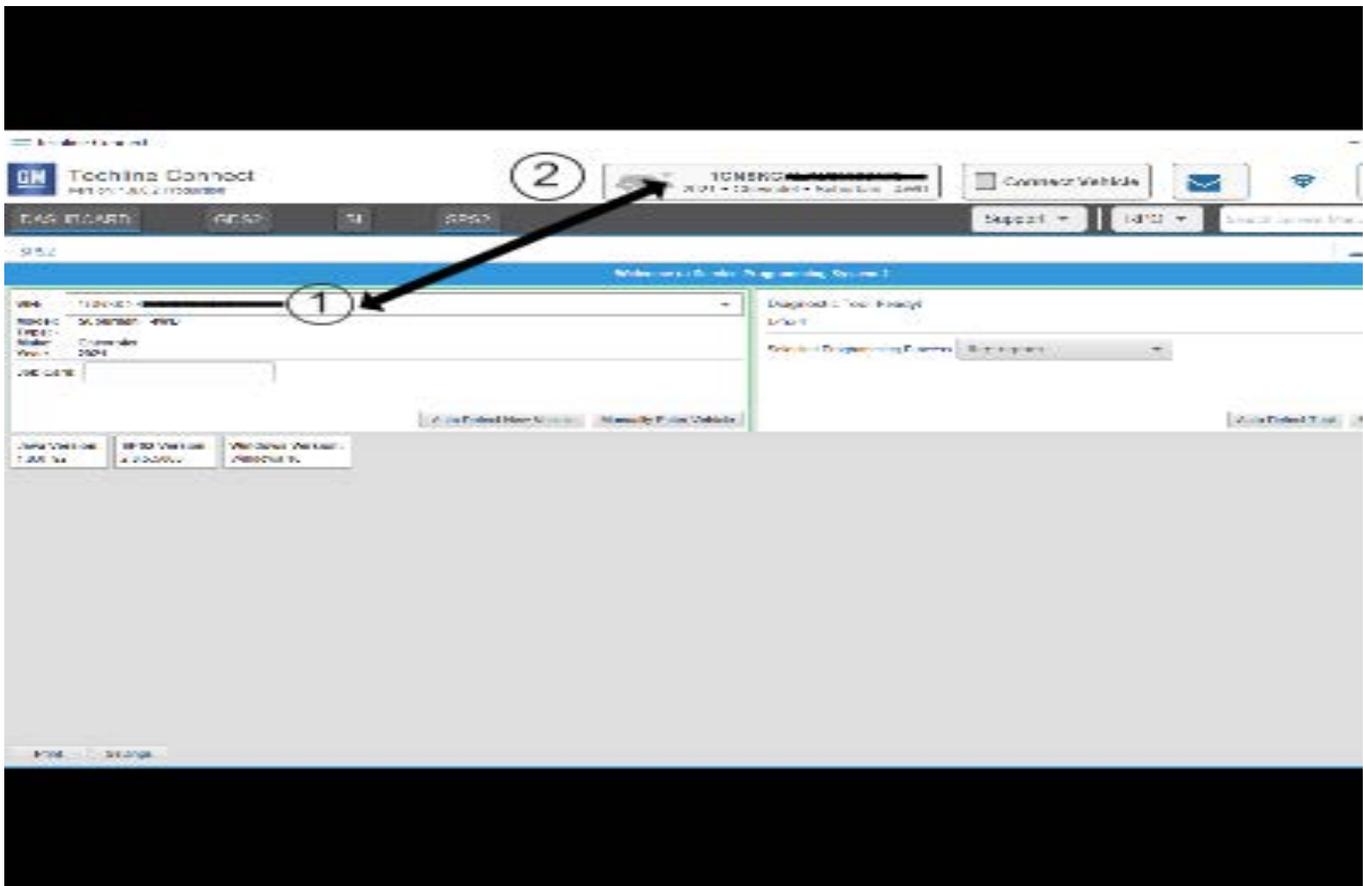
Caution: Be sure the VIN selected in the drop down menu (1) is the same as the vehicle connected (2) before beginning programming.

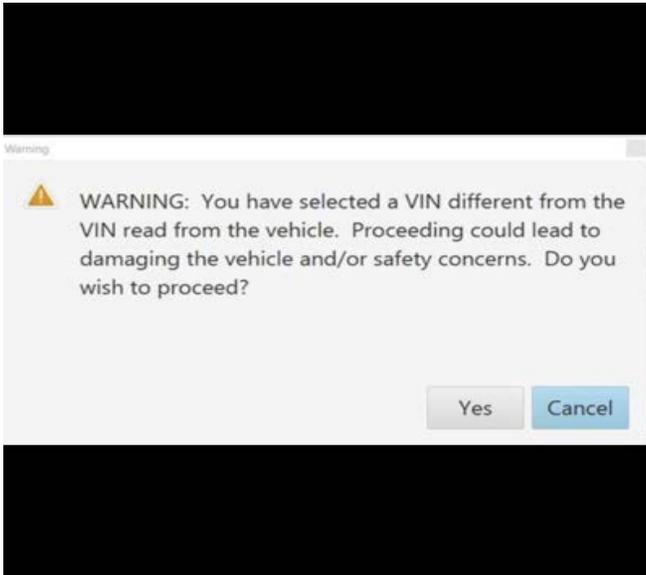
5877000

Important: If the vehicle VIN DOES NOT match, the message below will be shown.

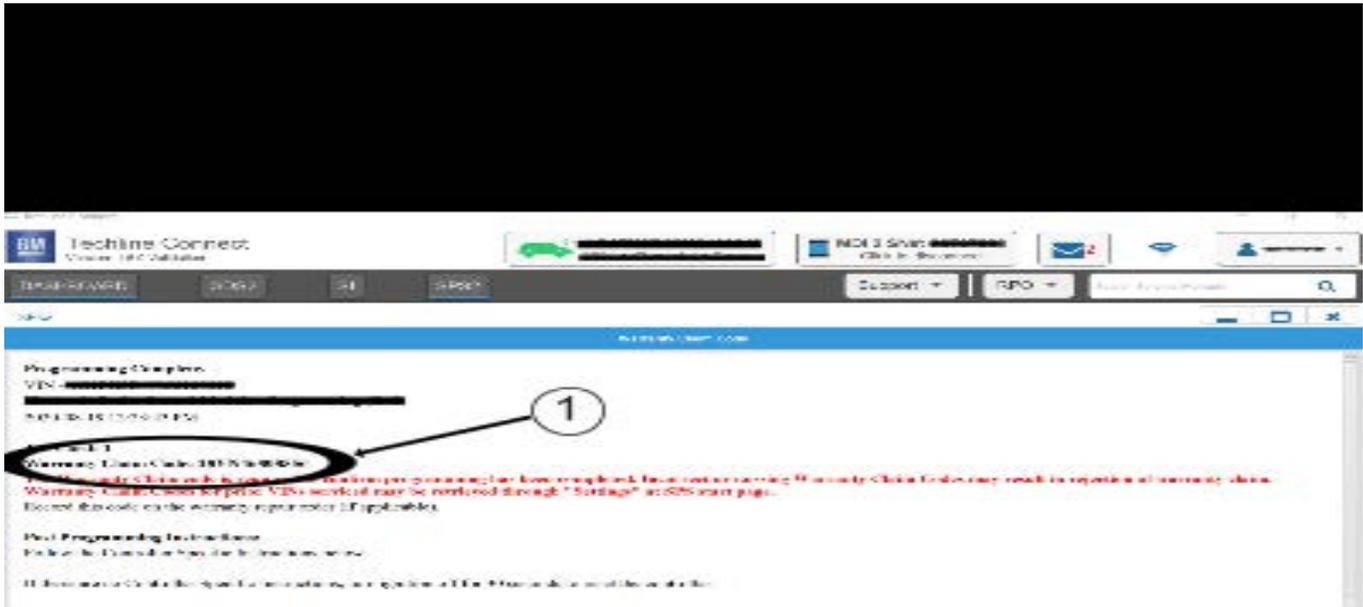
Note: The screenshot above is an example of module programming and may not be indicative of the specific module that is being programmed. Module selection and VIN information have been blacked out.

Important: To avoid warranty transaction rejections, you **MUST** record the warranty claim code provided on the Warranty Claim Code (WCC) screen shown above on the job card. Refer to callout 1 above for the location of the WCC on the screen.
