Service Bulletin

Bulletin No.: 22-NA-133

Subject: Convertible Wind Noise at Rear Quarter Glass

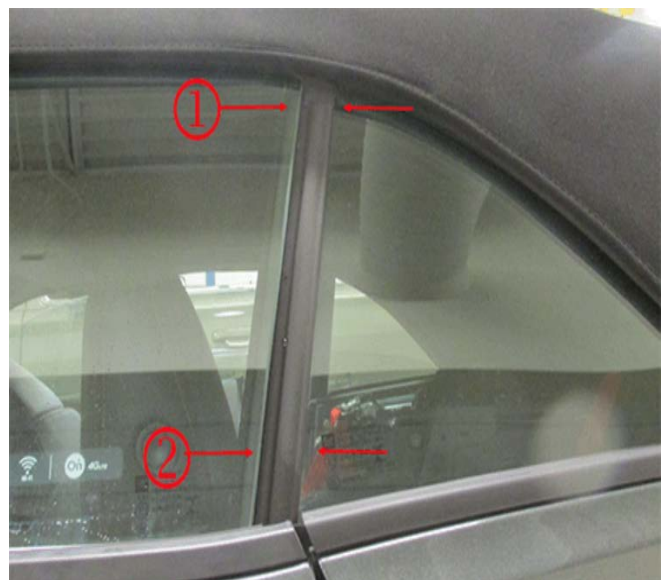
4805542

between the rear quarter window and the front side window, there are three measurements that must be checked / adjusted. The first two measurements are actually both related to the vertical gap between the front side window and the rear side window. The vertical gap between these two windows is not parallel. It is actually "V-shaped" by design. When in the relaxed position, (folding top is stowed or in the lowered position) the gap at the top between the 2 windows is 12 mm wide, and the gap at the bottom of the glass between these two is actually 10 mm. This adjustment **MUST** be made with the folding top in the stowed or lowered position. The reason for this is when the top is closed and latched, it pinches the windows together and pushes the top of the quarter glass forward slightly. The result is an even, 10 mm gap between the two windows from top to bottom. This even gap can be seen in the photo above as the folding top is in the raised, or closed position.

The third measurement / adjustment that must be made is the height of the rear quarter glass. It should be located so that it sits 4 mm higher than the front side window glass. This can also be seen in the photo above.

1. Rear Quarter Glass
2. Front Side Glass
3. 4 mm difference in height

The first step in diagnosing a wind noise is to confirm the noise is actually coming from the side window area. Dealership technicians are to tape off this gap between the front side window and the rear quarter window. Test drive the car to verify the noise has been eliminated. If so, the quarter glass to front side window gap may be mis-adjusted. To correctly set the gap / location

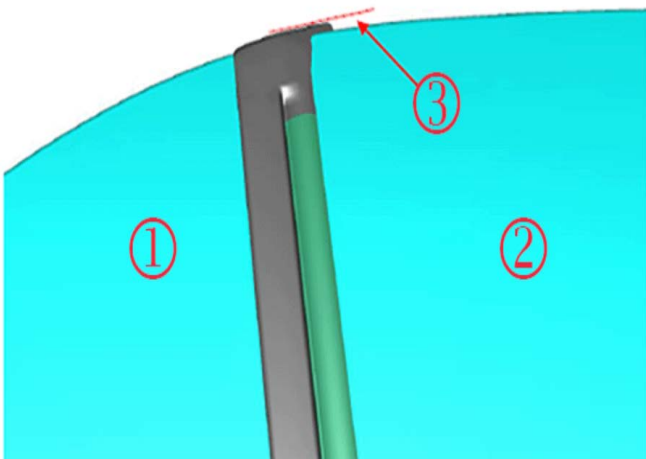
4784706

Once the quarter window is adjusted into position, compare the 2 panes of glass at the base to make sure they are flush with each other (inboard vs outboard). If the difference between the front and rear windows is more than 1.5 mm, or if there is a visible gap / daylight can be seen between the seals, the rear quarter glass needs to be adjusted further.
