Service Bulletin

Bulletin No.: 22-NA-094

Subject: Loss of Cabin Heat

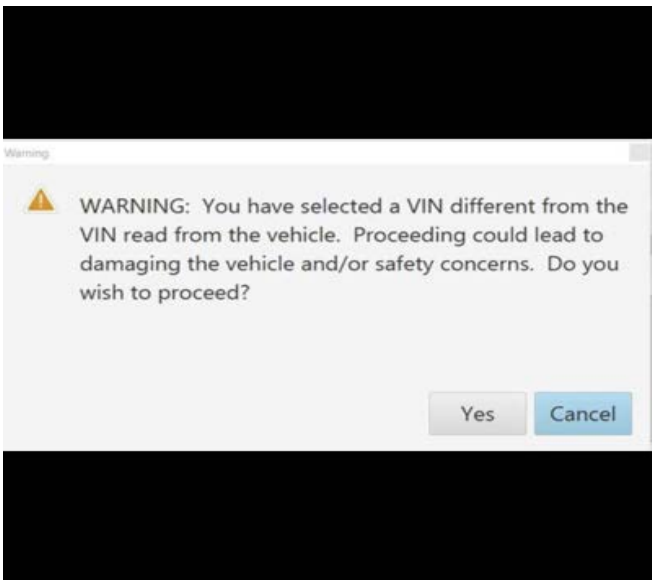
5877000

Important: If the vehicle VIN DOES NOT match, the message below will be shown.
