GLOBAL SAFETY FIELD INVESTIGATIONS
DCS6213
URGENT - DISTRIBUTE IMMEDIATELY

Subject: N222358700 - Service Update
Mass Air Flow Drift

Models: 2022 Cadillac XT4
Equipped with 2.0L, 4-cylinder engine (RPO LSQ)

N222358700 Mass Air Flow Drift

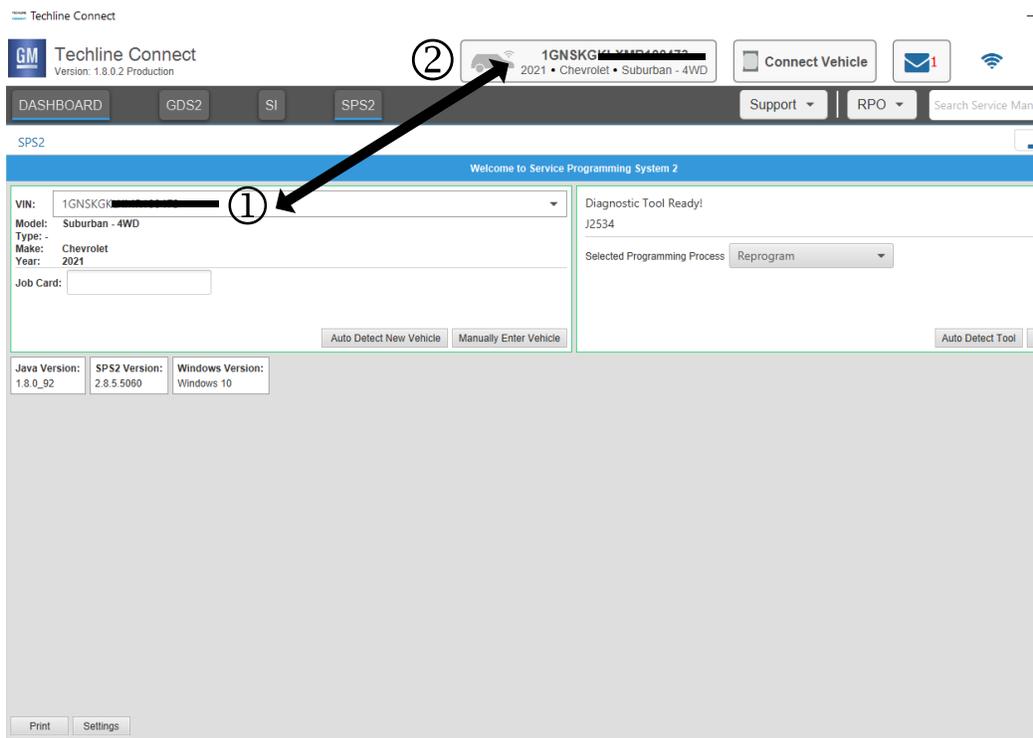
5743643

Caution: Be sure the VIN selected in the drop down menu (1) is the same as the vehicle connected (2) before beginning programming.

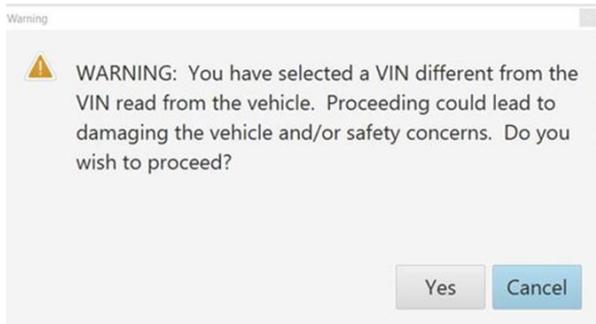
5877000

Important: If the vehicle VIN DOES NOT match, the message below will be shown.

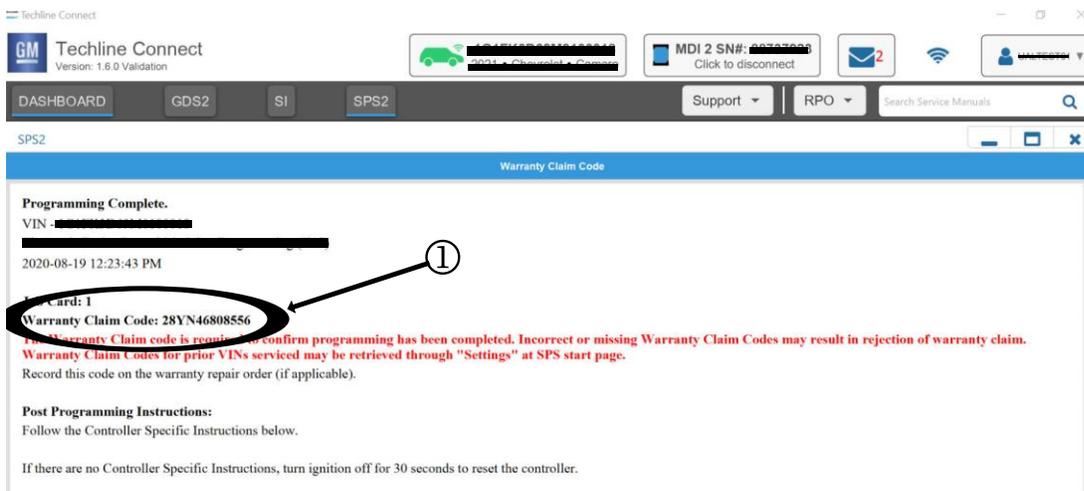
5644478

Important: To avoid warranty transaction rejections, you **MUST** record the warranty claim code provided on the Warranty Claim Code (WCC) screen shown above on the job card. Refer to callout 1 above for the location of the WCC on the screen.

- Record SPS Warranty Claim Code on job card for warranty transaction submission.
