Special Coverage Adjustment

N192266181 Wiper Transmission Arm Linkage Failure – USA Only

Release Date: July 2022

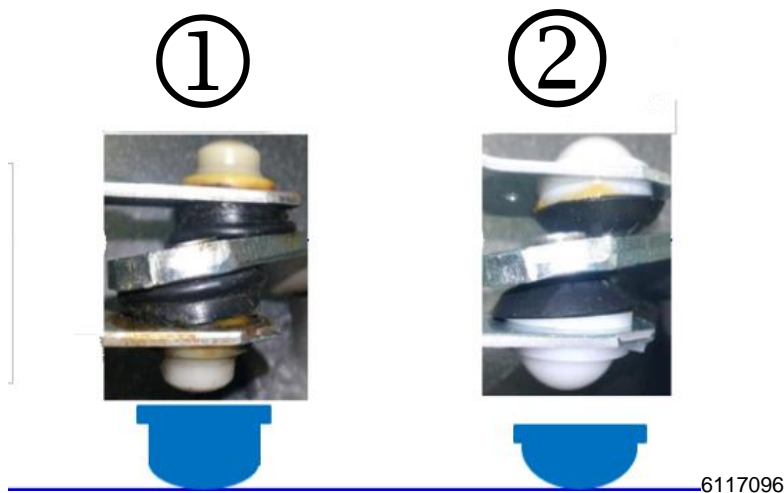
There are two types of nylon pivot cups.

- If the module has a “top hat” design (1), proceed with the link replacement procedure.
- If the module has “dome shaped” design (2), Replace the module assembly.

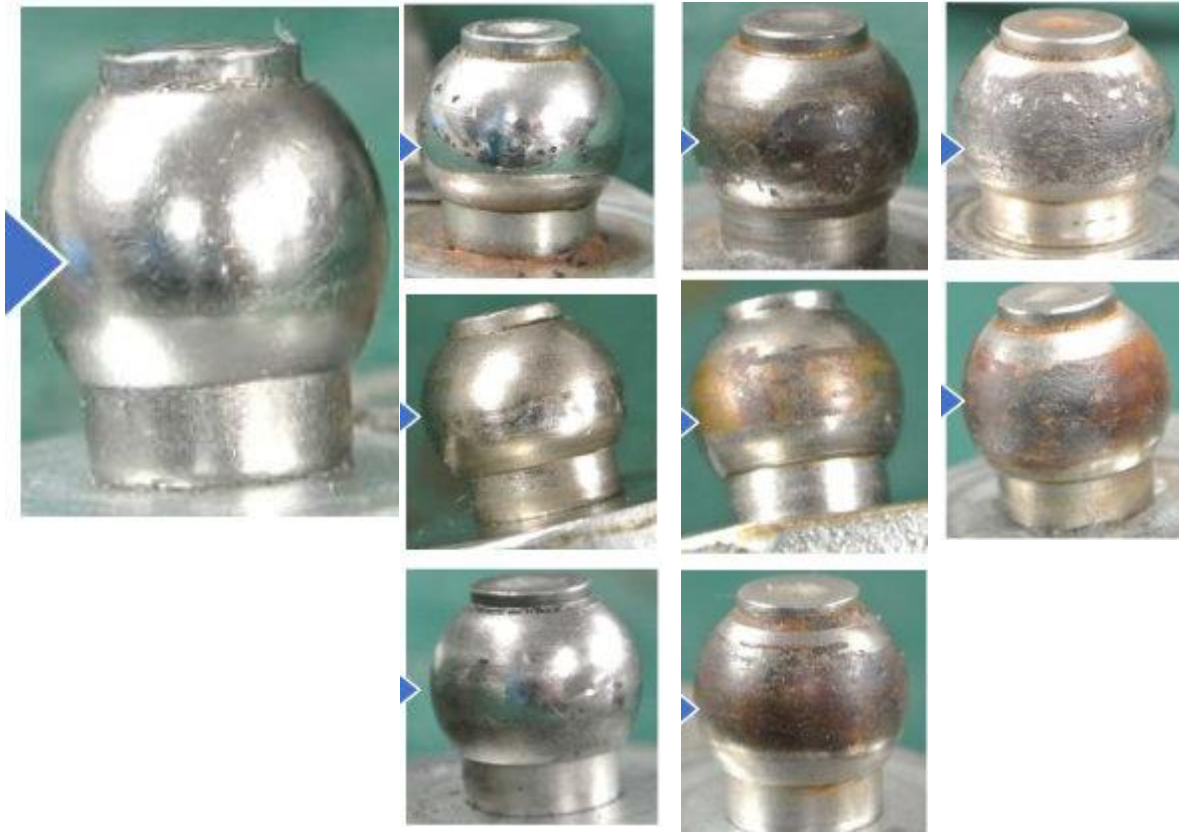
- Using a suitable aerosol solvent and a small wire brush or abrasive pad, clean the old grease and debris from the ball joints. Wipe the ball joints clean with a suitable disposable towel.
- With the ball joints cleaned, inspect the surface for severe damage (material missing).

The below examples are acceptable levels pitting, flaking and rust residue
