SIB 17 01 22

CHECK CONTROL MESSAGE: TOP UP COOLANT

G01 (X3 Sports Activity Vehicle)	G02 (X4 Sports Activity Coupe)	G05 (X5 Sports Activity Vehicle)	G06 (X6 Sports Activity Coupe)
G07 (X7 Sports Activity Vehicle)

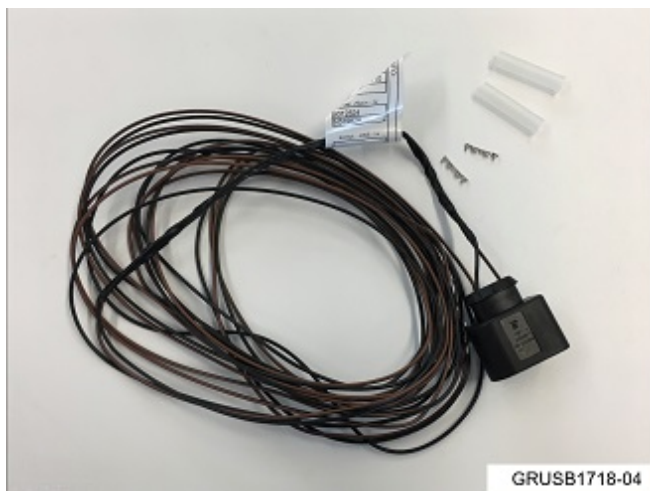
Corrosion on the pin contacts for the coolant level sensor in the expansion tank.

- Remove the protective tape approximately 4 inches away from the connector
- Cut the connector off the harness
