Subject: Child Safety Lock with Update Unsuccessful Message on Infotainment Screen

Brand:	Model:	Model Year:		VIN:		Engine:	Transmission:
		from	to	from	to		
Cadillac	CT4	2021	2022	—	—	—	—
	CT5

Involved Region or Country	United States, Canada, Middle East, China
Condition	Some customers may comment on a message reading UPDATE UNSUCCESSFUL on the infotainment screen. Note: An over-the-air update was released to correct a concern with the Child Safety Lock but did not complete properly if this message is displayed.
Cause	The cause of the condition may be an over-the-air update for the Body Control Module (BCM) failed to complete.
Correction	Update the BCM with the latest released software.

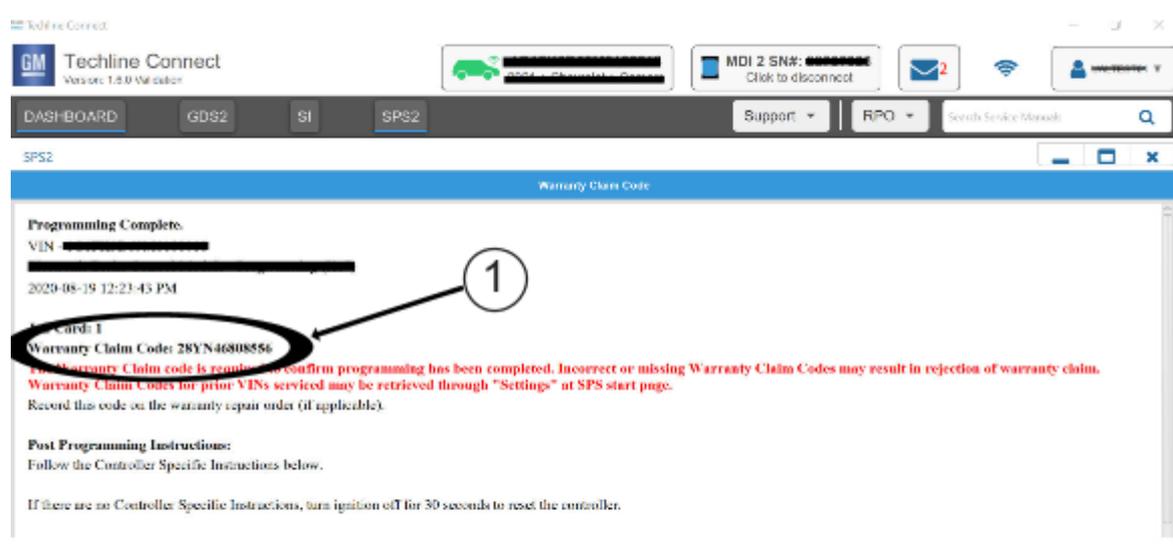
5644478

Important: To avoid warranty transaction rejections, you **MUST** record the warranty claim code provided on the Warranty Claim Code (WCC) screen shown above on the job card. Refer to callout 1 above for the location of the WCC on the screen.

2. Record the Warranty Claim Code on the job card for warranty transaction submission.
