# Service Bulletin

Bulletin No.: 22-NA-040

Date: February, 2022

**Subject: 2022 Enhanced Driver Information Center 8" (UHS) Digital Display Off Center**

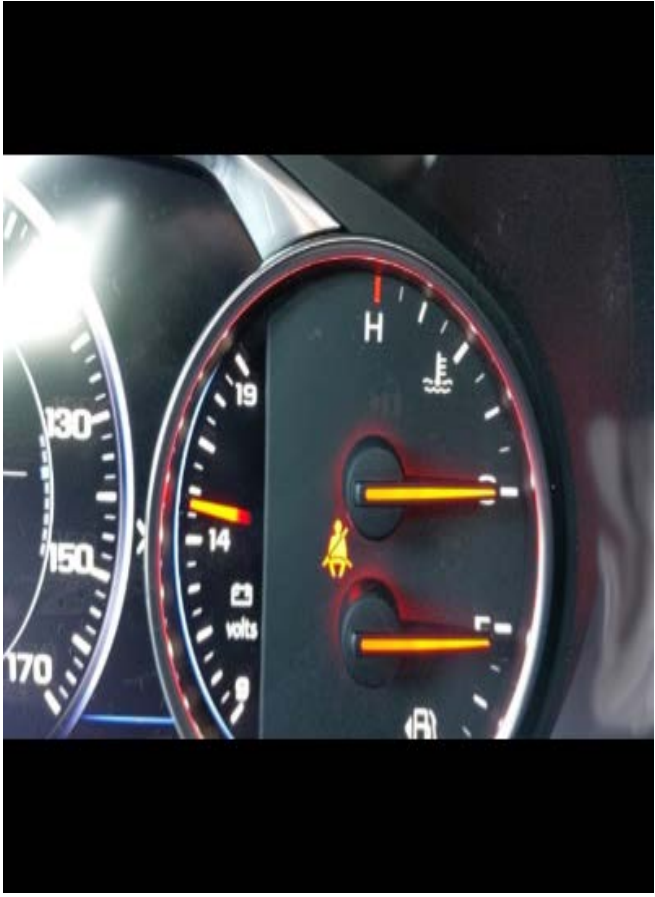
<b>Involved Region or Country</b>	North America, Europe, Middle East, Israel, Palestine, Chile, Colombia, Paraguay, Peru, Japan, Cadillac Korea (South Korea), China, Thailand
<b>Condition</b>	Some customers may comment that the digital gauges are off center from the cluster trim rings.

<p><b>Cause</b></p>	<p>The cause of the condition may be a software anomaly causing the digital display to shift 1–1.5 mm and appear off center from the cluster opening.</p>
<p><b>Correction</b></p>	<p>Update the instrument panel cluster (IPC) via USB to the latest version.</p>
