# Technical Service Bulletin

## 72 Seat fore-and-after adjustment incorrect

72 22 45 2058268/2 July 12, 2022. Supersedes Technical Service Bulletin Group 72 number 20-22 dated January 17, 2020, for reasons listed below.

Model(s)	Year	VIN Range	Vehicle-Specific Equipment
R8 Spyder	2017	901529 – 905737	Not Applicable
	2018	900030 – 900262

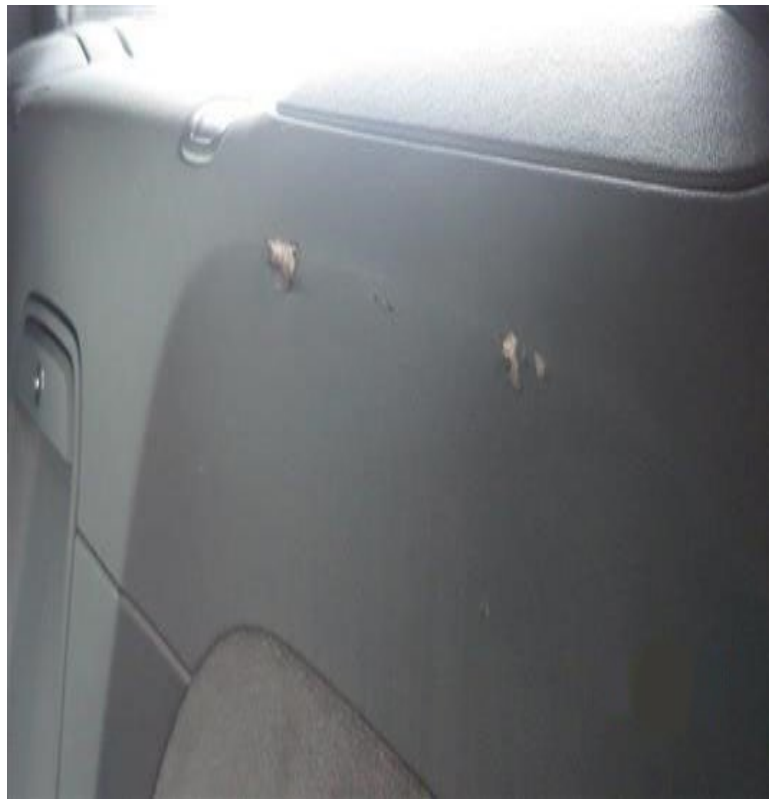
- One or both sides seat backrest panels chafe on the rear panel trim panel and/or windscreen resulting in damaged trim panels and/or windscreen.

On R8 Spyders with sport seats and fully electric seats, the seats can be adjusted to positions that allow for mechanical interference between the seat backrest panels and the rear panel trim panel and/or windscreen during normal operation. This interference can result in damaged trim panels and/or windscreen (Figure 1).

*Figure 1. Damaged rear panel trim panel.*

2. Update the seat control modules J136, (address word 0036) and J521, (address word 0006) using the SVM action code as listed in the table below, if necessary:

3. Perform basic settings of the seats via Guided Functions in ODIS Service.
4. Replace any damaged seat backrest panels, rear panel trim panels, and/or the windscreen according to the repair manuals in Elsa.

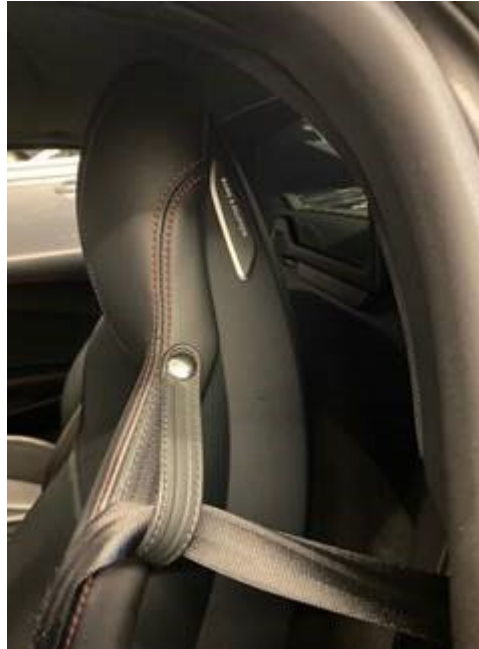
In some cases, the seats cannot be adjusted backward far enough (Figure 2).

*Figure 2. Seat not moving backward far enough.*
