### 90 Instrument cluster: trip odometer and/or clock sporadically resets to zero

90 22 76 2064301/3 July 11, 2022. Supersedes Technical Service Bulletin Group 90 number 22-47 dated January 28, 2022, for reasons listed below.

Model(s)	Year	VIN Range	Vehicle-Specific Equipment
A3	2021	All	With FPK

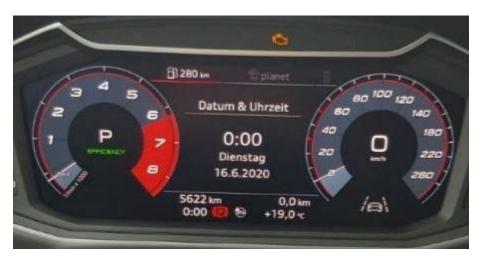
• The trip odometer and/or the clock in the instrument cluster will sporadically reset to zero (Figure 1).

Figure 1. Clock and trip odometer reset to zero.

A software issue in the instrument cluster can cause it to reset on start-up clearing the clock and trip odometer.

- 1. Follow all instructions in TSB 2011732: 00 Software Version Management (SVM), operating instructions.
- 2. Update the instrument cluster, J285 (address word 0017) using the SVM action code as listed in the table below, if necessary:

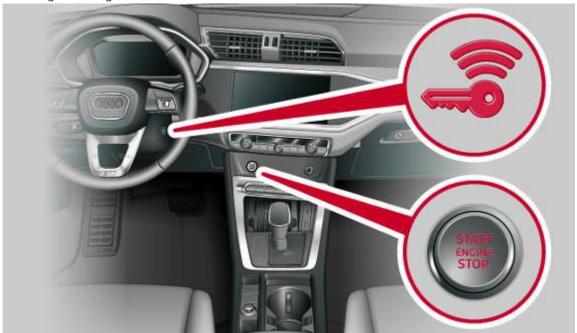
Figure 2. Key reader coil location.

• Affix the vehicle key to the key reader coil before starting the update (for example with adhesive tape), then turn on the ignition (Figure 2).
