Service Bulletin

Bulletin No.: 22-NA-138

Subject: Information on Appearance of the Male Buckle on the Front Seat Belt Retractor Being Different in Side to Side Comparison

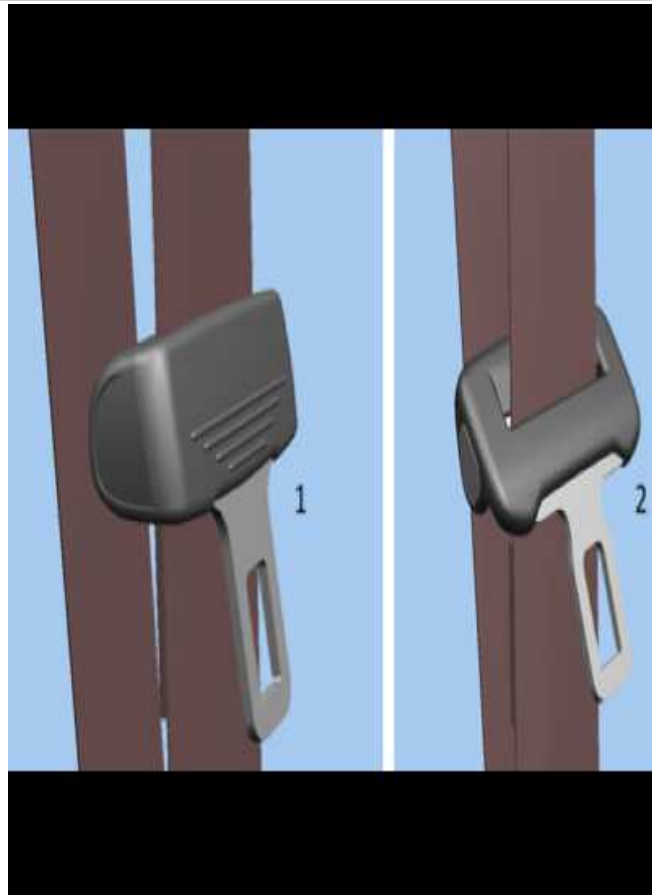
6116836

Note: Vehicles may have the original, standard front male buckle (1) on both sides, the temporary, optional front male buckle (2) on both sides, or one of each.

The cause of the condition may be that due to a supplier part shortage, on certain Equinox and Terrain vehicles, an optional, validated male buckle design was temporarily used in production of the front seat belt retractor.

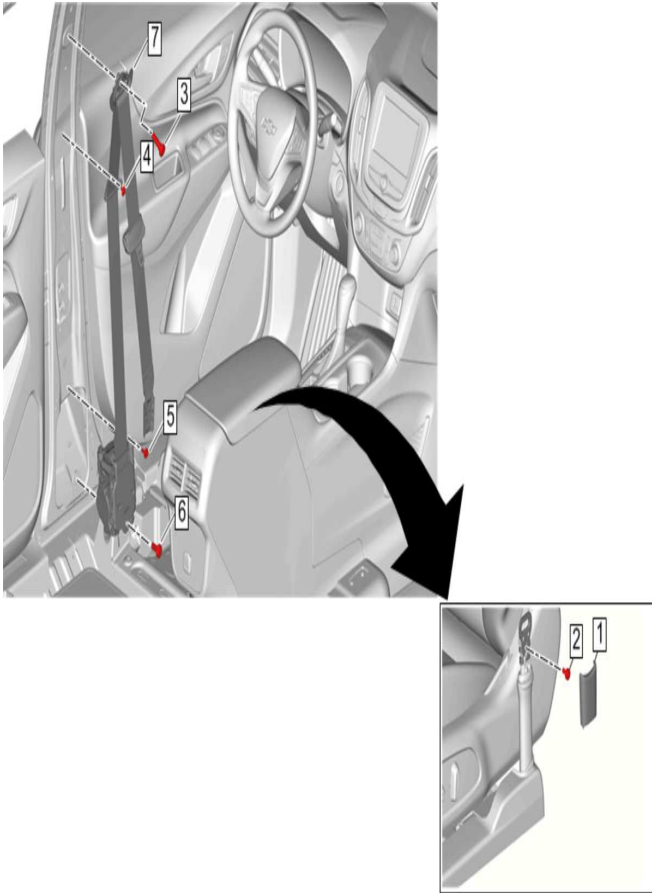
4601414

If a customer comments their dissatisfaction with the mixed buckles side to side, the **optional** design retractor (2) can be replaced.

Replace the affected driver or passenger seat belt retractor (7). Refer to *Front Seat Belt Retractor Replacement*, in SI.
