Preliminary Information

PIT5912C Lane Keep Assist Unavailable / Adaptive Cruise Control Inop / Service Driver Assist Systems / Amber Front Collision Icon On / Dead Battery / No Crank / Front View Camera DTC U3000 49

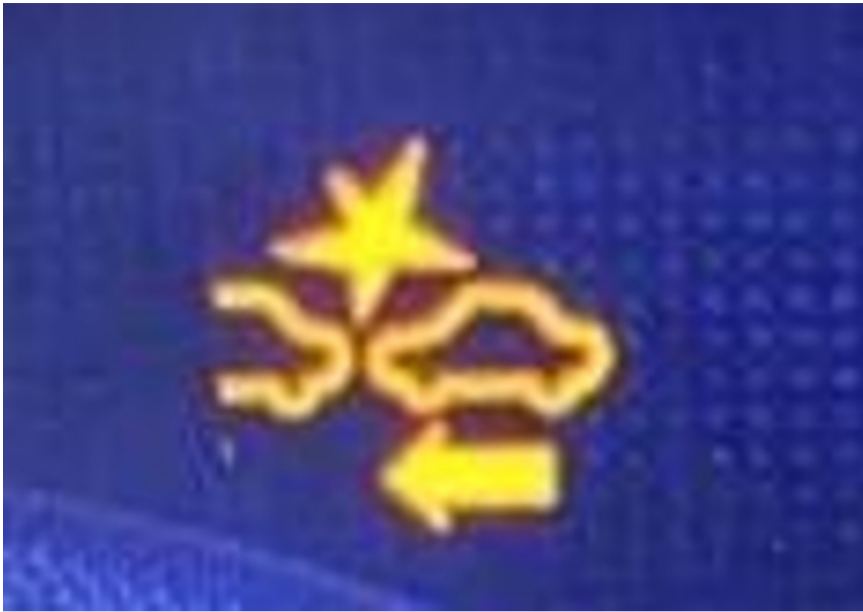
| Condition | <p>Some customers may comment on an amber Forward Collision icon displayed in the IPC, as shown below. Also, DTC U3000 sym49 may or may not be set current in the Front View Camera Module. In some cases, there could be a low or dead battery condition. Customers may also notice certain features related to the Front View Camera are unavailable, such as:</p> <ul style="list-style-type: none"> - Forward Collision Alert (RPO: UEU) - Following Distance Indicator (RPO: UE4) - Low Speed Collision Mitigation Braking (RPO: UHY) - Pedestrian Collision Mitigation Braking (RPO: UKJ) - Lane Keep Assist (RPO: UHX) - Automatic High Beam Assist (RPO: TQ5) - Adaptive Cruise Control (RPO: KSG) |
| Cause | The cause of this concern could be Onstar performing a task, which causes the B174W Front View Camera to set the DTC and disable during the next vehicle start up. |

Perform the following to repair the concern:

Note: If the battery was low or dead, then charge and test the battery. The battery may require charging a second time before it will pass the test.

1. Turn the ignition off.
2. Remove the F11DR fuse for the B174W Front View Camera, located in the X51R Right Instrument Panel Fuse block.
3. Leave the fuse removed for 1 minute, then reinstall the fuse.
4. Clear any DTC's and check camera operation.
5.
 - If the camera operation has returned, then no further action is required.
 - If the camera operation has NOT returned, then perform a camera relearn using GDS2.
6.
 - If the camera operation has returned after the camera relearn, then no further action is required.
 - If the camera operation has NOT returned after the camera relearn then perform normal SI diagnostics and repair as necessary.

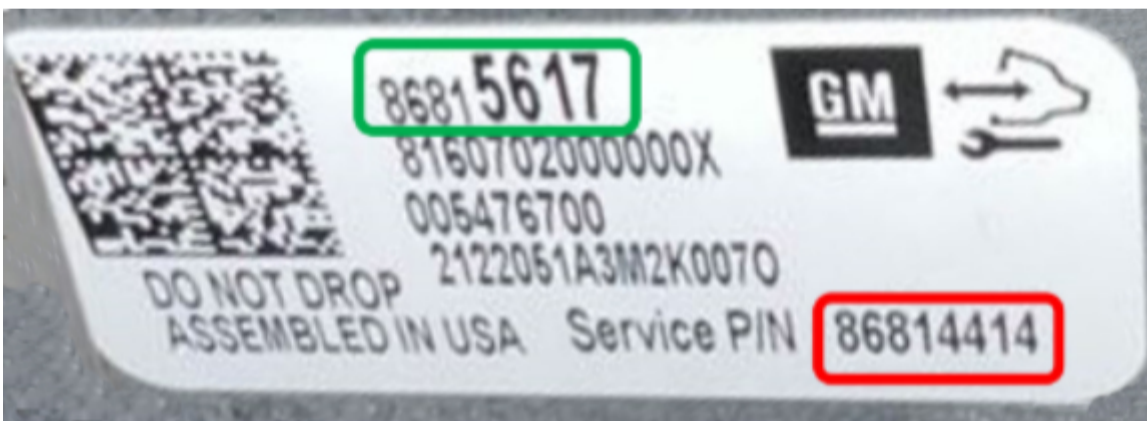
Note: If it is necessary to replace the Front View Camera, be sure to use the correct Part Number listed in the Electronics Parts Catalog. The Original Front View Camera may have "Service P/N 86814414" printed on the label (circled in red below) and that is the incorrect Part Number for this vehicle. Correct Part Number to use is in location circled in green below. If the part was ordered incorrectly it can be returned to the PDC using the correct MR return code.
