Bulletin No.: PIC6462  
Published date: 06/20/2022

## PIC6462 Mode Control Cable Kinks - Mode Control Inoperative C60 Models

Brand:	Model:	Model Years:	VIN:		Engine:	Transmissions:
			from	to		
Chevrolet	Spark	2016 - 2020	All	All	All	All

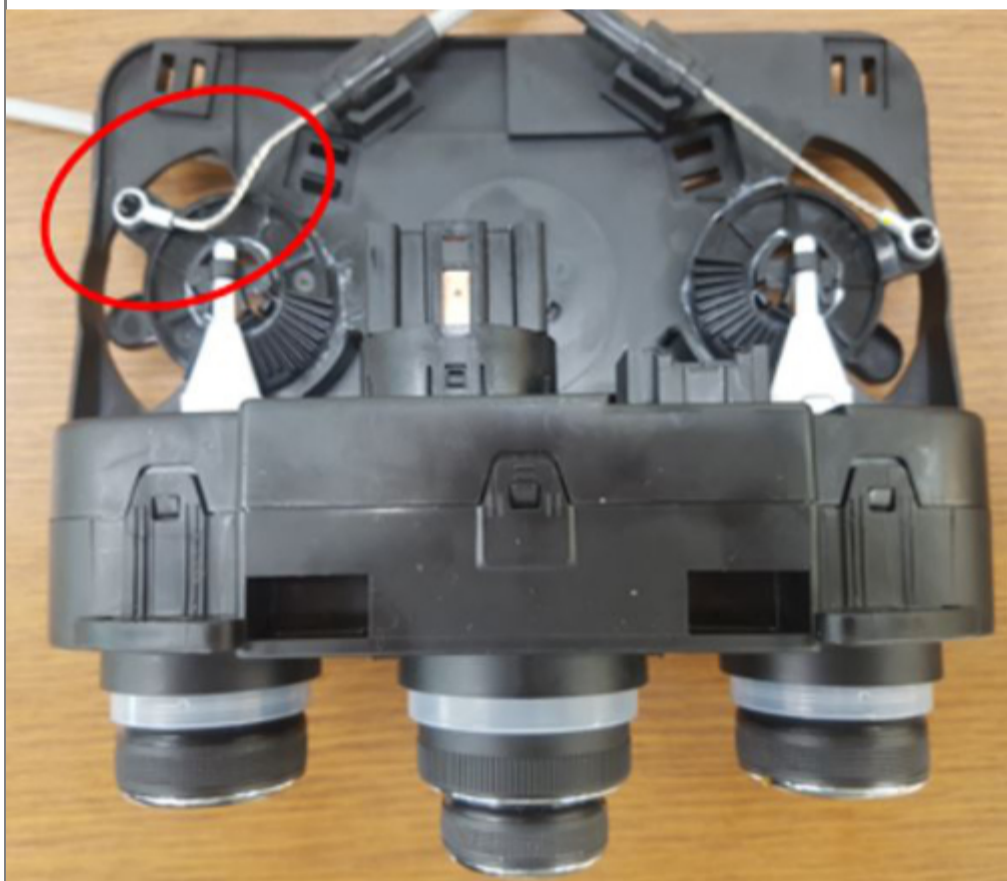
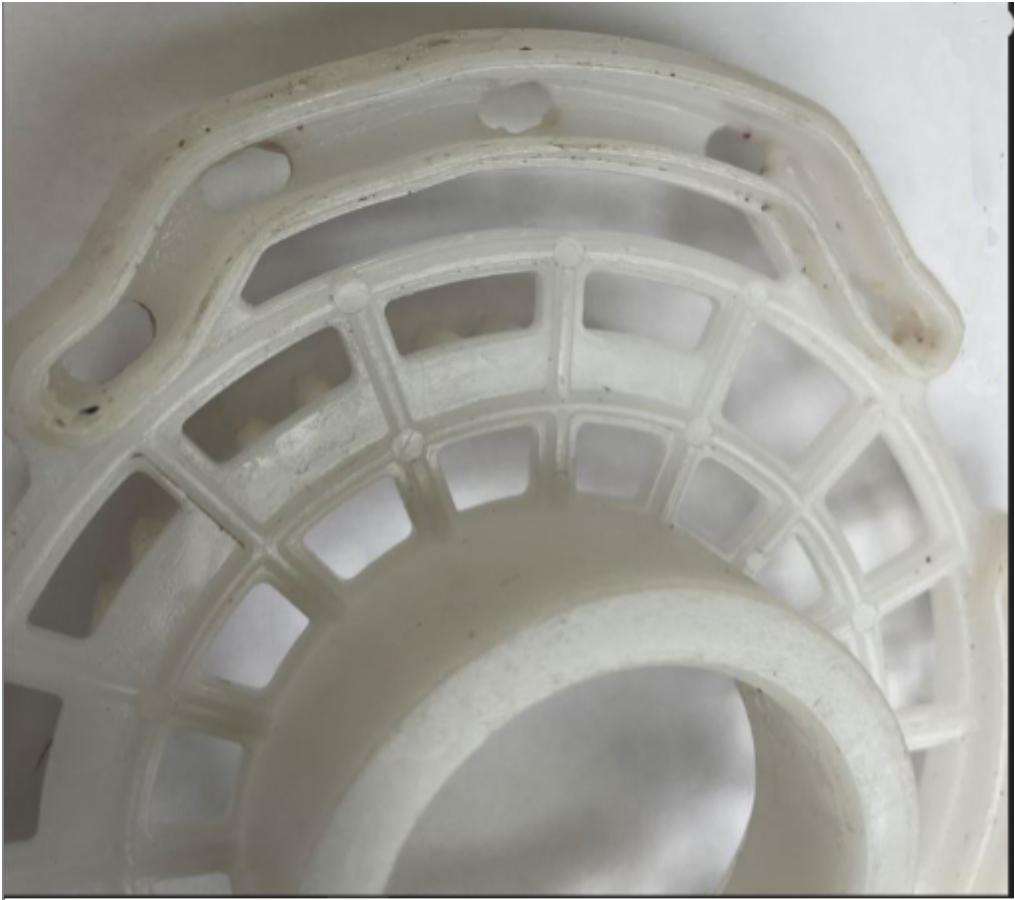
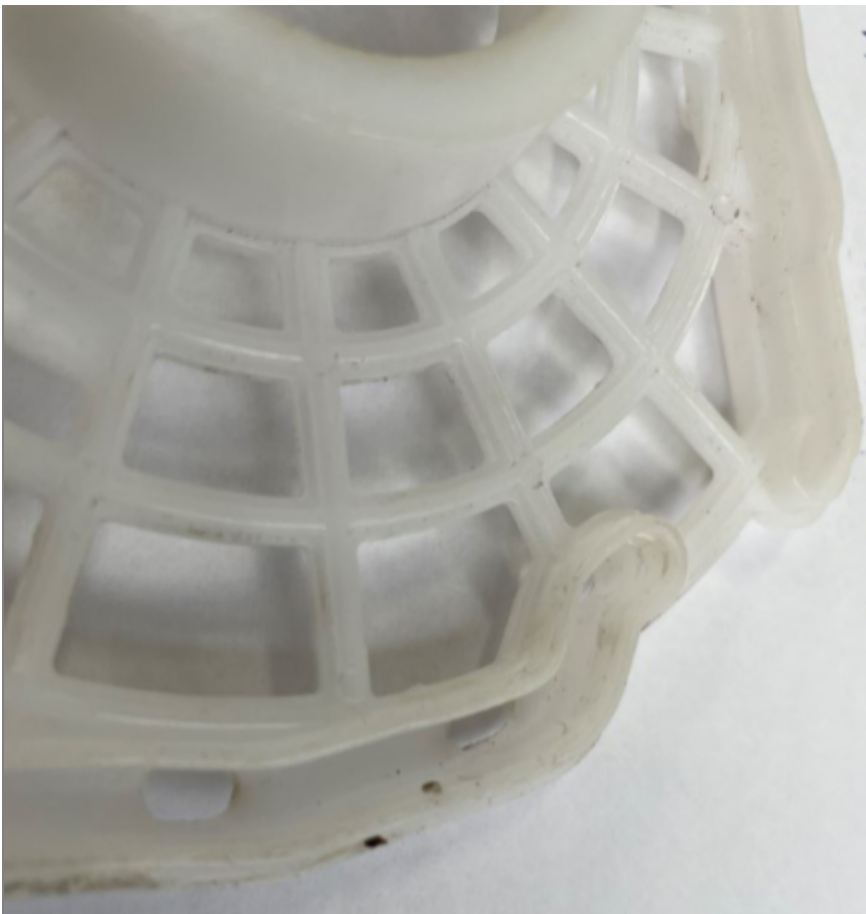
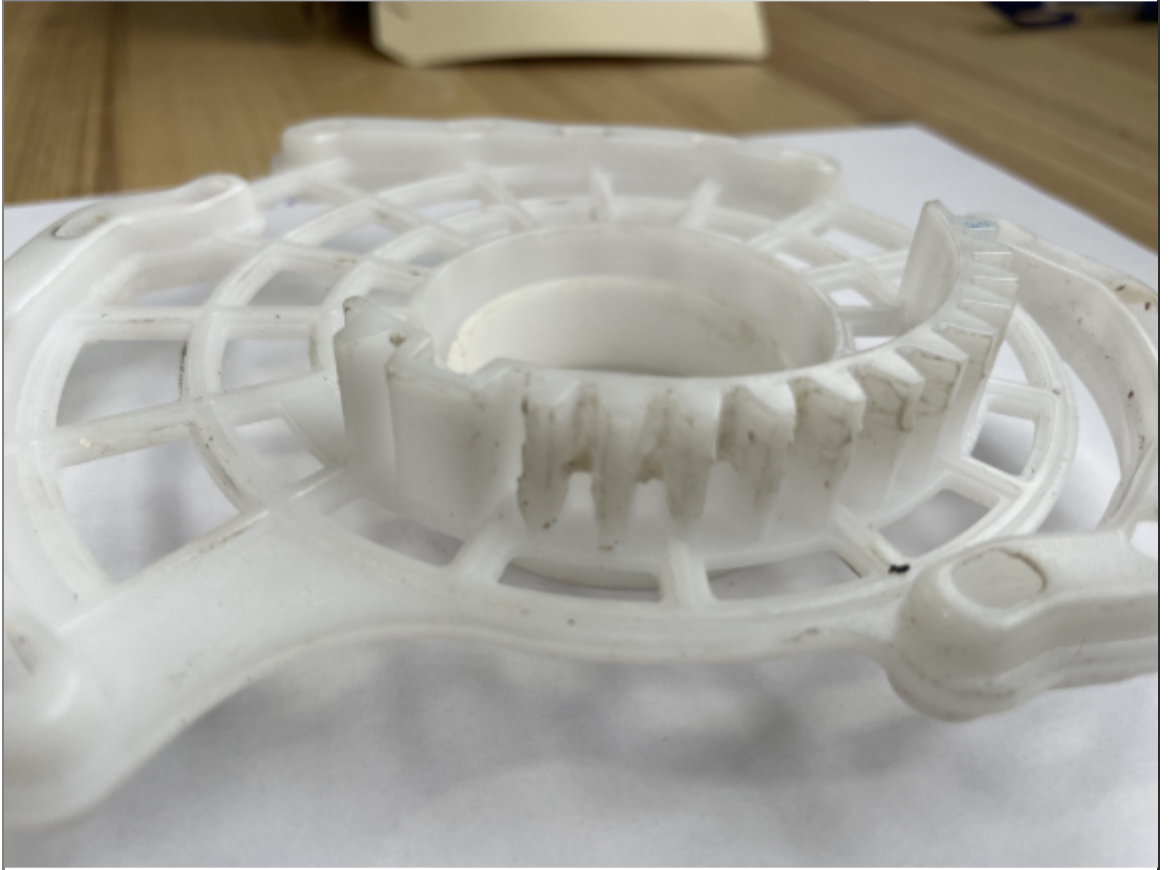
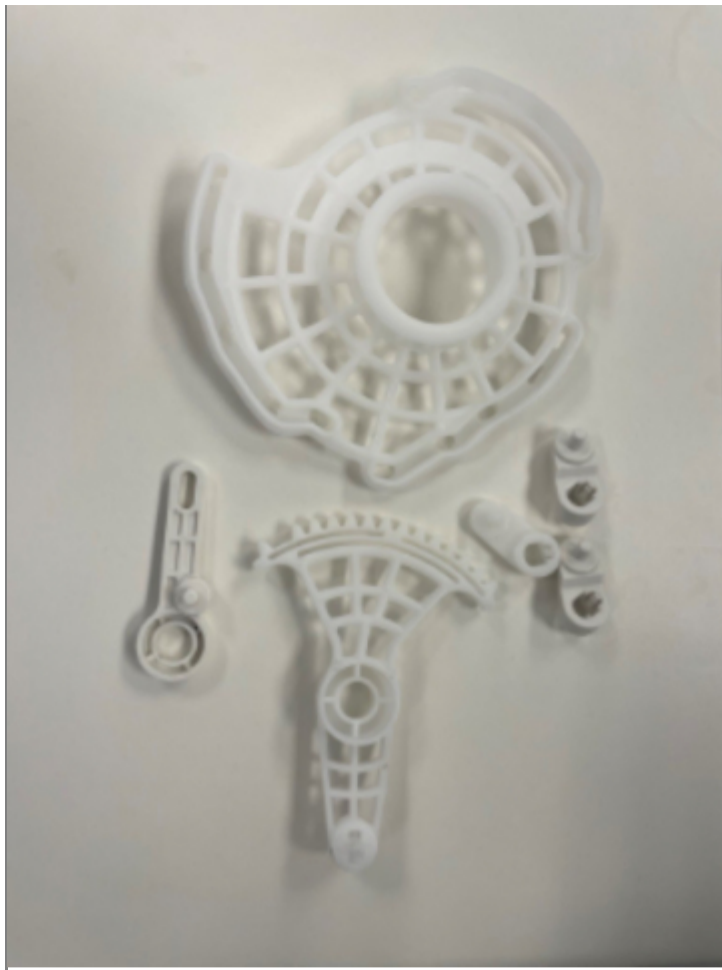
Condition  
Some customer may comment that they are not able to change the HVAC modes or there is no air flow from the defroster vents.  
Upon inspection, the tech may find that the mode control cable is bent.

Cause	This condition may be due to a combination of increased resistance from debris in the mode valve link assembly and high air flow (fan speeds above the setting of 3) against mode doors from the blower motor.
-------	--

If the above conditions are found, the tech will need to inspect the mode valve link assembly for debris or damage.

If debris is found, clean the link assembly and re-install or replace as needed.

Then, replace the mode control cable.
