Bulletin No.: PIP5857
Published date: 06/23/2022

PIP5857 10L1000 Fluid Leak At The Rear Of The Transmission.

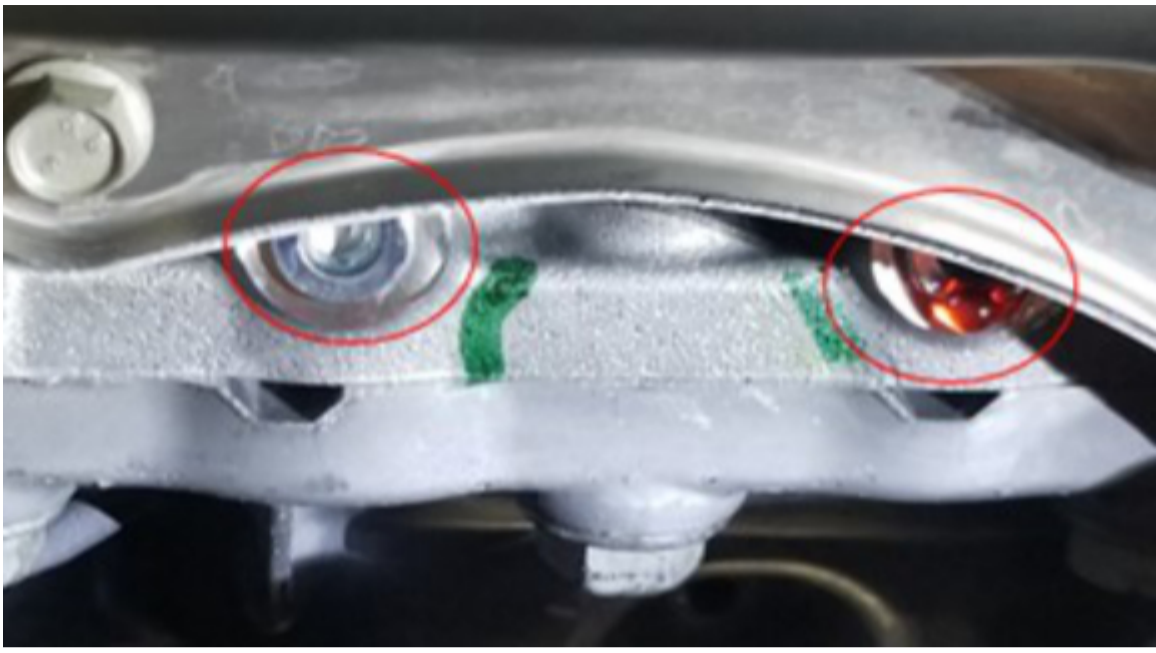
Case plug leak at transmission oil pan rail 2WD and 4WD.

Correction at the Oil Pan Rail:

Note: Only replace plugs that are leaking.

The case plugs can be accessed using a 5mm ball allen socket.

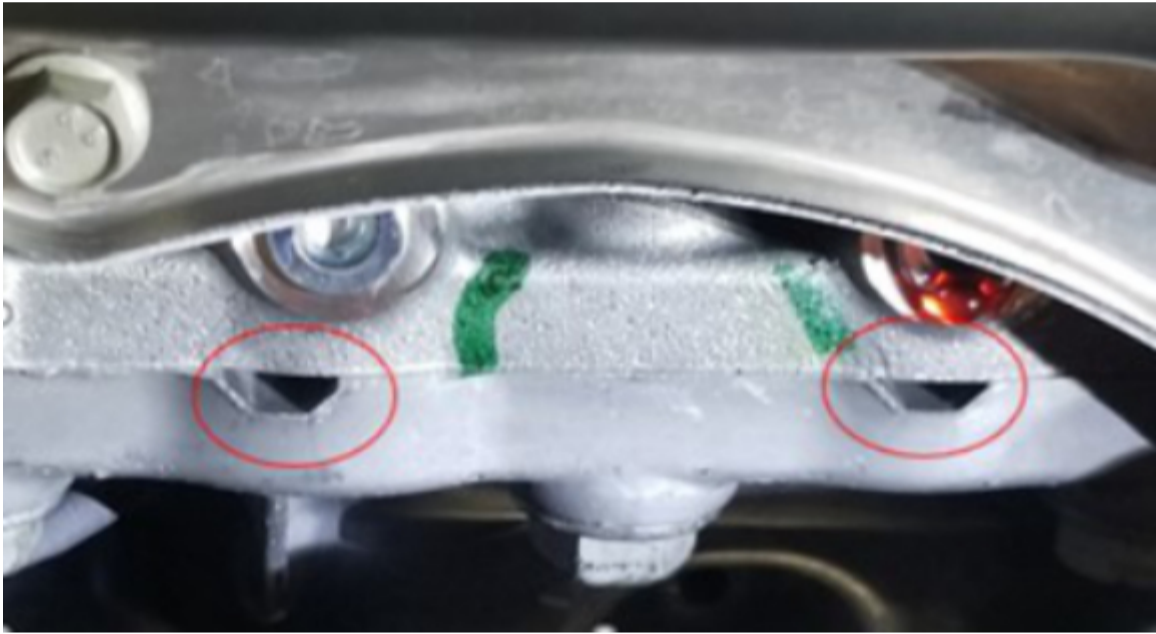
Rear of transmission case plug leak 4WD.

Correction at the leak from the transmission rear case plugs 4wd).

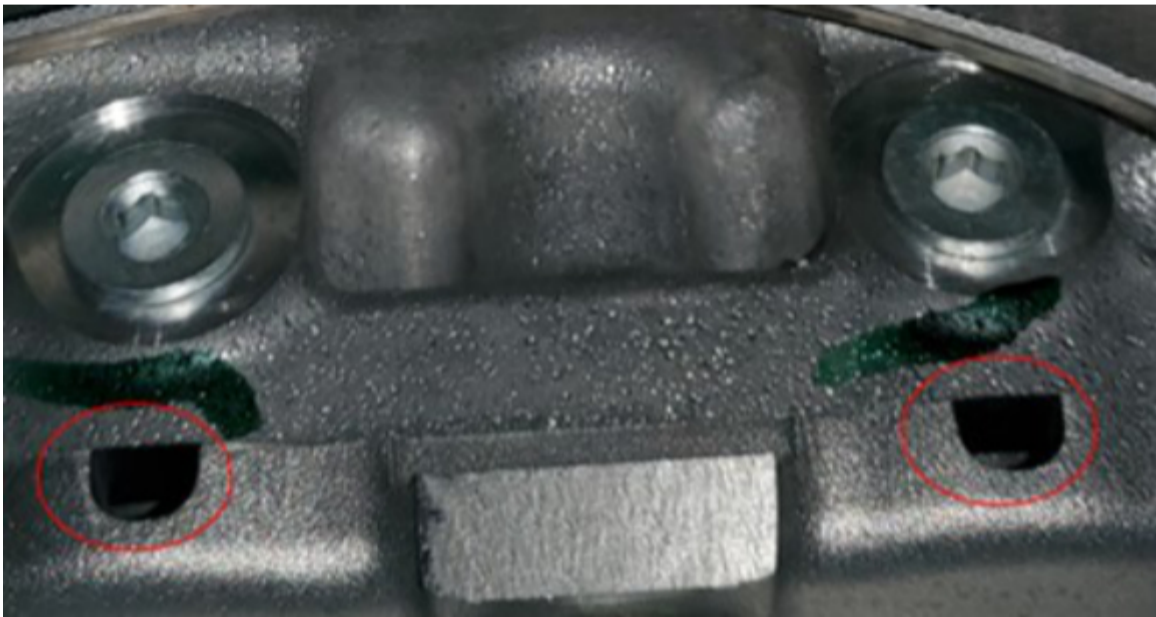
Rear of transmission case plug leak 2WD.

Correction at the leak from the transmission rear case plugs 2WD.

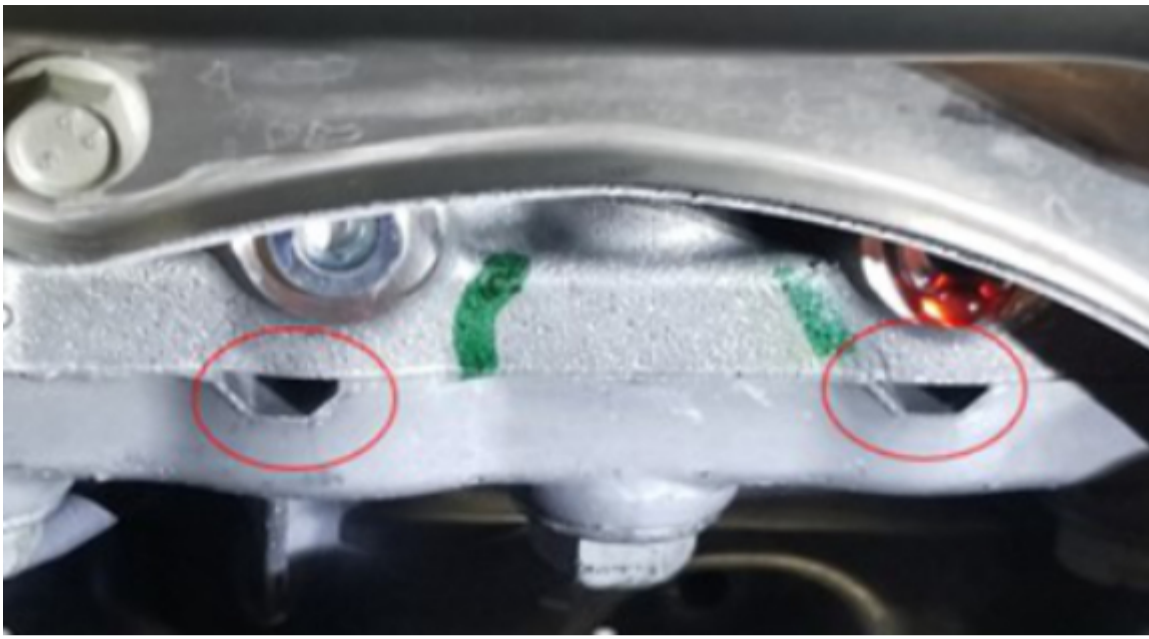
Transmission fluid should be visible at one or both weep holes.

The transmission case plugs are directly above the weep holes.

The use of a bore scope can be useful to confirm that the case plug is the source of the leak.

Remove the transfer case following published SI.
Discard the transmission to transfer case square cut rubber seal.

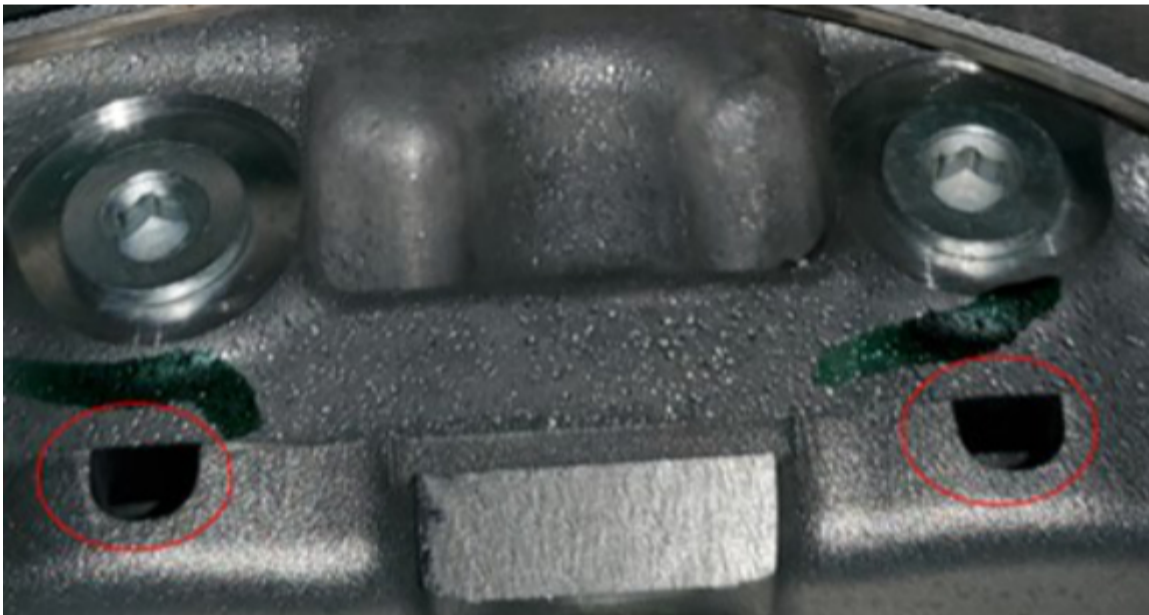
Transmission fluid should be visible at one or both weep holes.

The transmission case plugs are directly above the weep holes.

The use of a bore scope can be useful to confirm that the case plug is the source of the leak.

Remove the transmission case extension housing following published SI.

Discard the transmission to extension housing seal square cut rubber seal.
