# Preliminary Information

## PIP5705 DFM/AFM Vibration Or Drone Models

| Condition | A vehicle may have a concern of a vibration or drone around 40 MPH and 1200 RPM under a light load. |
| Cause | Debris in the transmission mount |

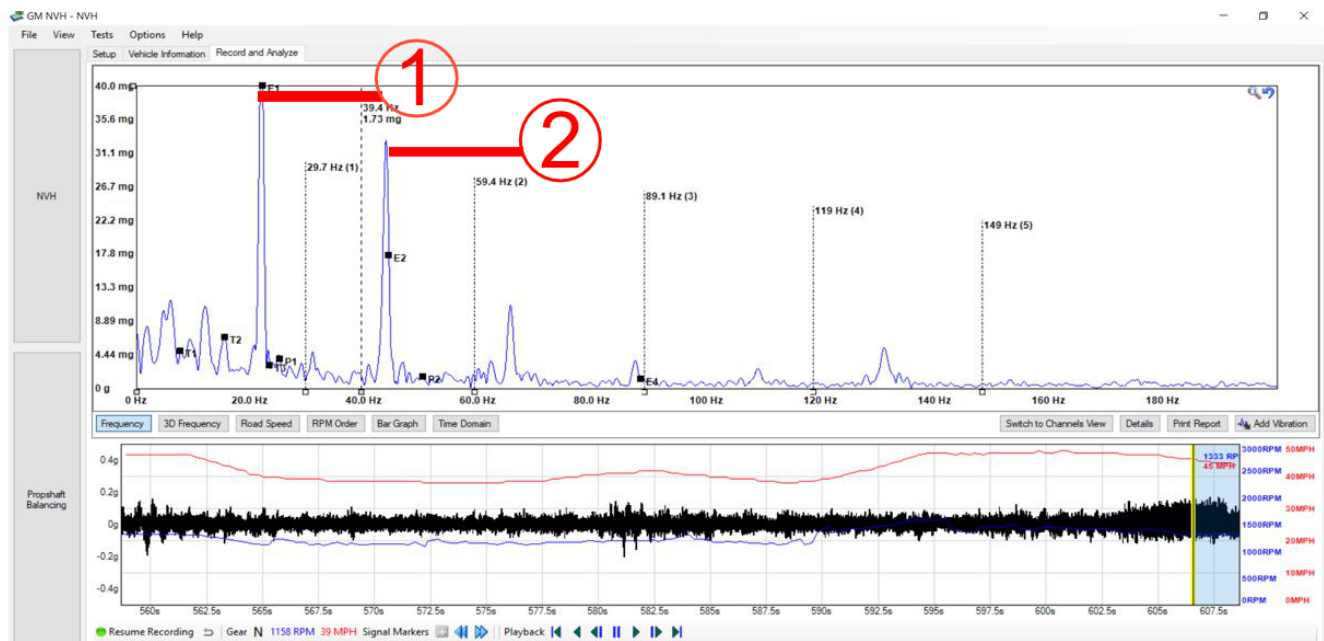
When vibration was first occurring there may be a large spike that aligned with E1 and E2.

After the tone shift the vibration no longer directly aligned with E1 and E2. (As seen below)

1, Show the E1 spike

2, Is the E2 spike

If this type of vibration is found remove and inspect the transmission mount for debris.

If debris is found, clean the mount, reinstall and evaluate for the concern.

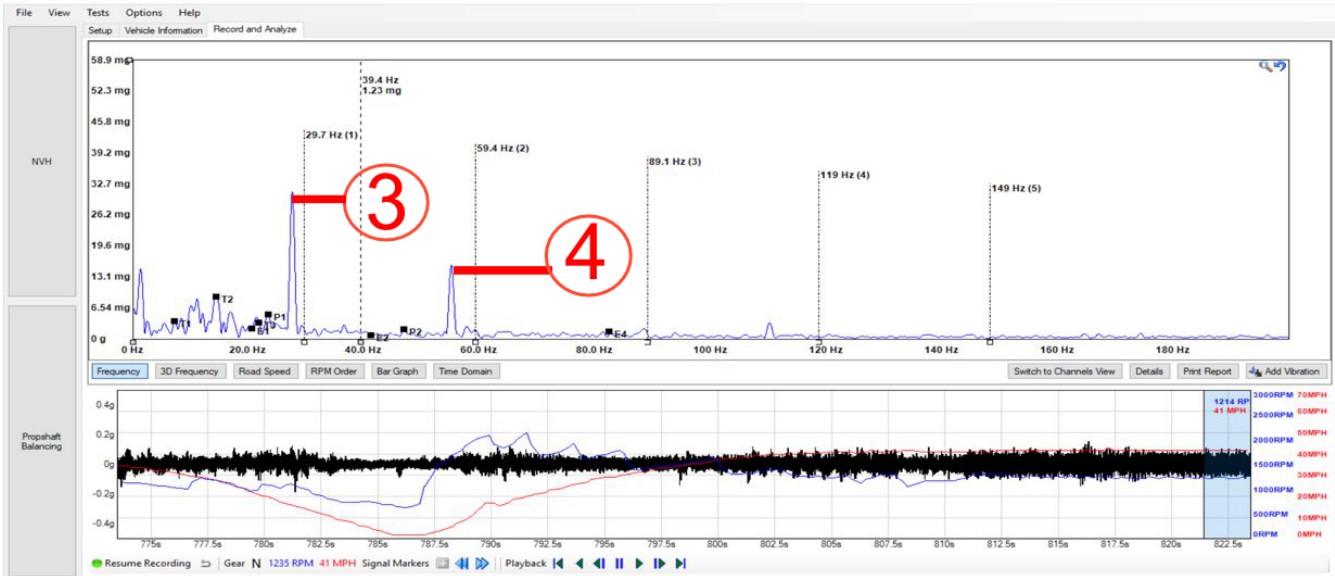
The above shows the change in the vibration.
