Preliminary Information

PIT5926 Rattle Noise from Under Vehicle

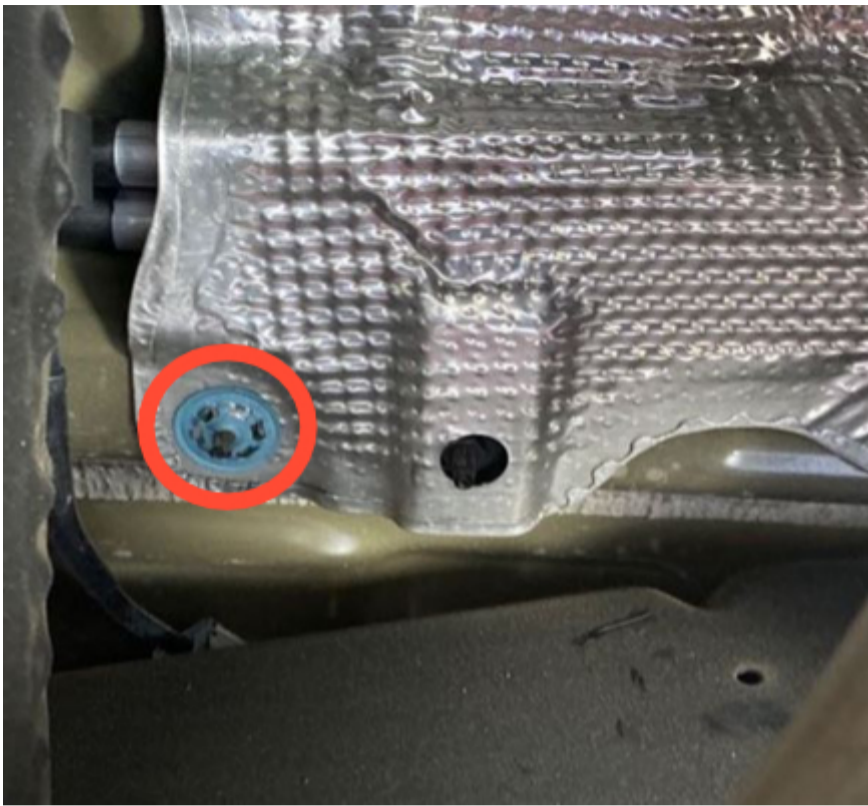
Picture of Blue Heat Shield Retaining Clip Installed

Install updated retainer clip P/N 11602886 for Silverado 1500 / Sierra 1500 and P/N 11603508 for SUV and tighten by hand until heat shield is secured into position.

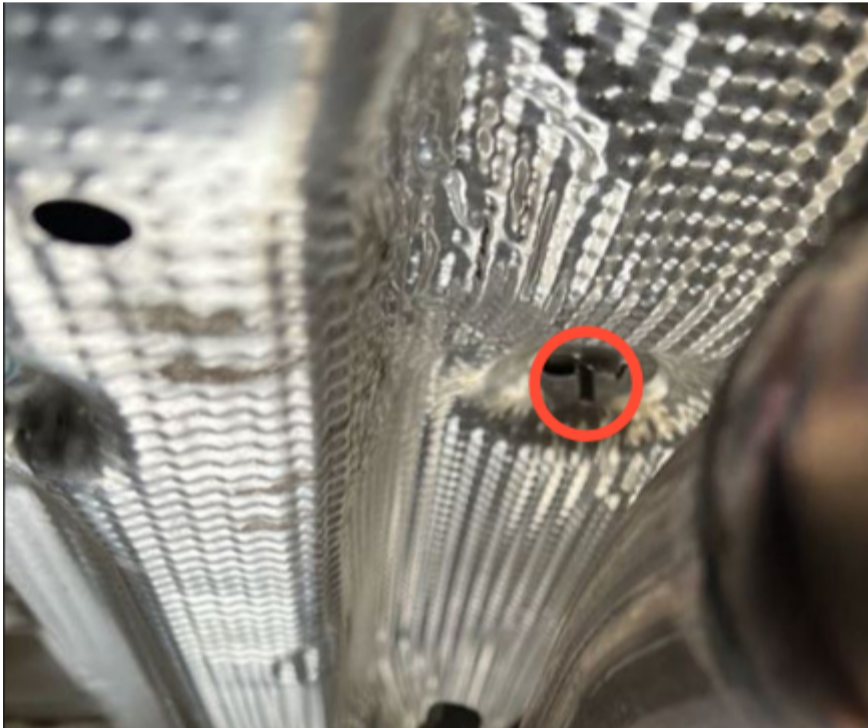
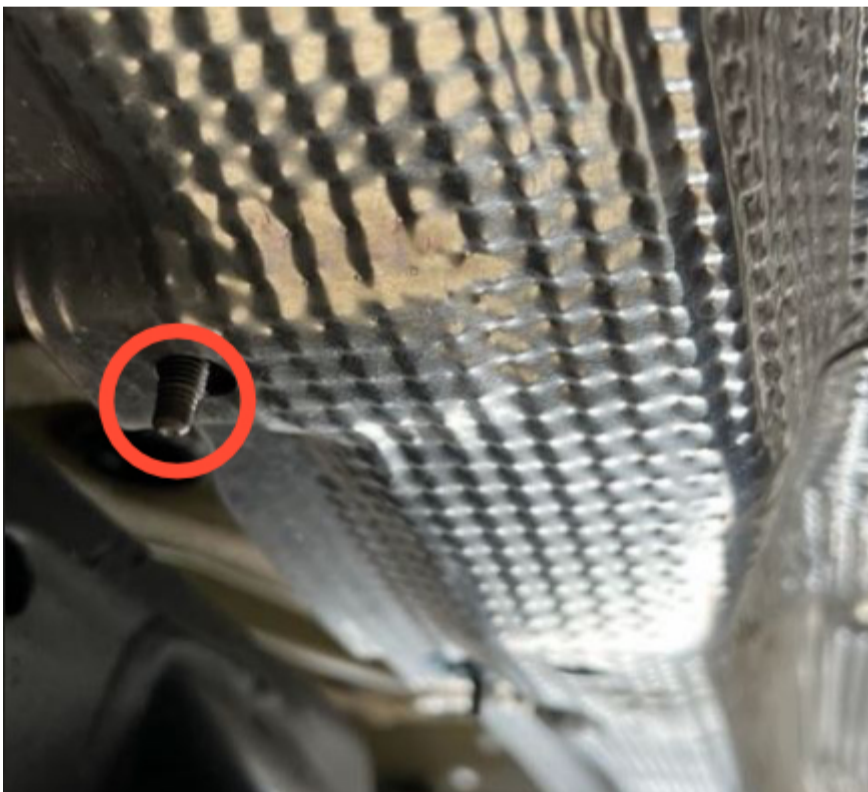
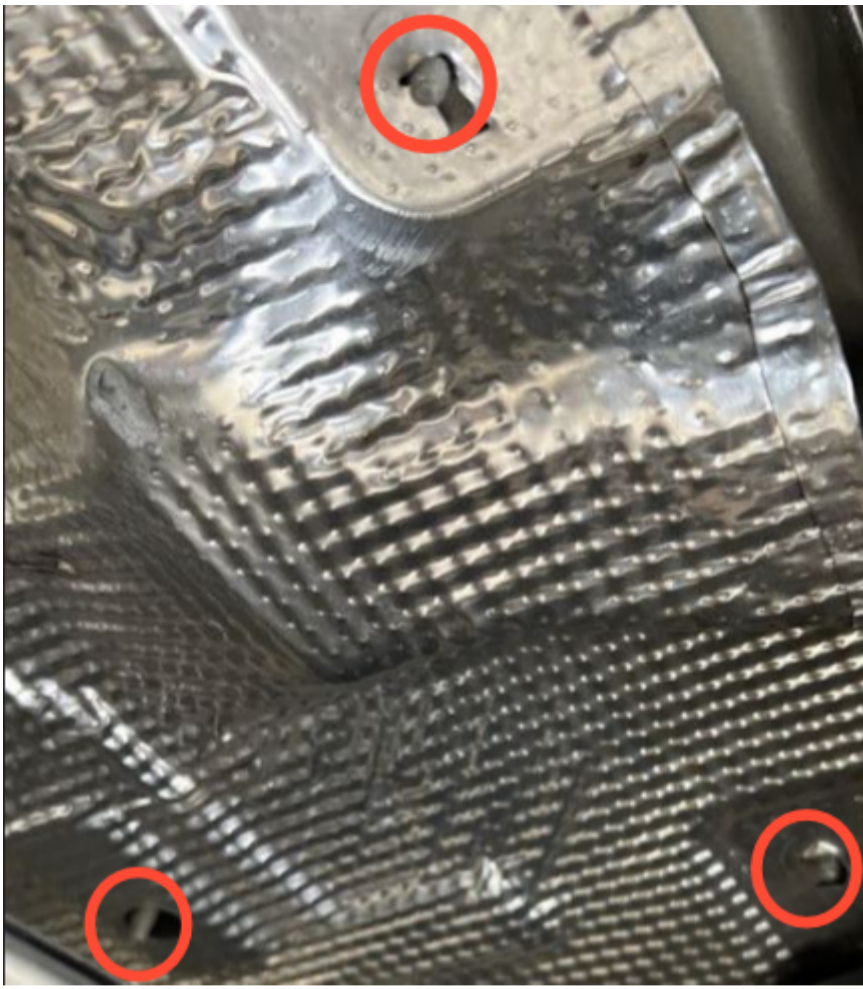
Involved Region or Country	North America
Condition	Some customers may comment on a rattle noise from under the vehicle while driving.
Cause	The retainer clips that hold the Exhaust Underbody Heat Shield may have become loose or missing, shown below.

Pictures of Missing Heat Shield Retaining Clip
