TECHNICAL SERVICE BULLETIN

Hard Top Roof - Front Roof Panels - Uneven Height Causing Poor Appearance, Excessive Wind Noise, Water Leaks And/Or Difficulty Latching

22-2288

Ford 2021-2022 Bronco	Hard top roof
---------------------------------	---------------

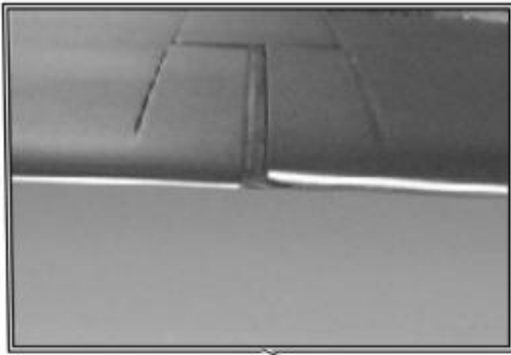
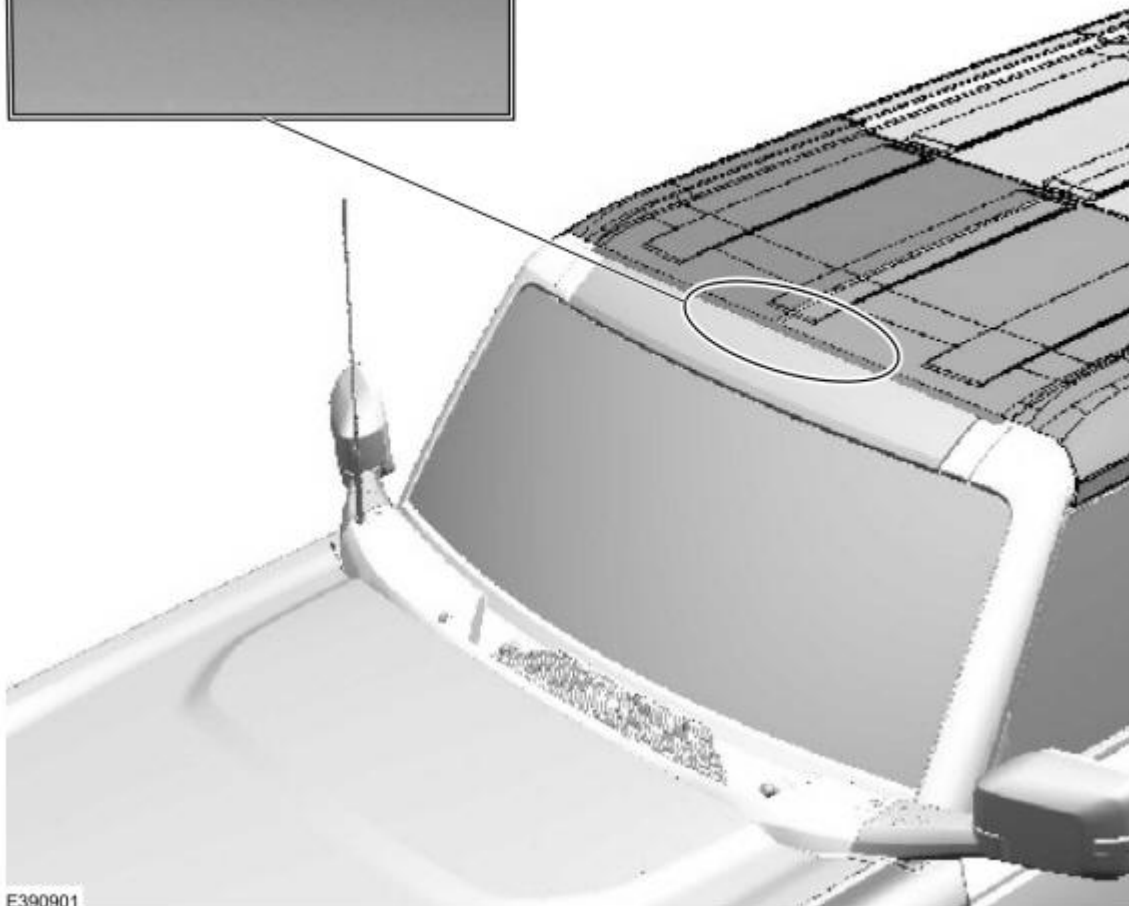
Figure 1

1. Do the front roof panels sit at an uneven height? (Figure 1)

- (1). Yes - proceed to Step 2.
- (2). No - this article does not apply.
2. Remove the windshield header trim panel. Refer to Workshop Manual (WSM), Section 501-05.
3. Locate the front center strikers, just above the rear-view mirror. Using a marker, outline the mounted position of both strikers on the body. These marks may be used to return the strikers to their original position or to show how much adjustments were made when the repair is complete. (Figure 2)
