TECHNICAL SERVICE BULLETIN

5.0L Engine - MT-82 Manual Transmission – Loss Of Movement And/Or Difficulty Shifting

22-2302

22 July 2022

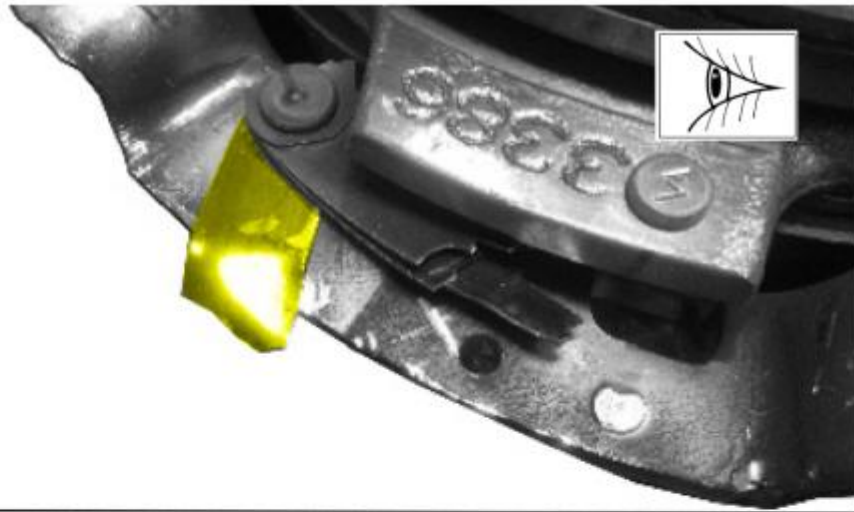
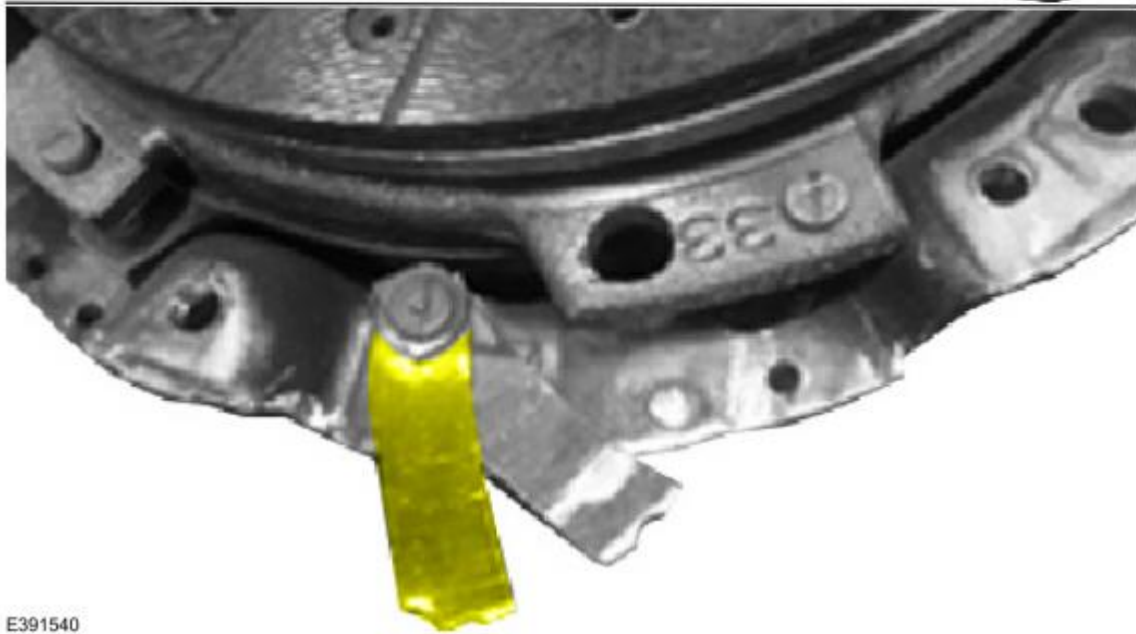
E391540

Figure 1 - A torn strap of the intermediate pressure plate on clutch

- (1). Yes - proceed to Step 3.
- (2). No - this article does not apply. Refer to WSM, Section 308-03A and continue with normal diagnostics.
3. Replace the clutch, dual mass flywheel and any other damaged components. Refer to WSM, Section 308-01 and 303-01.
4. Replace the peak torque limiter.
 - (1). Disengage the 2 retention clips (1 clip must have been disengaged during transmission removal).
 - (2). Install the new peak torque limiter, making sure it is fully seated into the transmission and line (during transmission installation) and that both clips are fully engaged. (Figure 4)

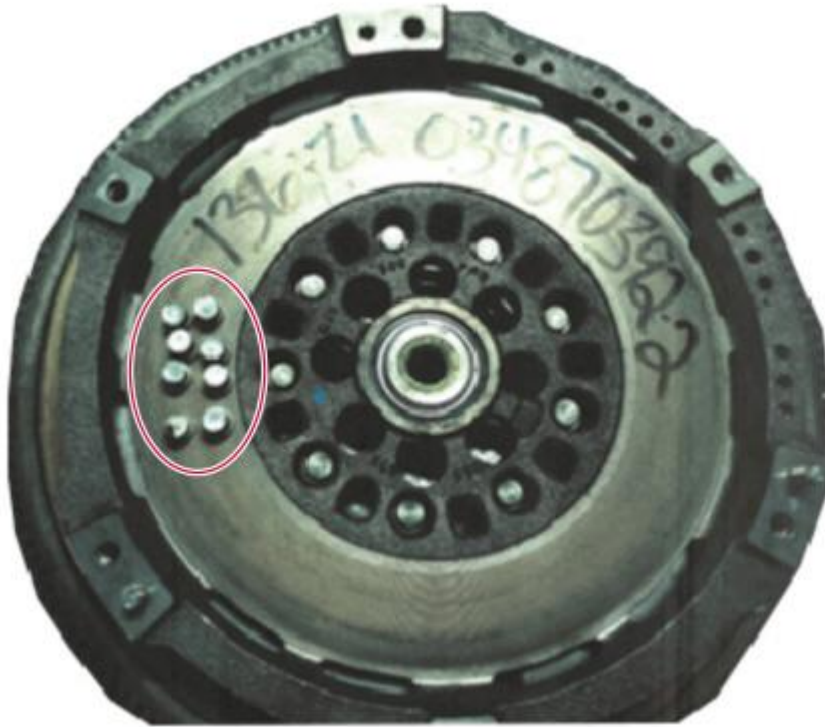
E391541

Figure 2 - Dual mass flywheel rivet failure

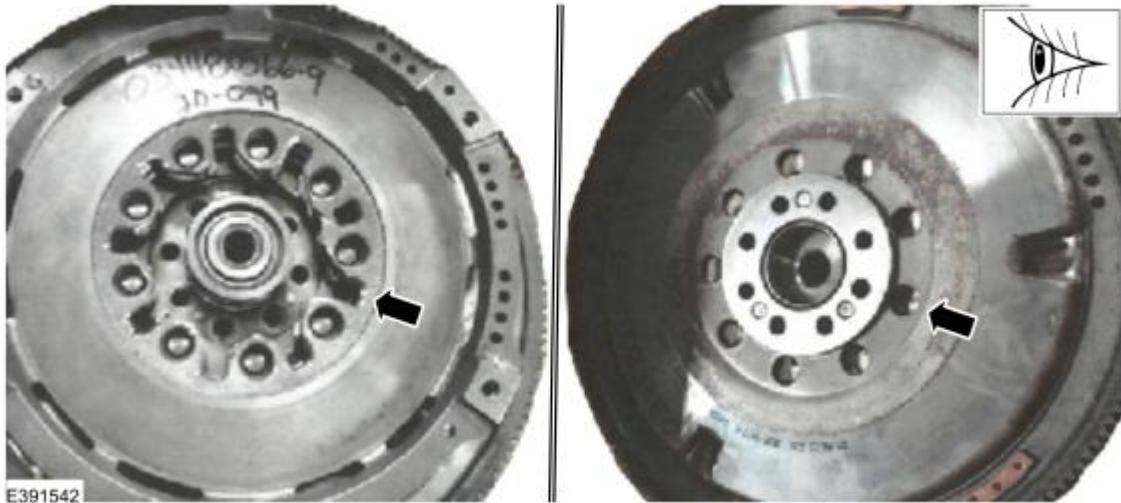
E391542

Figure 3 - Stuck dual mass flywheel due to spring breakage. Bolt access requires cutting through the flywheel.
