## Thor Motor Coach Technical Service Bulletin

| TSB # | <b>TSB 22-09</b> | | |
| Description/Title: | Rize/Scope A/C install | | |
| Affected Product Line(s): | Certain model year<br>2022 – 2023 Rize & Scope | | |

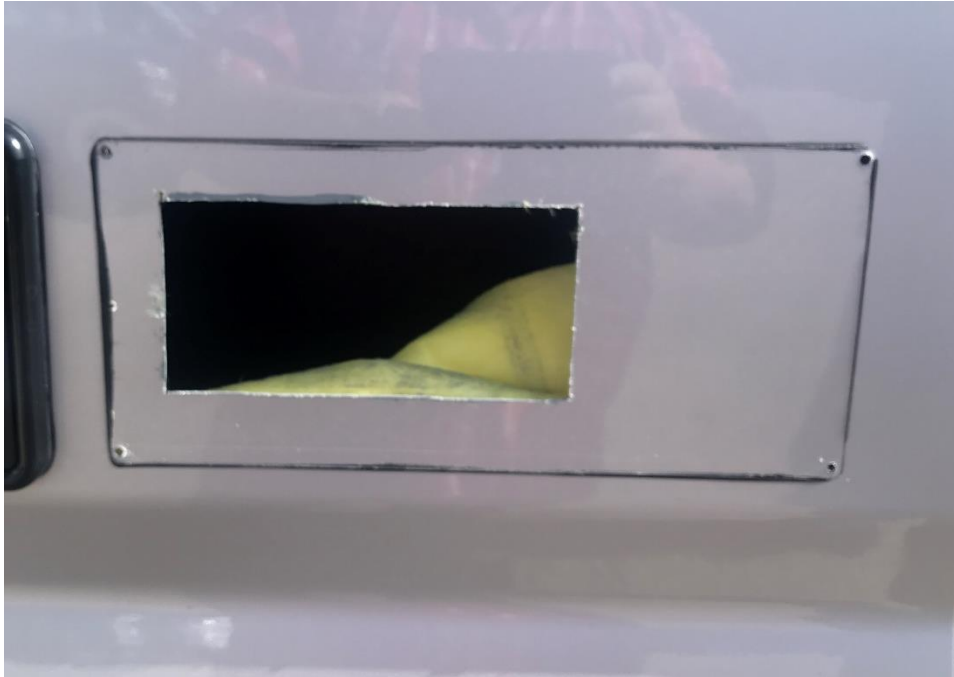
1. The outside intake vent hole may not be cut large enough. Please use attached prints to confirm cutout size and cut larger is needed.

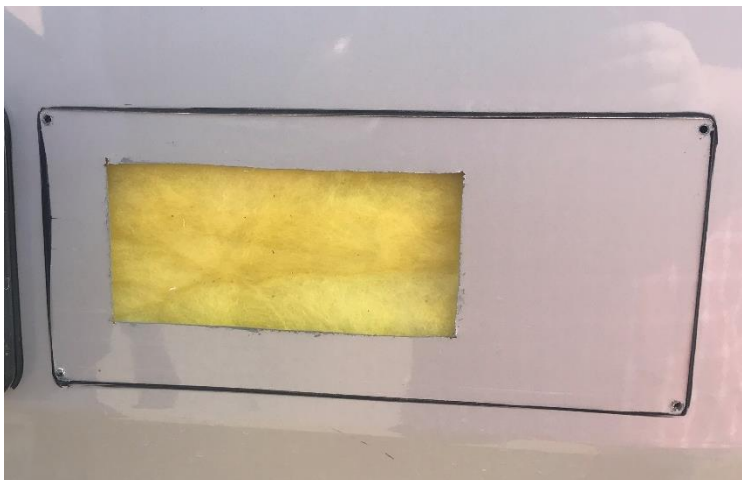
2. Ensure there is no insulation blocking the intake opening.

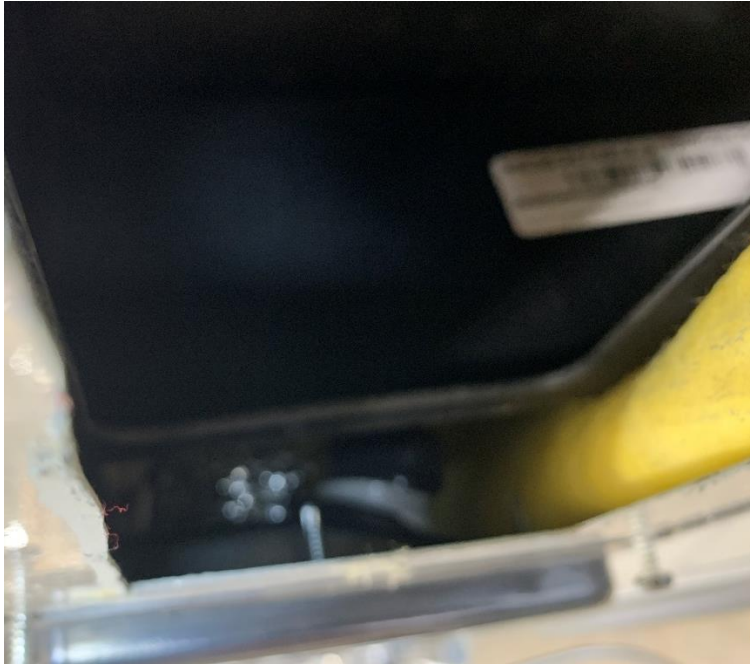
3. Seal needs to be added around the opening between the intake plenum & van body.

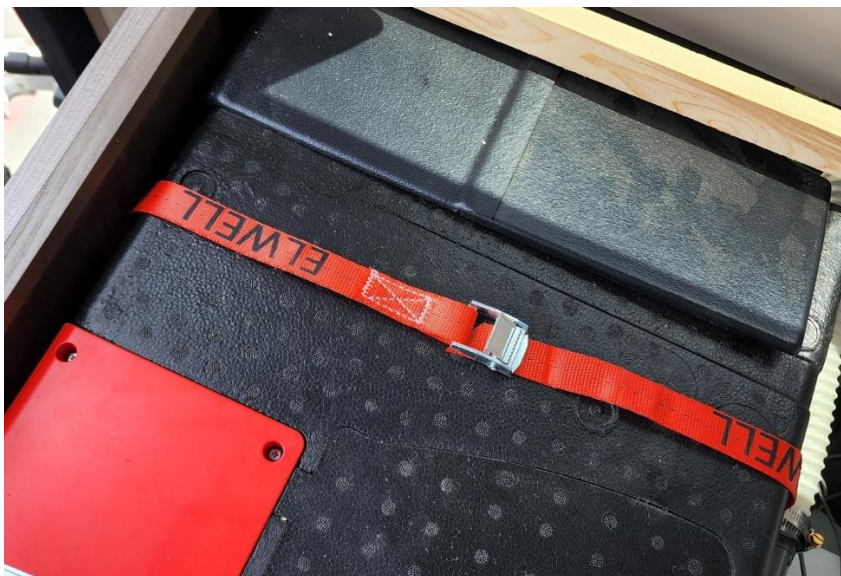
4. Remove two black Southco latches in the front of the cabinet. Loosen and remove the red strap holding the A/C in place and remove A/C to access exhaust.

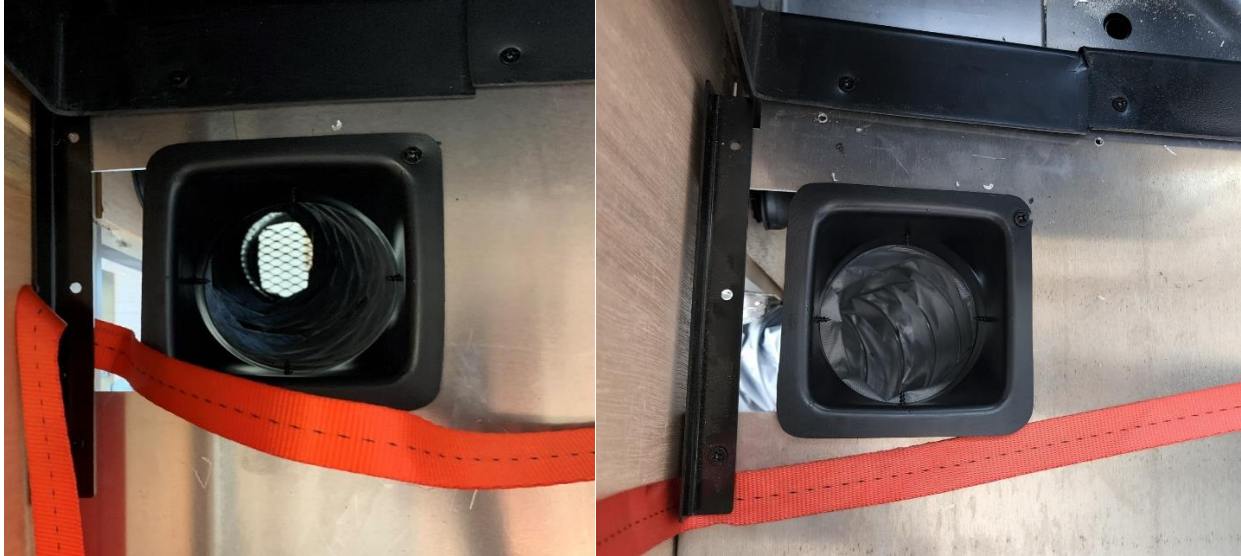
5. A/C exhaust plenum #16 on the TIP0425 print is not lined up with the air exhaust opening. The screws need to be removed and the plenum slid rearward. The strap needs to be moved clear as well.

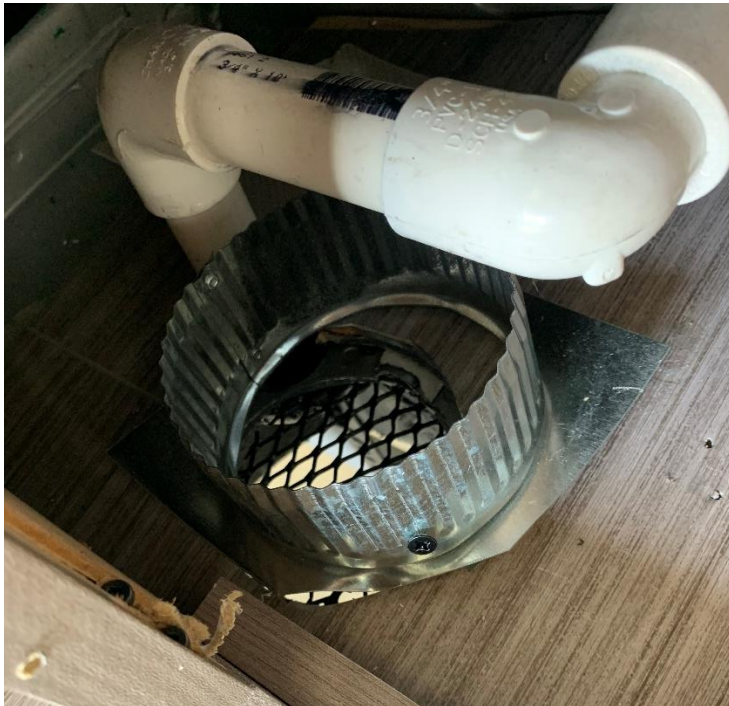
6. Exhaust flange at the floor is not lined up with the hole in the floor and the floor hole is too small. (hole in floor is 3.5" and should be 4")

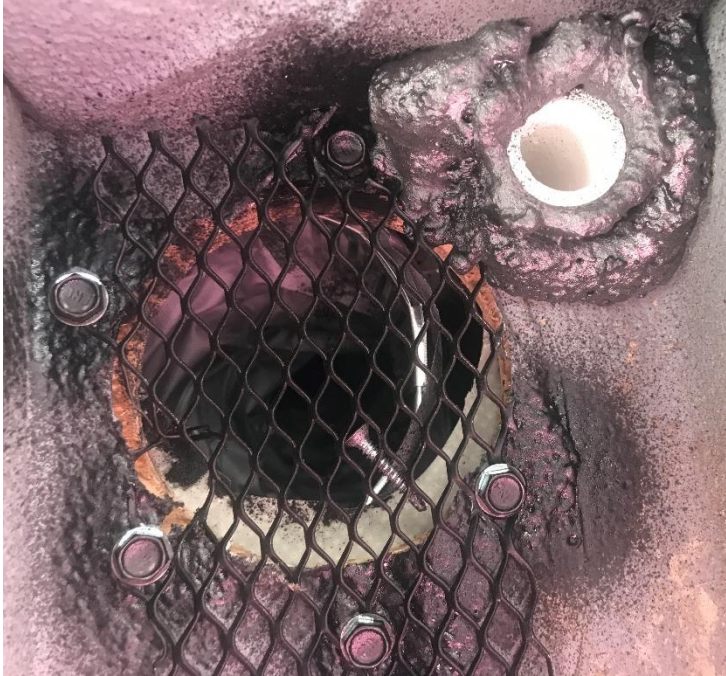
7. Mesh cover not installed properly & wrong size, should be a larger piece and needs secured to bottom of frame rail. TFM7703

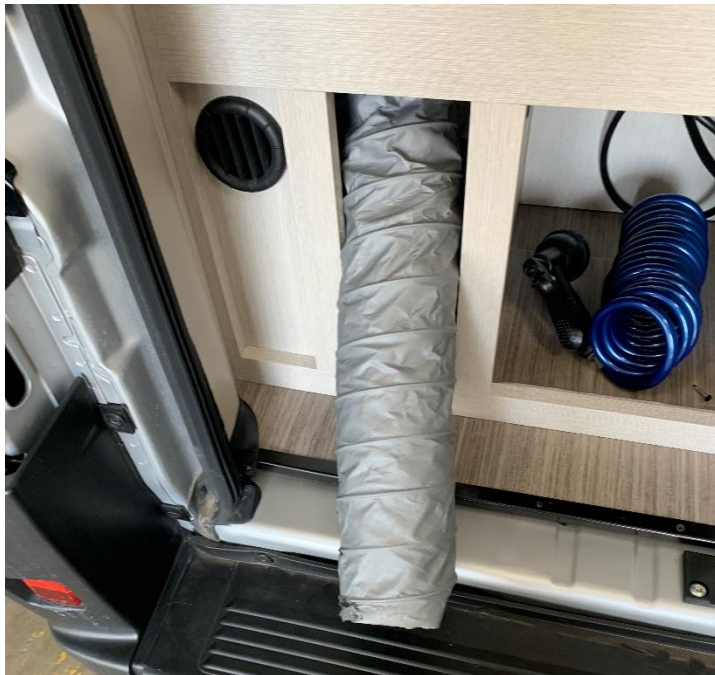
8. Exhaust hose may be too long and should have the excess cut off to keep the hose from kinking.
