GROUP
**Emissions Service
Campaign**

MODEL
**2019-2021
Multiple Models
with IVT**

NUMBER
SC199 (Rev 2, 07/21/2022)

**IVT SOFTWARE LOGIC IMPROVEMENT
AND/OR IVT REPLACEMENT (SC199)**

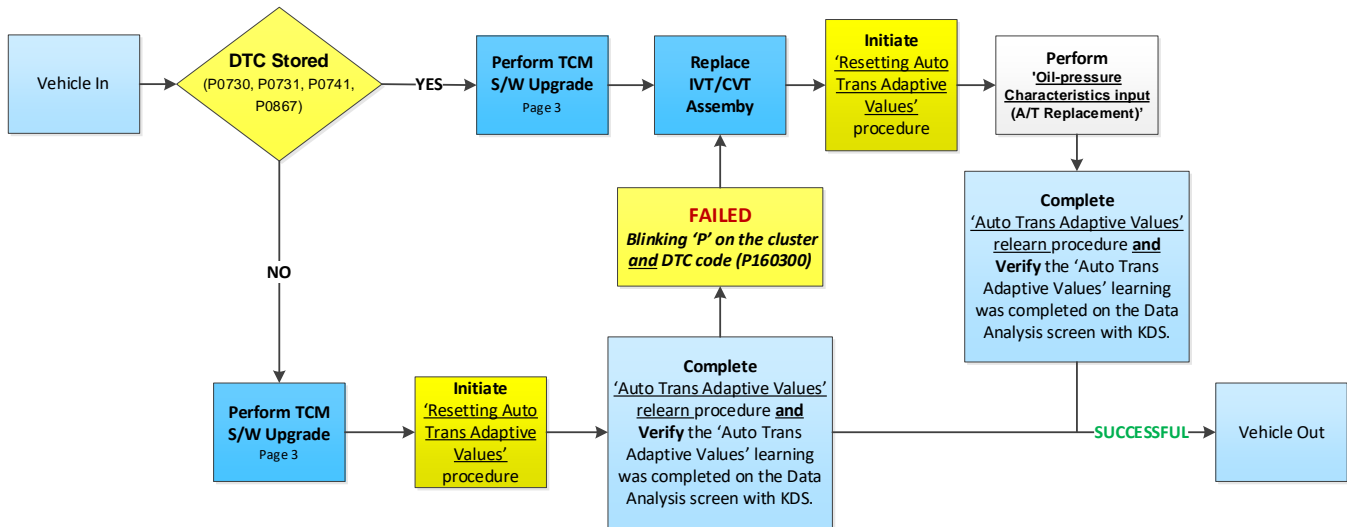
Flowchart:

**Vehicle In DTC(s):**

- P0730 – Incorrect Gear Ratio
- P0731 – Gear 1 Incorrect Ratio
- P0741 – Torque Converter Clutch Circuit Performance or Stuck Off
- P0867 – Transmission fluid pressure

After completing 'Resetting Auto Trans Adaptive Values' on the KDS:

- P160300 – P-Learning Fail (CVT System)

When replacing the IVT/CVT assembly, carefully follow the installation procedure outlined on KGIS to complete the Auto Trans Adaptive Values learning procedure. Performing the 'Oil-pressure Characteristics Input', refer to the IMPORTANT and NOTICE boxes on page 10. The adaptive values learning procedure may require that the engine be shut OFF/ON multiple times until the values are fully learned; start the vehicle, confirm the vehicle is idling in 'Park' without accelerator or brake input and verify the 'CVT Learning – P Range' Current Data reads 'ON'.

A **Vehicle Diagnosis Number (VDN)** must be created with at least one of the five (5) DTCs listed above, prior to IVT replacement. If a VDN is not created, **Parts Ordering and Warranty claim submission issues WILL occur.**
