GLOBAL SAFETY FIELD INVESTIGATIONS
DCS6221
URGENT - DISTRIBUTE IMMEDIATELY

Subject: N212354524 - Customer Satisfaction Program
Heated Vented Seats Retrofit Due to Chip Shortage
Rear Seat Heater Module and Programming

Models: 2022 Buick Enclave
2022 Cadillac XT5
2022 Cadillac XT6
2022 Chevrolet Traverse
2022 GMC Acadia

N212354524 Heated Vented Seats Retrofit Due to Chip Shortage

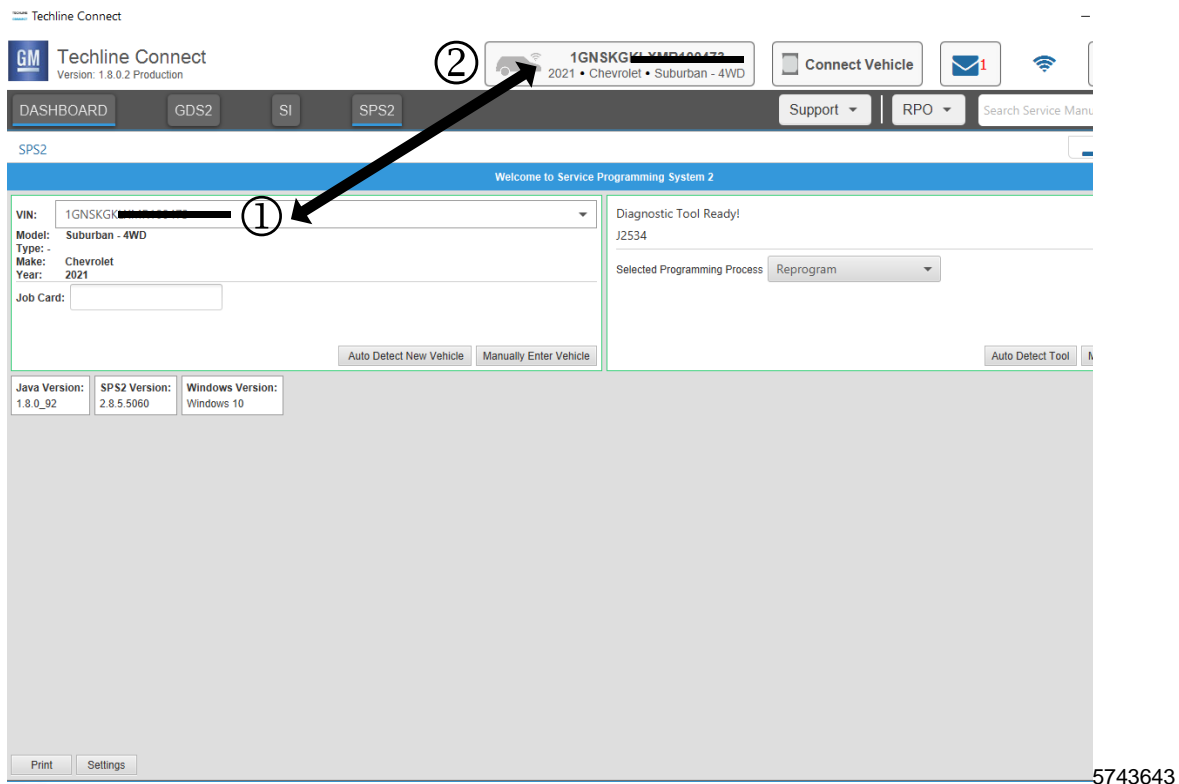
Caution: Be sure the VIN selected in the drop-down menu (1) is the same as the vehicle connected (2) before beginning programming.

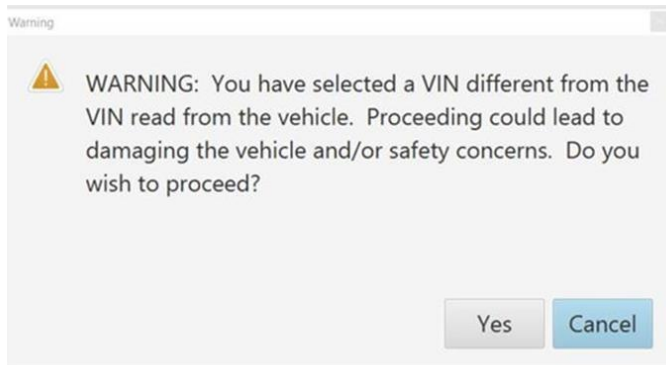
5877000

Important: If the vehicle VIN DOES NOT match, the message below will be shown.
