MAS003118 (MSC 22-21)

Campaign 494  
FROM Maserati TSO  
TO Maserati Network

## Service Campaign 494 MC20 - Fender Bracket Sealing Detachment

DATE: JUNE 10 2022

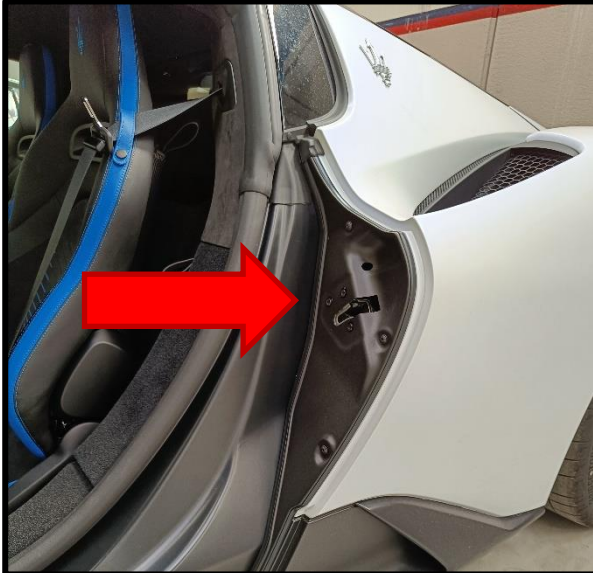
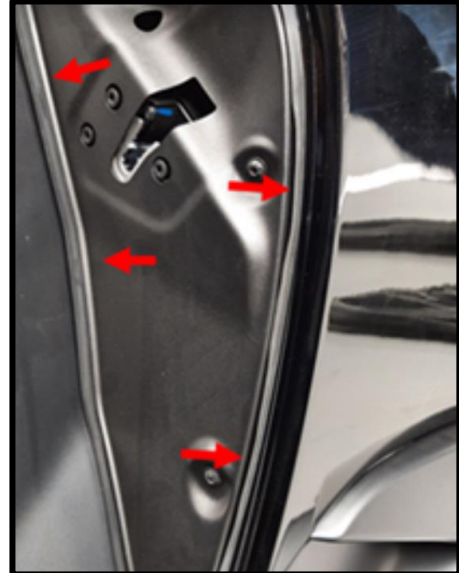
1. Always check in ModisCS+ to see if the vehicle is involved in this campaign and if the campaign has not been previously performed.
2. Open the door to inspect the sealing of the fender bracket.

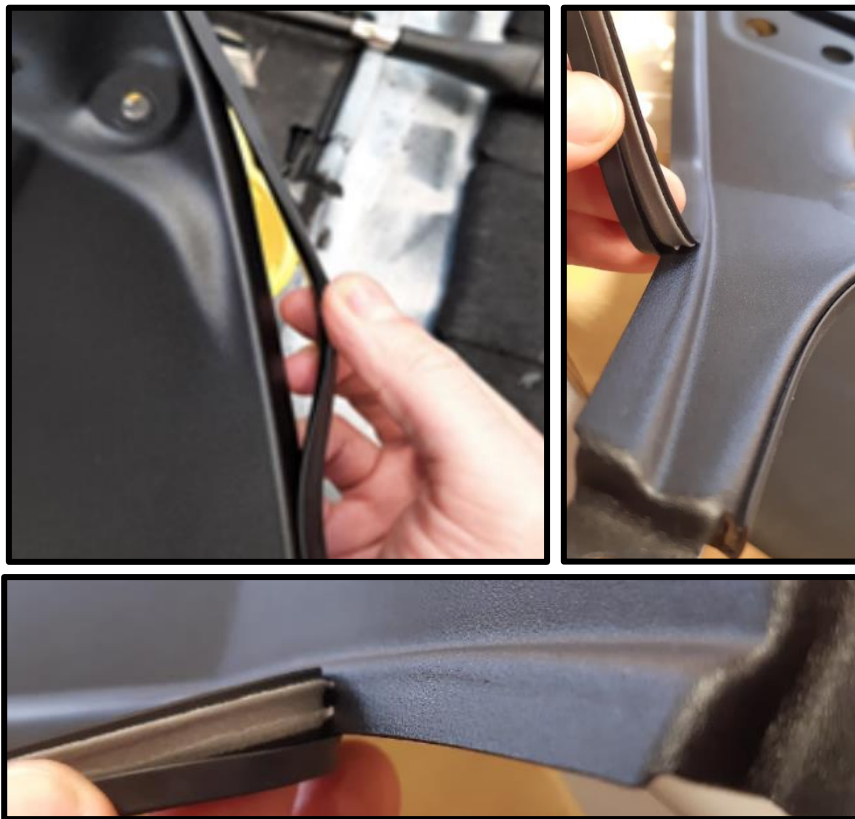
3. Only If the sealing adhesion is compromised, like in the below pictures, the complete rear lateral seal must be replaced.

- Before performing this operation, please follow the indicated procedure for interior protection: **00.AA.005 - INTERIOR VEHICLE PROTECTION**
- Replacement procedure is identical for both driver and passenger side
- Please replace only the seal that is defective.
