MAS003117 (MSC 22-22)

Campaign 497

Service Campaign 497 M15X – Phone Box Lid potential failure of the mechanism opening

DATE: JUNE 14 2022

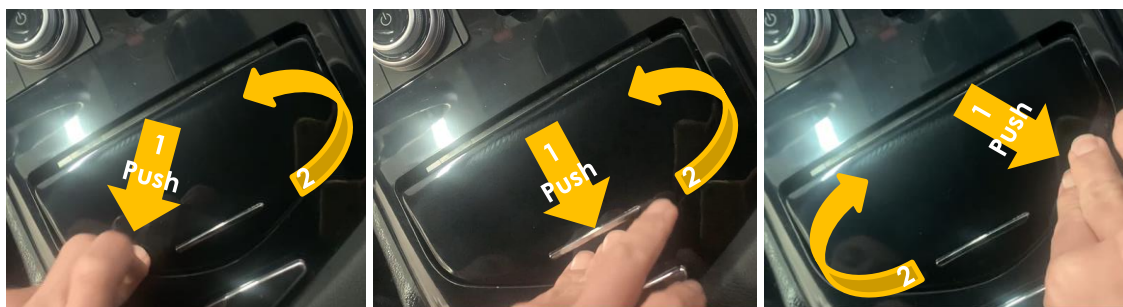
NOTE: Apply light pressure to the central, right and left handle areas as shown below. Repeat 7 opening/closing cycles for each area (left + right + central).

Do not force the Lid open. The Lid should automatically open completely on its own. If it does not, then it will need to be replaced.

If the Phone Box Lid opening and closing is **NOT OK**, the phone box must be replaced:
