MAS003104 (MSC 22-23)

Campaign 505

Service Campaign 505 M15x-M161 - Customer Protection Action

DATE: JUNE 30 2022

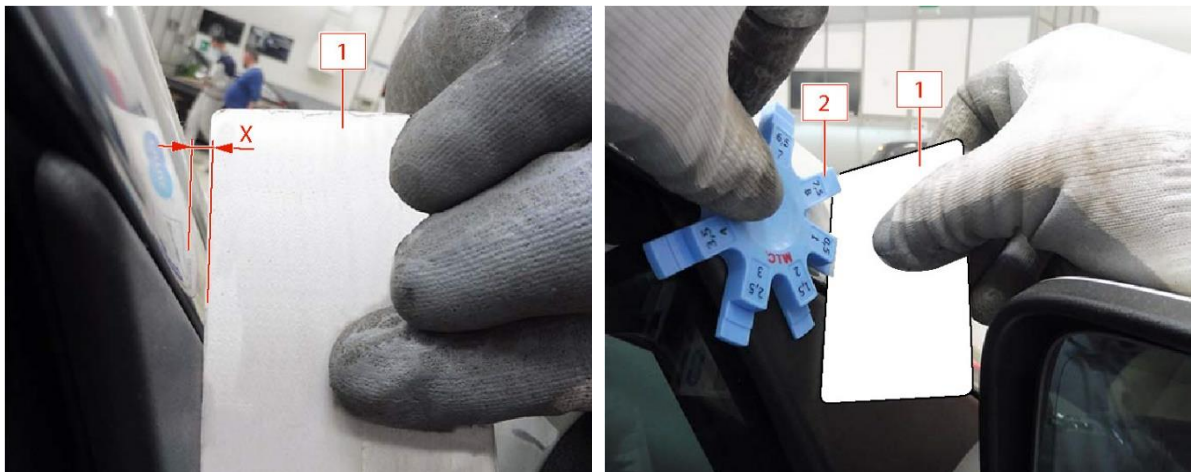
A) M161 – Wind noise

1. Verify the correct alignment of the RH front door as indicated below.
2. Position a suitable tool (1) and with a feeler gauge (2) measure the distance as illustrated:

3. If the distance is:
 - < 1,5mm adjust the door 0,5 mm inwards.
 - > 1,5mm adjust the door 1 mm inwards.
4. If the gap is close to 0mm, less than 1 mm, it can be considered as ok.
5. Repeat the inspection for the LH side and perform the **rework only** if needed.

6. Open the LH/RH front door.
7. Undo the indicated screw and perform the adjustment:
 - If the measure is $< 1,5\text{mm}$ move the door (1) $0,5\text{ mm}$ towards the interior of the car.
 - If the measure is $> 1,5\text{mm}$ adjust the door (1) 1 mm towards the interior of the car.

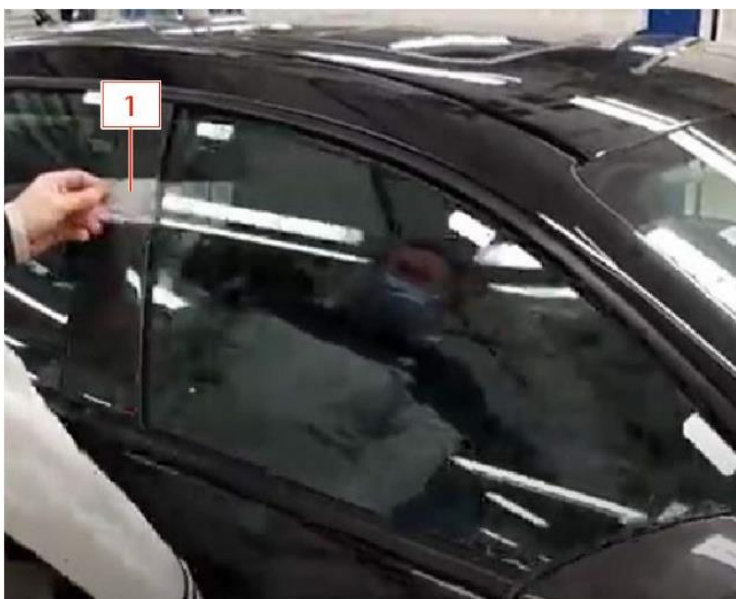
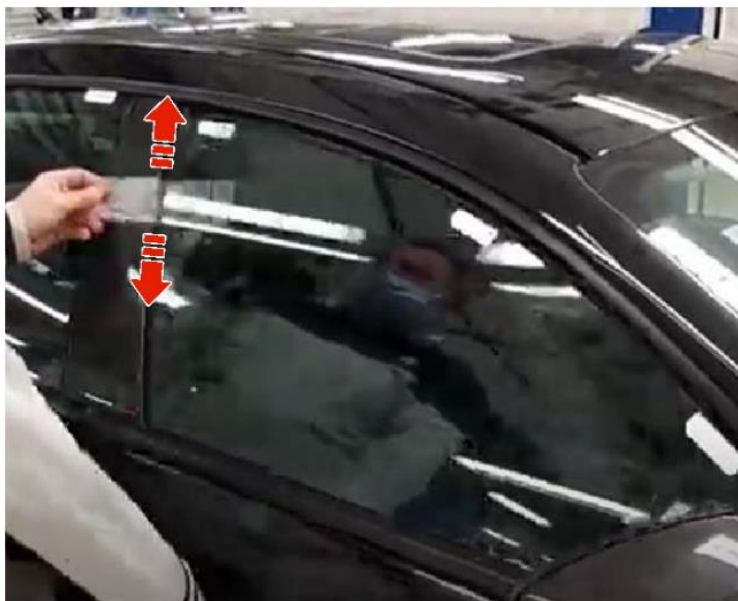
B) M15X – Wind noise (Illustration video attached)

1. Open the RH front door and position a sheet of paper between the B-Pillar and the back side of the window (1), then close the RH front door as figured.

2. Move the sheet of paper up and down as illustrated below.

3. If the movement of the sheet is easy, with little to no drag. Perform the window adjustment.

4. Adjust widow on passenger front side:
09.34.005 - PASSENGER'S SIDE FRONT MOVABLE WINDOW-Adjustments
5. Repeat the Inspection for the LH side.

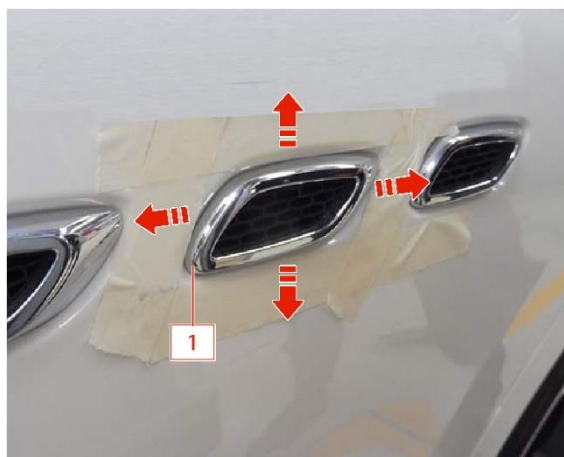
C) M161 – Air vent detachment

1. Verify the integrity and the correct position of ALL 3 air vents (Both driver and passenger side) as illustrated below.

2. If the check is **NOT OK**, (Example: the vent is loose and can be easily detached) = perform the rework.

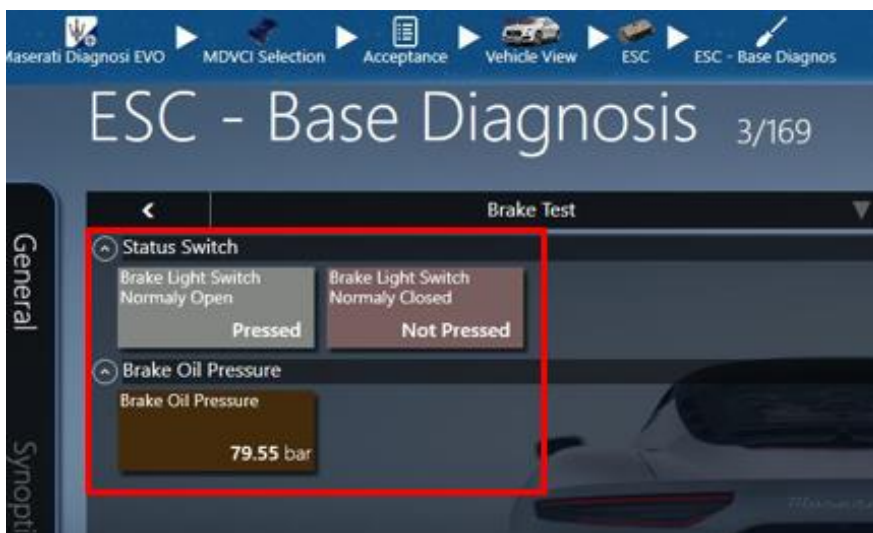
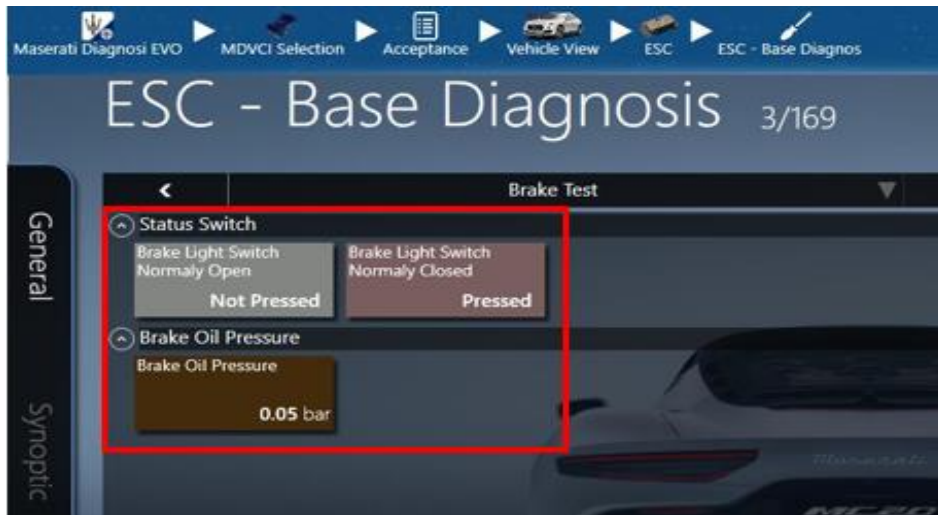
D) M161 – Brake Pedal Switch Failure Inspection

6. From the Brake Test Group, monitor the parameter values with the Brake Pedal Pressed:

- Brake Light Switch Normally Open 0889. (Pressed)
- Brake Light Switch Normally Closed 0889. (Not Pressed)
- Brake Oil Pressure 0884.

7. From the Brake Test Group, monitor the parameter values with the Brake Pedal Released:
 - Brake Light Switch Normally Open 0889: Not Pressed.
 - Brake Light Switch Normally Closed 0889: Pressed.
 - -7 bar < Brake Oil Pressure 0884 < 7 bar.

8. Refit the same brake pedal switch:
 - 05.20.011 - BRAKE PEDAL SWITCH - Removal/refitting or replacement**
9. Repeat the check procedure to be sure the pedal is mounted correctly.

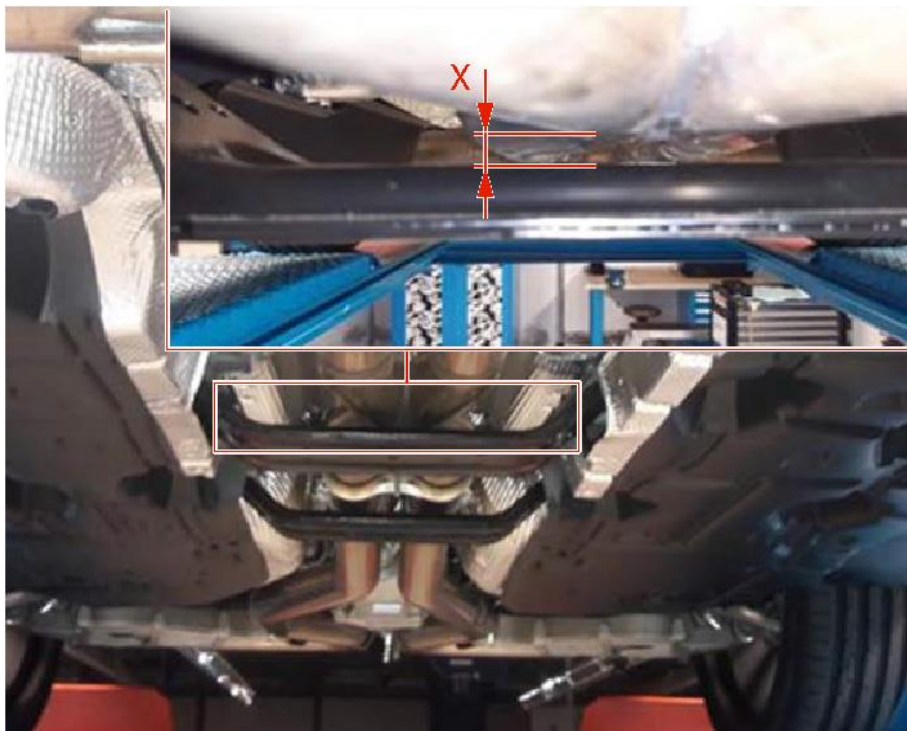
E) M161 – Rattling noise from silencer

1. Raise the vehicle on a lift.
2. Using a thickness gauge / calibrated block, measure the distance between the central pipe and the front tunnel reinforcement bracket (X = MIN 14 mm).

3. If the measurement is less than 14 mm, perform the rework.

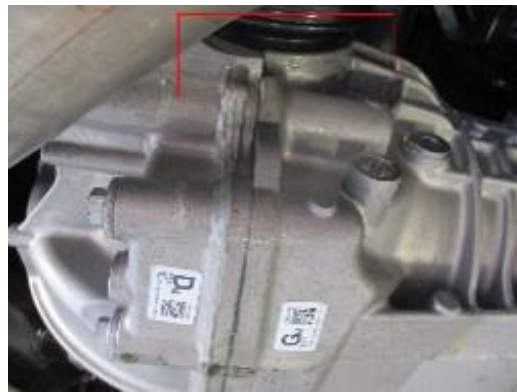
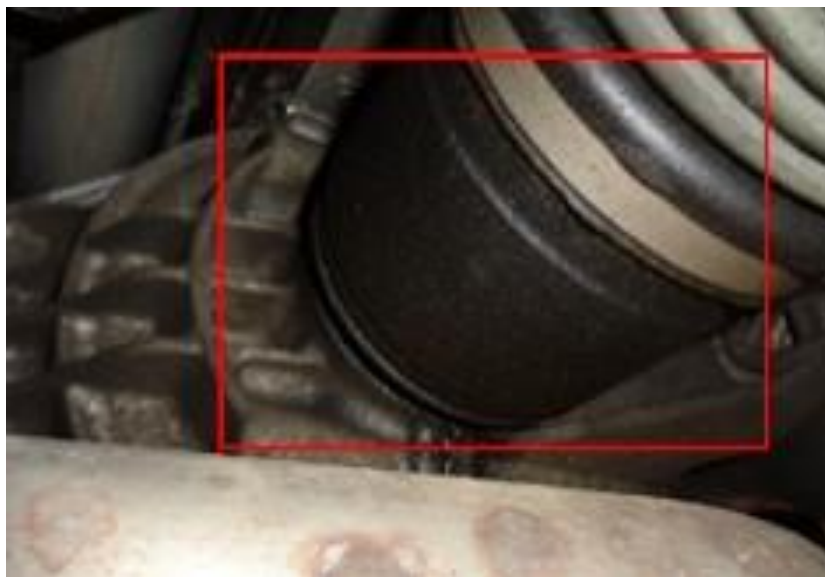
F) M157-M161 – Oil leak from the rear differential

- Raise the vehicle on a lift and check for the presents of oil leaks from the rear differential.

- If an oil leak has been found, open a BOL as "SUPPORT REQUEST" and attach pictures (including the parts label on the casing), vehicle scan, and await further instructions.
