MAS003141 (MSC 22-27)

Campaign 514

## Service Campaign 514 MC20 – Radiator pipe coolant leakage

DATE: JUNE 21 2022

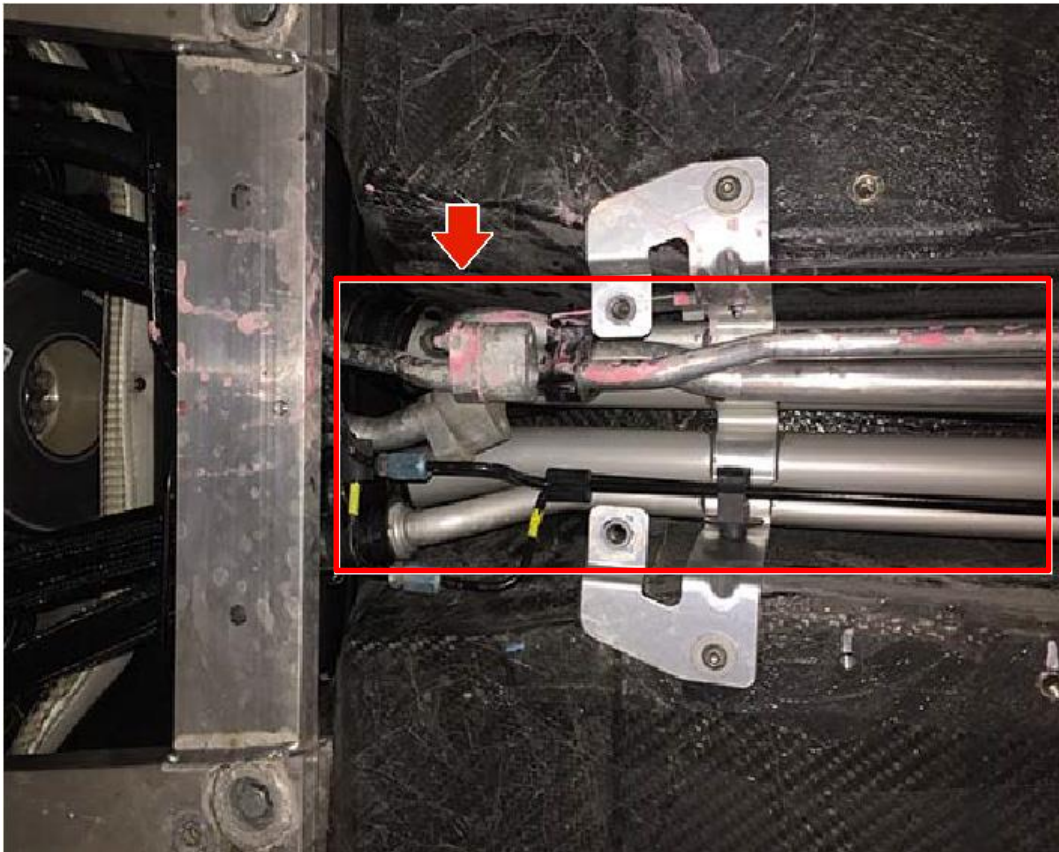
**Example Picture 1**

1. Always check in ModisCS+ to see if the vehicle is involved in this campaign and if the campaign has not been previously performed.
2. Drive the vehicle on the lift and raise it in the air.
3. Remove the body's aerodynamic cover.  
**09.14.89 - BODY AERODYNAMIC COVER - Removal/refitting or replacement**
4. Remove the rear aerodynamic central cover.  
**09.14.090 - REAR AERODYNAMIC CENTRAL COVER - Removal/refitting or replacement**
5. Visually inspect for possible coolant leaks. (See example pic. 1)

6. If coolant leaks are not present (No evidence of pink coolant residue, underbody is clean and dry). The vehicle can be considered **OK**. The operation is completed. No Further Action Required.
7. If coolant leaks are present (pink coolant residue on the pipe and the underbody e.g. example pic. 1), the vehicle must be considered **NOT OK**. In this case, continue with **Step 8**

8. Only in case of "NOT OK", perform the replacement of the pipes:  
**01.71.231 - REAR WATER PIPES - Removal/refitting or replacement**
9. **IMPORTANT:** During the pipe's replacement, it is necessary to use a soap and water solution to install them.

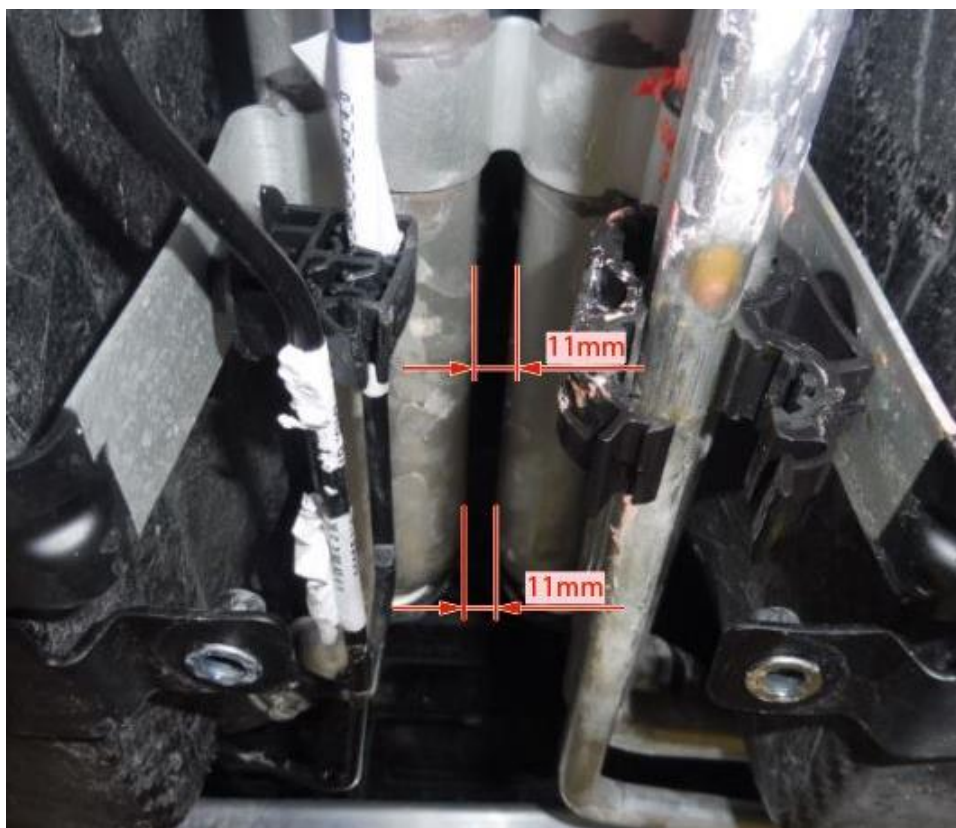
**NOTE:** The "NOT OK" pipes could have a strong deviation between the bracket and the hose injection. The distance between the two sections shown in the picture must be approximately the same (around 11mm).
