Technical Service Bulletin

34 Function restriction with event memory entry P071800 - P276800 (symptom 20736 - 20737)

34 22 59 2067653/1 July 29, 2022.

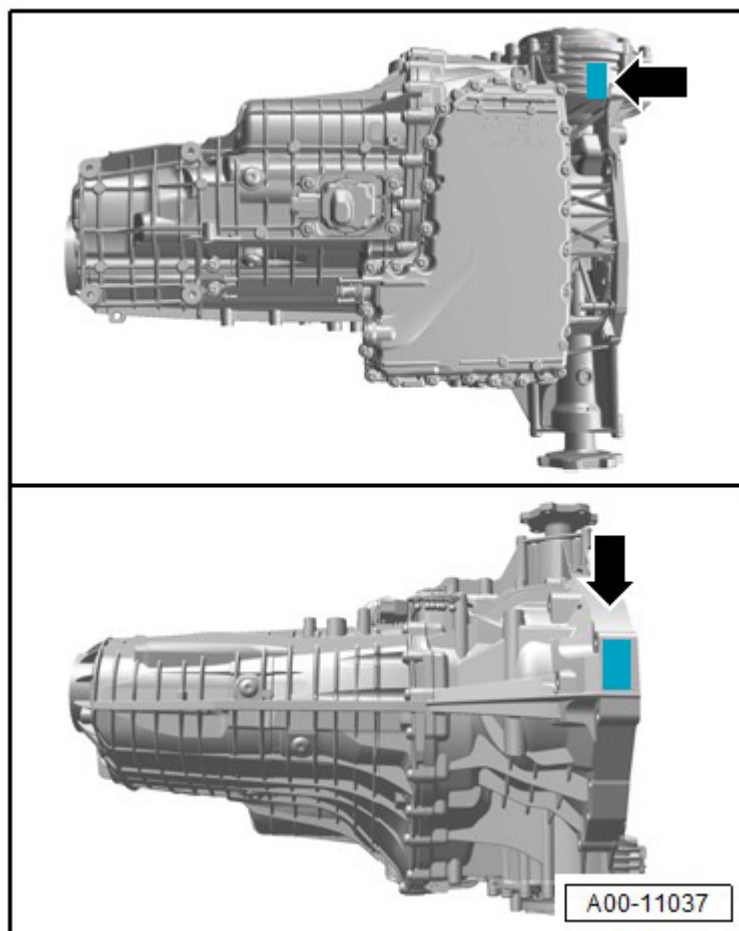
- **First determine if the Transmission was built within date range of June 15, 2020 and March 31, 2021.**
- Check one of the transmission data stamps which are located on the bottom of the front differential and the top of the bellhousing (Figure1).

Figure 1. Locations of data stampings.
