66 Door cover trim is loose

66 22 89 2063197/2 July 28, 2022. Supersedes Technical Service Bulletin Group 66 number 21-72 dated May 11, 2021, for reasons listed below.

Model(s)	Year	VIN Range	Vehicle-Specific Equipment
e-tron quattro	2019 – 2021		
e-tron Sportback quattro	2020 – 2021	All	Not Applicable

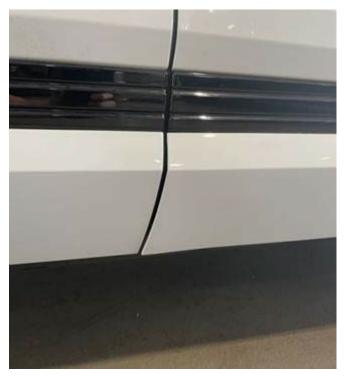
• The trim is not flush with the cover trim on the rear door (Figure 1).

Figure 1. Door cover trim as it appears when loose.

The two main pieces that comprise the door cover trim become disengaged one from the other if the trim is exposed to a sudden force such as contact with a foot during exit and entry or forceful closing of the front door. This symptom is only known to occur on the front door cover trim.

The door cover trim does not need to be removed from the vehicle to perform this repair. The two main pieces that comprise the lower door cover trim must be reconnected. Before reconnecting the pieces 2K plastic adhesive D 180 KU2 A1 (or alternatively D 180 KU1 A1) will be applied to prevent further instances of disengagement.

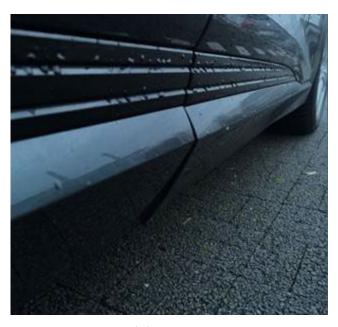
Figure 2. Disengaged door cover trim.

While the customer's vehicle may present with this symptom on one of the front doors and not both, apply the following bonding procedure to both front door lower cover trims (Figure 2). If the component parts of the trim are not yet disengaged they can be disengaged for the purposes of repair by pressing the inner trim upward and away from the outer shell.

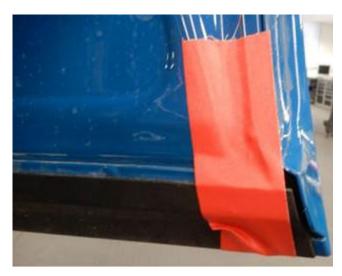
Figure 7. Painter's tape binding the newly adhered trim pieces.

Place a strip of painter's tape as shown in Figure 7 to keep the two pieces together during the adhesive curing time.
