| Electrical | 2020-2022MY Sportage (QL) |
| PS733 | July 2022 |

SUBJECT: **PARASITIC BATTERY DRAW/ALARM WARNING
W/ ILLUMINATED DOOR SILL PLATES ACCESSORY**

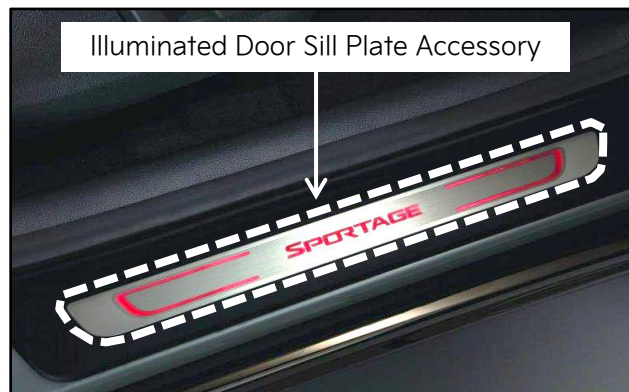
This Pitstop provides information regarding a parasitic battery draw concern on some 2020-2022MY Sportage (QL) vehicles equipped with Illuminated door sill plates accessory installed (LH and RH sides), which may cause the battery power to drain, and in some cases exhibit the alarm system/horn warning to sound off. Follow the steps below to determine if these conditions are related to this accessory.

1. Inspect the illuminated door sill plates and confirm it is correctly installed and functioning.
2. Disconnect the door sill plate (both sides) and verify if the parasitic draw is no longer present. If the conditions are intermittent, inspect the sill plates for evidence of water intrusion. If water intrusion is confirmed, replacement may be necessary. Refer to "Publication → Accessory Information → Body (Interior and Exterior) → 2020 - Sportage (QL) Illuminated Door Sill Plates (D9F45 AC000) Isheet" on KGIS. Note: Door sill plates should only be replaced if defective or damaged.
3. Confirm that the condition(s) is no longer present after repairing a bad connection or faulty part. If the condition(s) is still present, diagnose by referring to the applicable Shop Manual on KGIS.
