GROUP	MODEL
BOD	2021-2022MY Sorento (MQ4a) w/BSD
NUMBER	DATE
308	July 2022

## TECHNICAL SERVICE BULLETIN

### SERVICE ACTION: REAR CORNER RADAR UNIT BODY SEALER INSPECTION & REPAIR (SA503)

This bulletin provides information to inspect both rear (LH & RH) corner radar unit mounting body sealer surface on some 2021-2022MY Sorento (MQ4a) vehicles equipped with rear Blind Spot Detection (BSD) System, produced from November 30, 2021 through June 30, 2022, which may have excess body sealer applied during assembly causing improper mounting angle of the rear corner radar unit. An improperly mounted rear radar unit may cause the vehicle to exhibit a MIL 'ON' with DTC C270954. Follow the procedure outlined in this publication to inspect and, if necessary, file down the seam sealer behind the bracket. Before conducting the procedure, verify that the vehicle is included in the list of affected VINs.

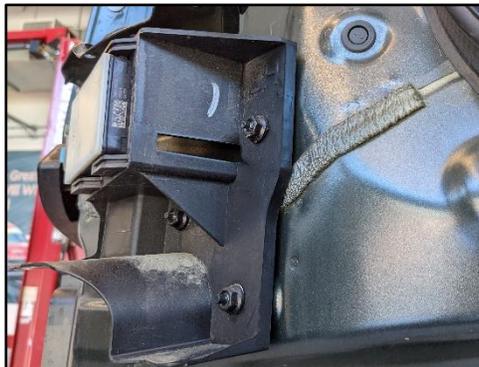
Rear corner radar unit bracket  
body sealer interference.

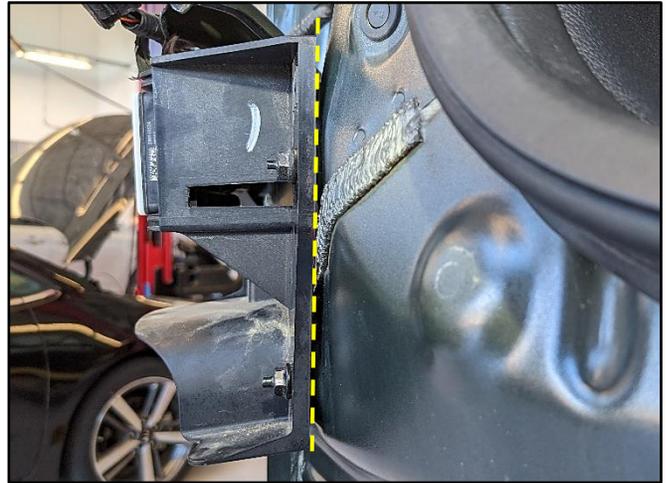
Note that the rear corner radar bracket mounting area is 'flat' over the body sealer. Excessive body sealer (NG) will cause the radar angle to aim improperly, resulting in a MIL 'ON' with DTC C270954.

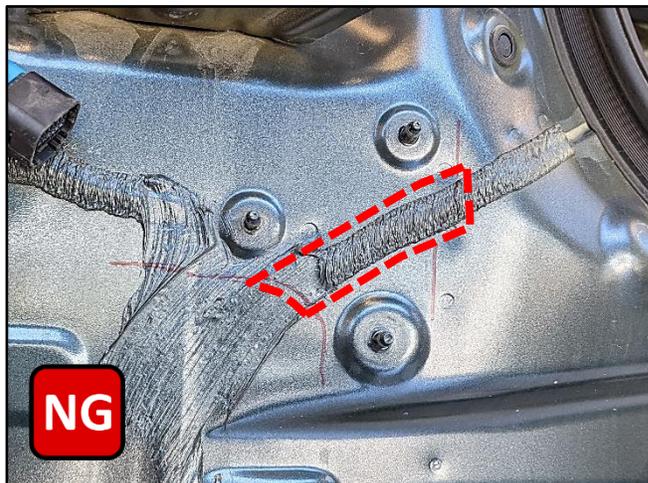
4. Inspect the surface of the rear radar bracket mounting area shown for excess body sealer.

Excessive body sealer will cause the radar angle to aim improperly.

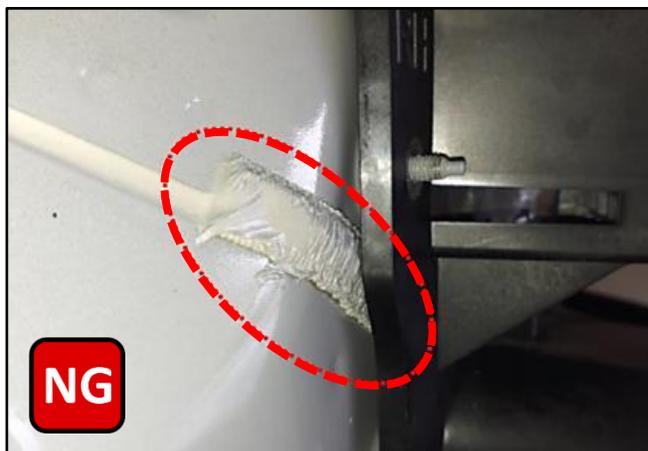
- If the body sealer exceeds thickness of 1.5mm (NG) and causes the rear radar bracket to mount improperly and/or DTC C270954 was stored, then proceed to step 5a/5b.

- 5a. Using a small sander/grinding pad, reduce any excess body sealer until the rear corner radar bracket mounting surface is no longer obstructed by excess sealer.
- 5b. Repeat for the opposite side as needed.

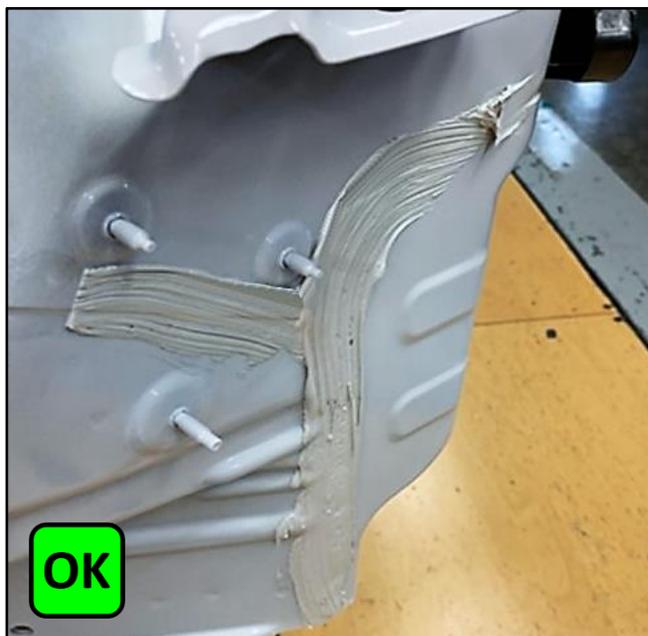
- If the body sealer is 1.4mm thick or less (OK) and the rear radar bracket mounts properly and/or DTC C270954 is not stored, then no further action is required. Proceed to step 8.
