MODEL
2020MY
Rio (SC) w/IVT

NUMBER
097 (Rev 3, 07/21/2022)

TECHNICAL SERVICE BULLETIN

SUBJECT: **SERVICE ACTION: IVT/CVT SW LOGIC IMPROVEMENT
AND/OR IVT/CVT REPLACEMENT (SA476)**

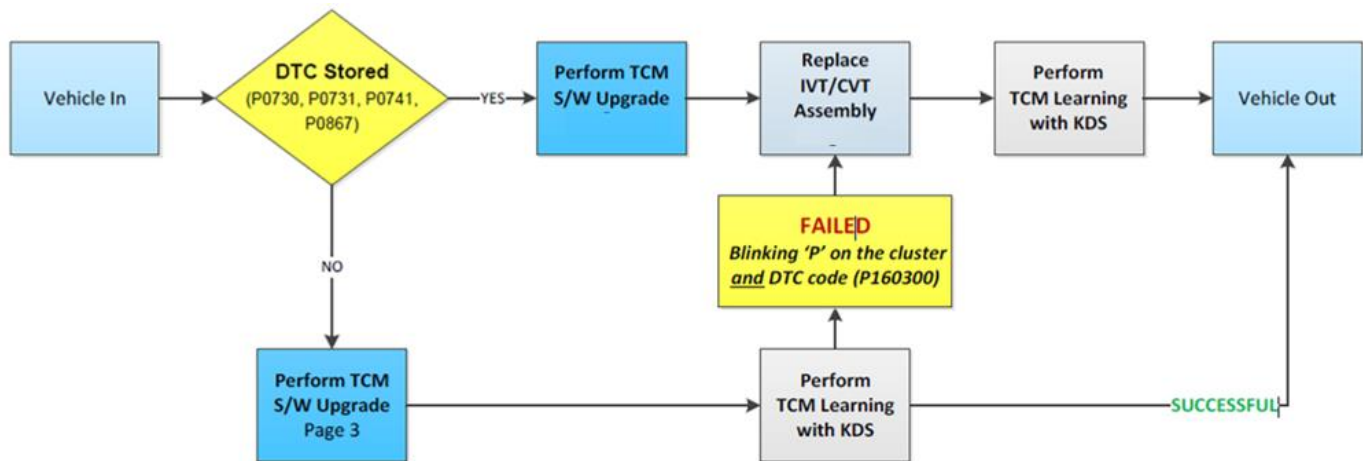
Flowchart:

This bulletin provides the procedure to improve the software logic of the IVT (Intelligent Variable Transmission)/CVT (Continuous Variable Transmission) on some 2020MY Rio (SC) vehicles produced from July 1, 2019 through August 10, 2020 equipped with IVT/CVT, which may exhibit an MIL with DTCs. The affected vehicles may exhibit the illumination of the MIL with DTC(s) listed below in addition to lack of acceleration or delay in accelerating due to transmission slippage. To correct this concern, apply the improved logic to the IVT/CVT system using the KDS ECU Upgrade function as described in this bulletin, and, if necessary, replace the IVT/CVT. For confirmation that the latest reflash has been applied to a vehicle you are working on, verify the ROM ID using the table on page 3 of this bulletin. Before conducting the procedure, verify that the vehicle is included in the list of affected VINs.

- **P0730** – Incorrect Gear Ratio
- **P0731** – Gear 1 Incorrect Ratio
- **P0741** – Torque Converter Clutch Circuit Performance or Stuck Off
- **P0867** – Transmission fluid pressure

- **P160300** – P-Learning Fail (CVT System)

- 1) Using the KDS (connected to the internet to create and transmit a VDN*), perform a Fault Code Search and confirm DTC P0730, P0731, P0741 or P0867 is/are stored (Active, History or Pending). Follow the flow chart above and perform the necessary procedure(s).

- 2) If one of the four DTCs (P0730, P0731, P0741, P0867) applies during the DTC Check, upgrade the TCM S/W and replace the IVT/CVT.
- 3) Replace the IVT/CVT according to the applicable Shop Manual on KGIS.

- 4) Then perform the IVT/CVT resetting auto T/A values, oil-pressure characteristics input, TCM adaptive values learning procedure.
- 5) If DTCs P0730, P0731, P0741, and P0867 do not come back, upgrade the TCM S/W and perform TCM adaptive values learning procedure. If successful, complete the service. If not, and TCM Learning fails, 'P' will be blinking on instrument cluster and DTC code P160300 will set. Then replace the IVT/CVT and do TCM Learning again.
