GROUP	MODEL
ENG	Multiple Models Listed
NUMBER	DATE
237	July 2022

TECHNICAL SERVICE BULLETIN

SUBJECT: OIL PRESSURE SWITCH (OPS) REPLACEMENT

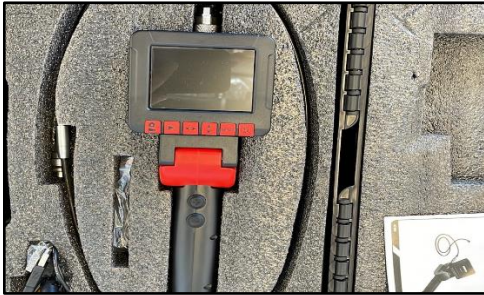
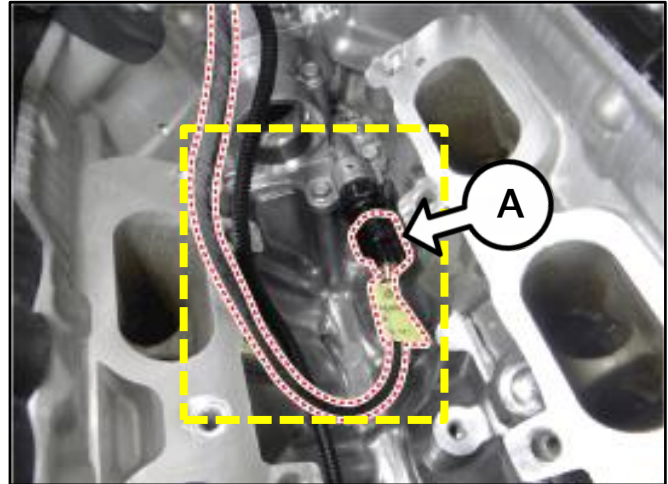
1. Open the hood and remove the engine cover.
2. Using a videoscope such as SST JSP97305 Snake Scope II or similar tool inspect the Oil Pressure Switch (OPS) (A) for oil leakage.

Note: Be sure to check the surrounding bottom and wall area of the engine block for oil leak traces.

- 3a. If oil leak is **not** present (OK), no further action is required.
- 3b. If oil leak is present (NG), proceed to the 'Replacement Procedure' on page 3 to replace the OPS with the new part.

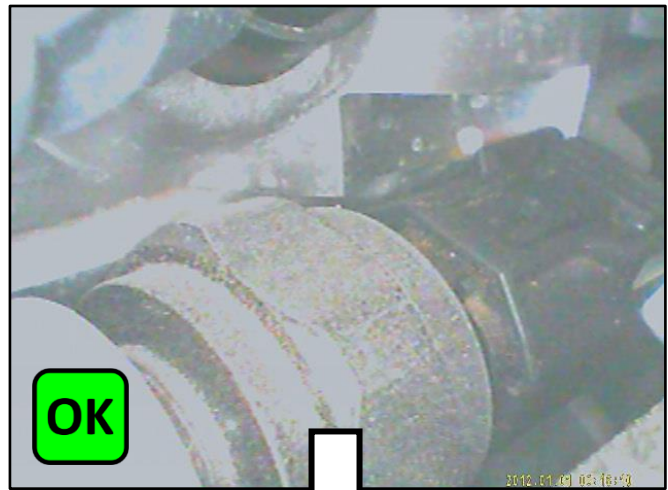
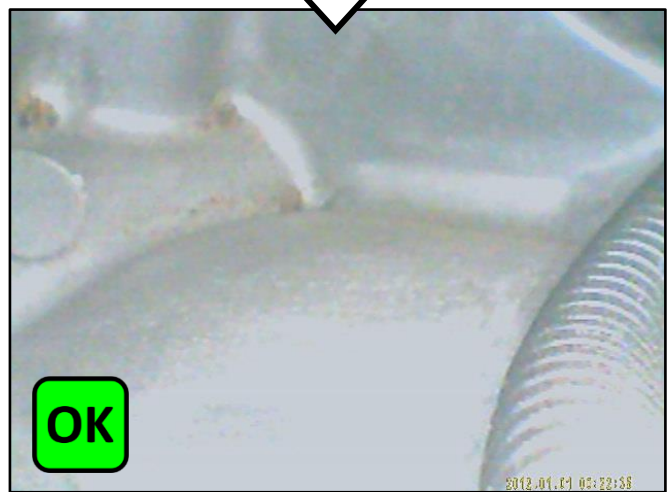
Dealer Technicians: Sometimes a leaking Oil Pressure Switch (OPS) can be misdiagnosed as a rear main oil seal leak due to the fact we have a drain hole in the engine valley to the rear of the engine. Using your videoscope we can identify where the oil leak is coming from and determine within a few minutes if the OPS is leaking.

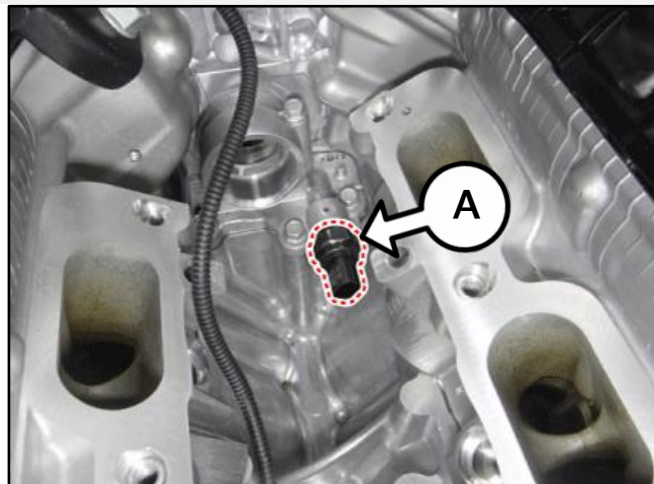
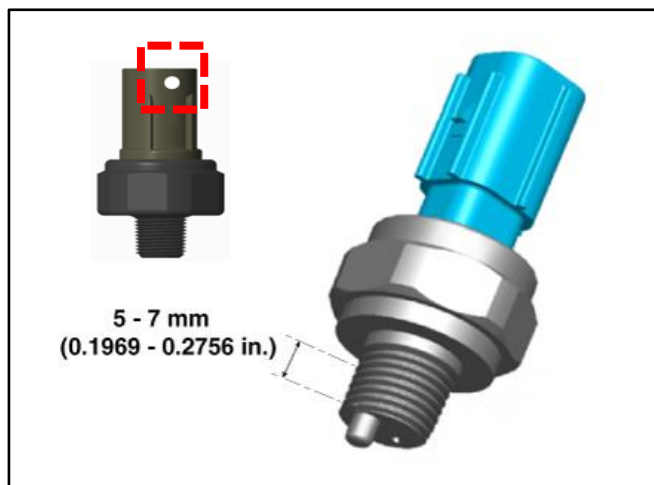
The new OPS may have a white marking as shown. Remove any debris and clean gasket surface prior to assembly.

1. Replace the Oil Pressure Switch (OPS) by referring to "Engine Mechanical System → Lubrication System → Oil Pressure Switch → Repair procedures" in the applicable Shop Manual on KGIS.

Add sealant (3M 2510) to the OPS threads in the area shown.
