Articles Contained in this Issue

01 TechShare QMR of the Month

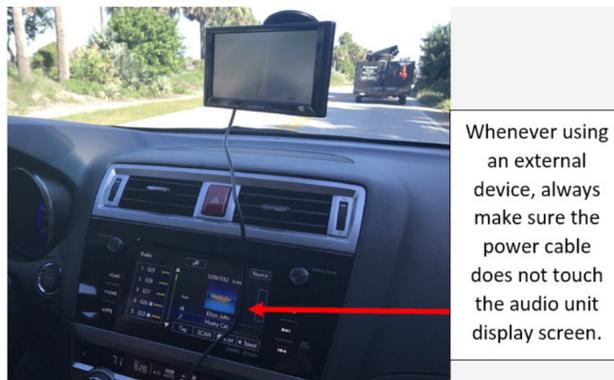
Please be aware that charging cables should not be routed in front of any touch device such as the Denso F10, Harman Headunits, and CP1 Cockpit Display. Routing the cables across the touch screen can cause erratic operation of the screen. This is referred to as 'ghost touch'. This is caused by an electrical pulse through the wire being interpreted as an input by the screen. This unwanted input can cause intermittent screen concerns and even unit crashing. This concern can be traced back to the first Denso F10 Units.

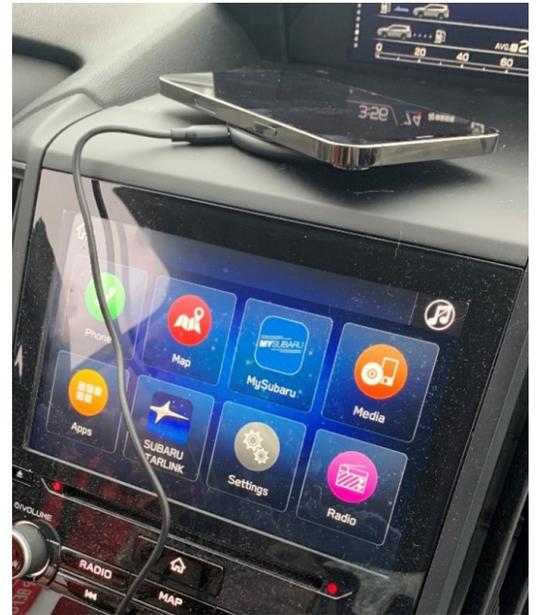
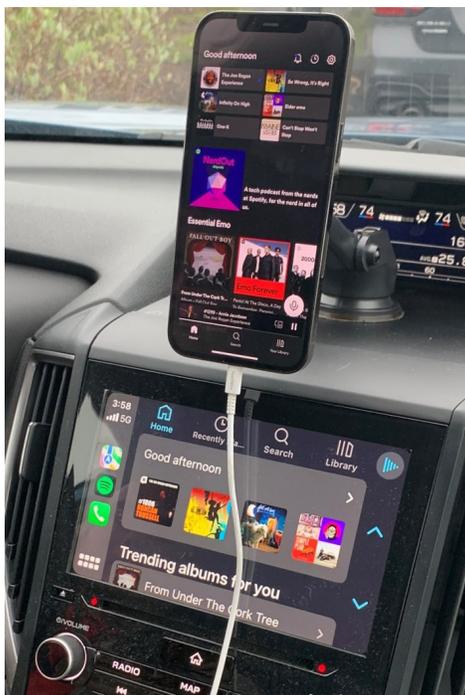
Pictured to the right, is an example from Techline of a customer with a wireless charger mounted to the pocket above the Headunit. The Customer concern was intermittent no response from the touch screen and screen distortion. Not only is the charging cord across the screen but the electromagnetic effect of the wireless charger. In some vehicles this may affect speaker performance.

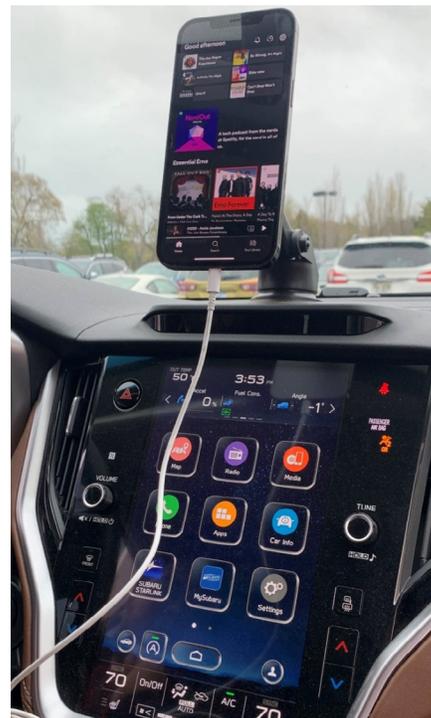
Pictured to the left, is an example of a phone mount and charging set up that could affect the screen responsiveness and behavior. Projection apps can be affected by this concern as well.

Finally, with the addition of CP1 to the Subaru lineup, there is a much larger screen where multiple inputs can be made. Shown to the right is an example of how a charging cord could affect the screen. This is especially noticeable in radio mode or a screen with several selections such as SXM or Navigation. This could cause a no response situation or screen distortion until the key is cycled and the cord is removed.

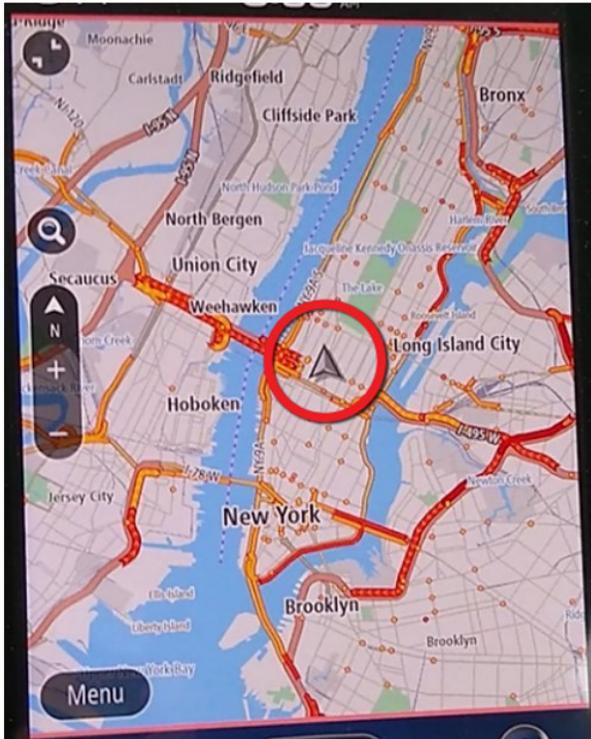
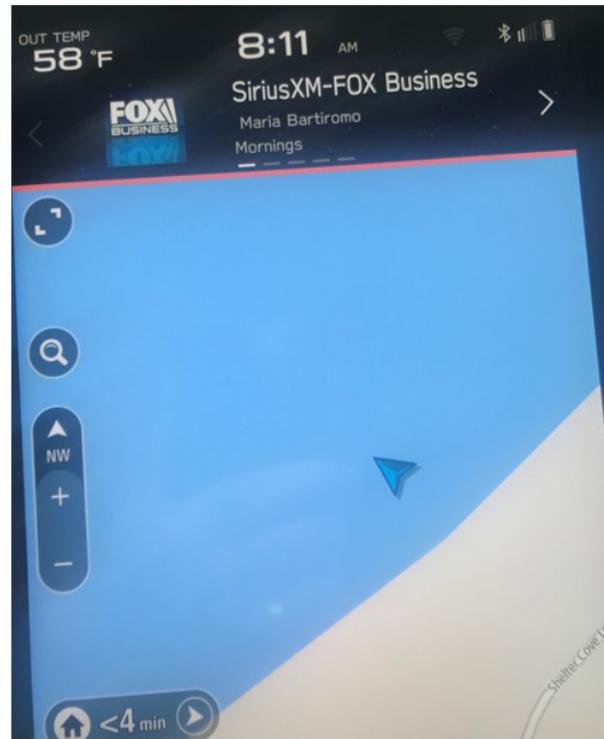
Retailers may receive vehicles with a customer complaint of the navigation showing the wrong location. This condition may show the vehicle a few miles off from the current location, the wrong town, the wrong state, or out in open water. The following instructions will clear the condition and explain how to reset the vehicle properly. Failure to follow these steps will not resynchronize the unit and may lead to unnecessary part replacement.

Below are two examples of common wrong locations seen.

Note: The default GPS location for CP1 is Manhattan, New York. The arrow icon could be gray, which indicates the vehicles' location is not found by the Navigation satellites (shown above).

1. Verify the condition.
2. Install the newest logic as per TSB 15-261-20R; refer to the TSB for the latest version.
3. Document the customers' settings, radio stations, favorites, and saved locations.
4. Perform a 10-minute capacitive discharge.

It is recommended that no short cuts be taken at this time. Failure to meet the allotted capacitive discharge time may not erase the memory and the Technician will find the same condition present when setting the vehicle back up.

5. Set up the customers' settings, radio stations, favorites, and saved locations.
6. Road test the vehicle in as straight of a line as possible for 10 minutes or ten miles, whichever resets the GPS arrow icon from gray to blue. Be mindful of the road test route selected.

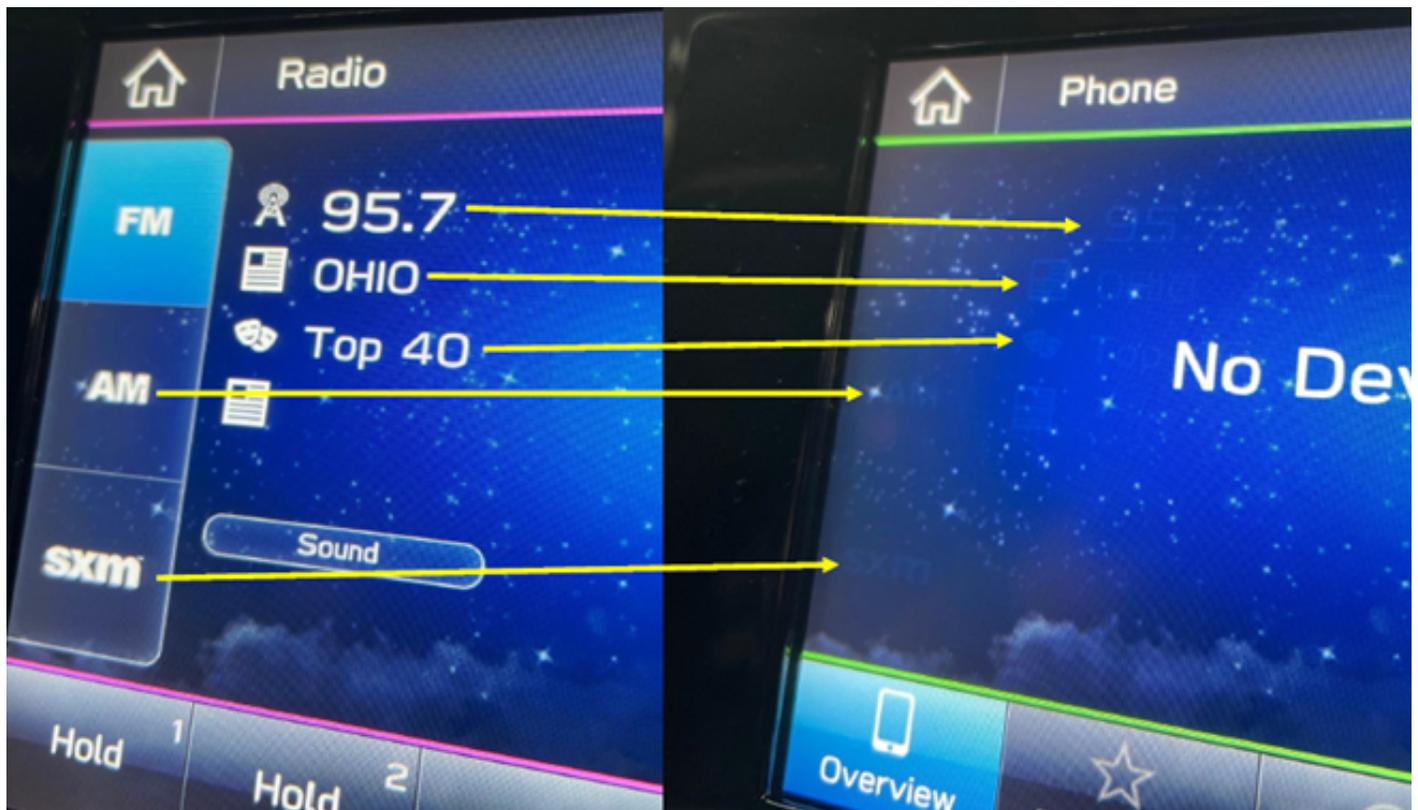
If a customer is concerned with a Ghost Image or Double Image on a Base+ or Base Harman unit, this condition requires no repair at this time. The vender has determined that this condition is non detrimental to the operation of the Headunit and will clear with time as the unit is used. The exchange process is NOT recommended for this concern.

Refer to the images below for an example of the condition.

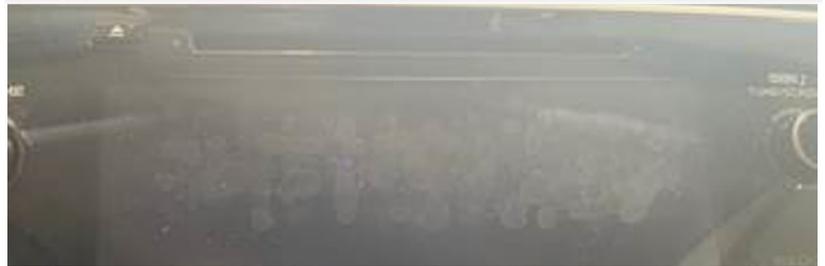
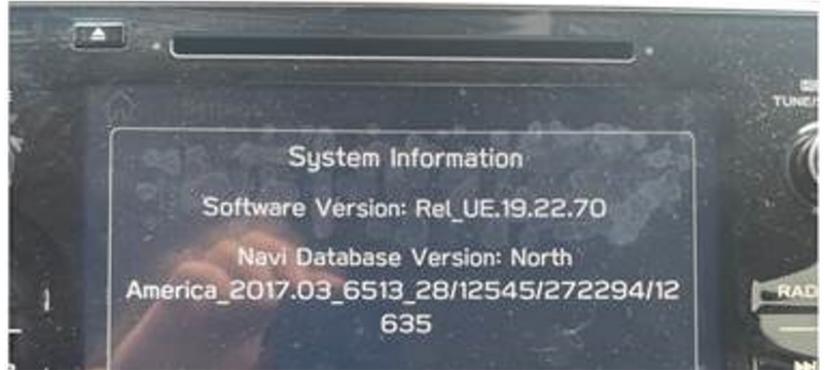
Recently, there have been an increase in reports of Harman Headunits exhibiting screen bubbling to TechShare and Techline. The root cause of this concern is liquid entering the airgap between the screen and inner Headunit components through the CD player port. Liquid enters down into the air gap of the screen and will cause permanent damage. This may originate from spray bottle splash or liquid cloth wipes coming in contact with the area. The only repair for this concern is the Headunit exchange program.

If you suspect the unit has been damaged by liquid, some Technicians report being able to use their flashlight on an angle to see the liquid behind the clear plastic when the Headunit is off. If liquid can be seen, a Headunit exchange will be needed.

In the Starlink owner's manual, reference page 7 for cleaning recommendations. No liquid should be put on the display. This means spray disinfectants, liquid cleaners (wipes included), or food products. If the screen is dirty, it should be cleaned with a soft, dry cloth. If a chemical cleaner is needed, see the recommendations listed in the manual.
