**PRODUCT CAMPAIGN BULLETIN**

**APPLICABILITY:** 2019MY Crosstrek  
**SUBJECT:** Rear Seat Belt Webbing Locking

**NUMBER:** WRC-20R  
**DATE:** 04/01/20  
**NHTSA ID:** 20V-189  
**REVISED:** 07/06/22

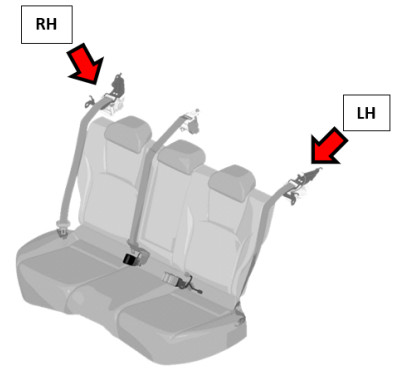
**NOTE:** Position Code and ID Code details are provided in the Service Procedure section below.

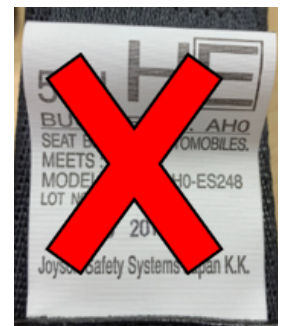
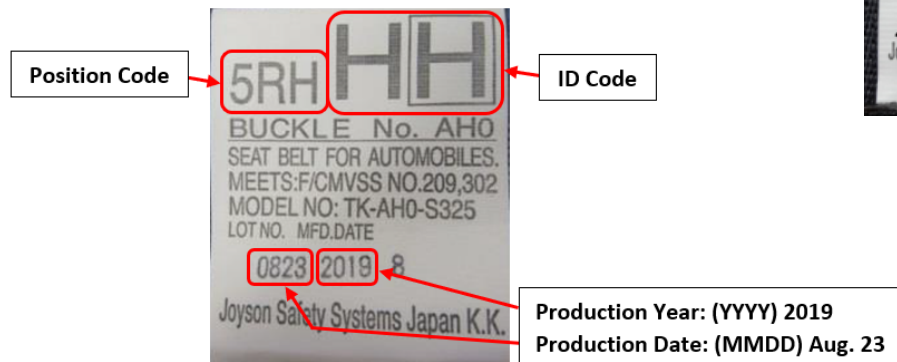
- **After seat belt removal, mark the tag with a permanent marker** as shown here to distinguish the old part from the replacement (new) part. If by chance the old parts become confused with the new parts, check the date code to identify the new seat belt assemblies using the photo below as a guide.
