**PRODUCT CAMPAIGN BULLETIN**

**APPLICABILITY:** 2022 MY Outback 2.4L (turbo)

**NUMBER:** WRC-22

**SUBJECT:** Safety Recall - Engine Harness and ECM replacement

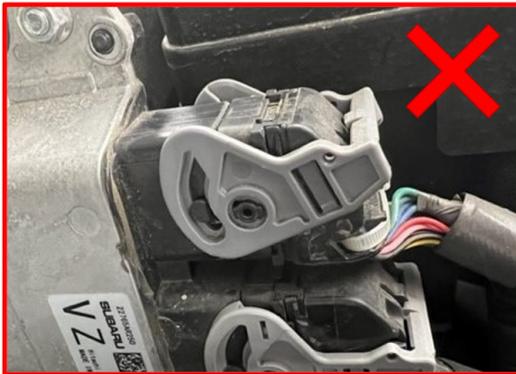
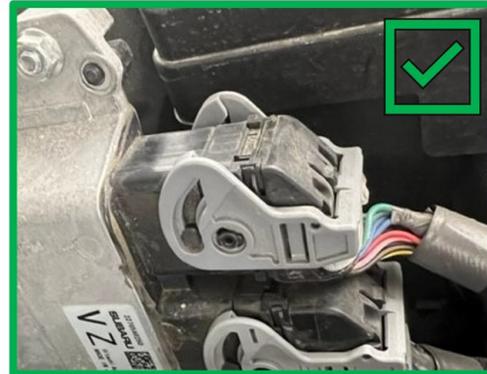
- **ALWAYS** confirm the connector levers are in the fully locked position. See images below.

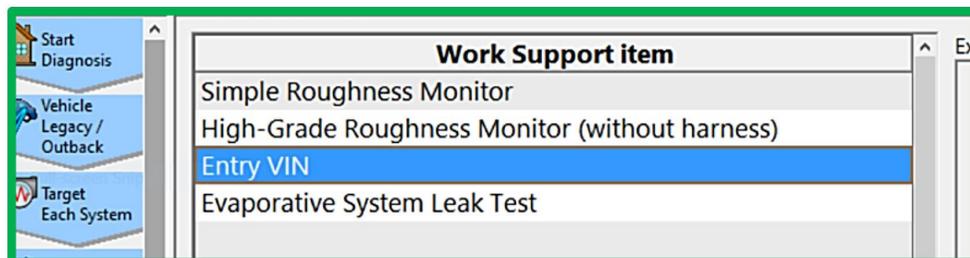
- **ALWAYS** perform the “Entry VIN” procedure using SSM.

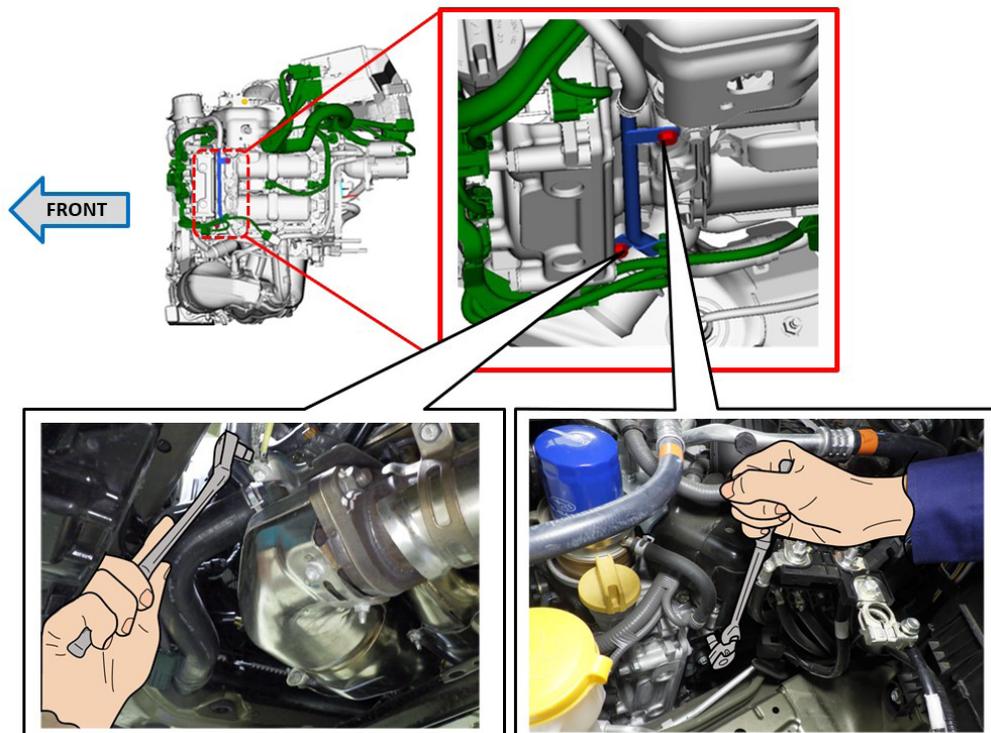
**TIP 2)** Remove the two bolts securing the engine oil cooler pipe. DO NOT remove the water hose. This eliminates engine coolant loss.

**NOTE:** The lower bolt can be removed easily with the vehicle on a lift.

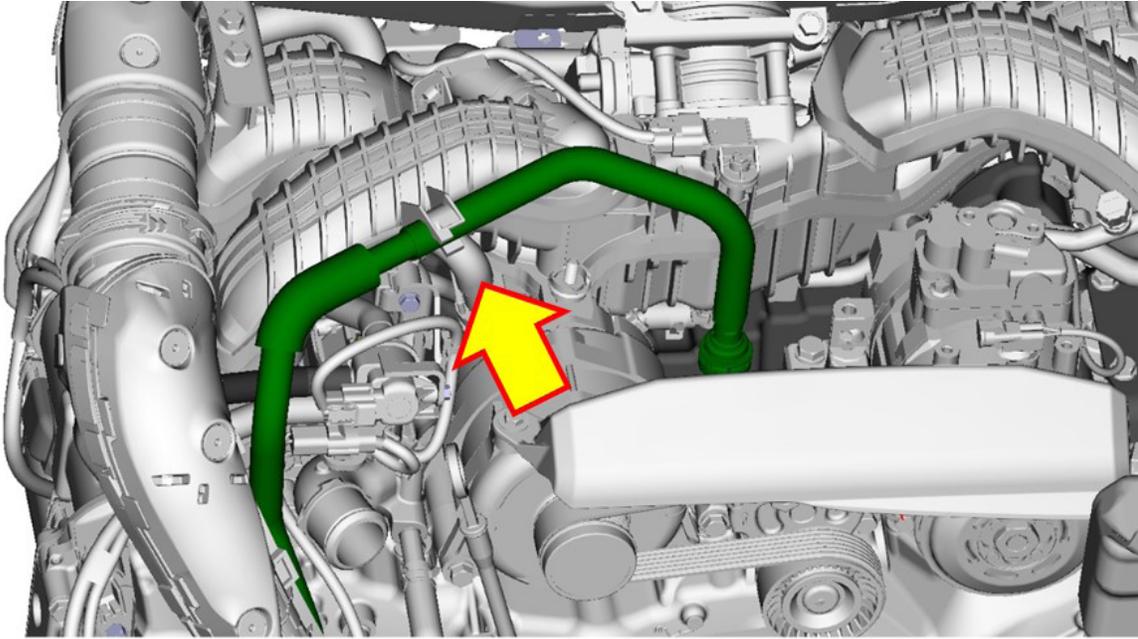
**TIP 3)** It is not necessary to remove the entire PCV pipe. Detach the pipe from the holding clamp. This will avoid replacement of the PCV pipe which is a one-time use part.

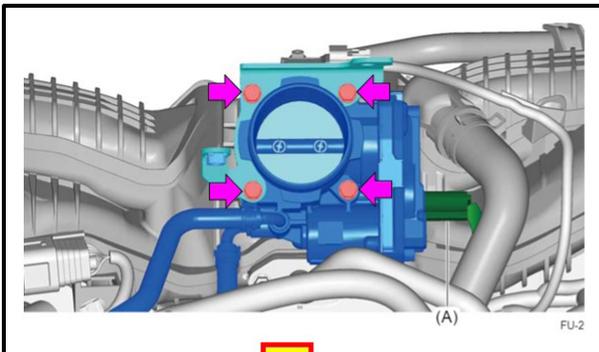
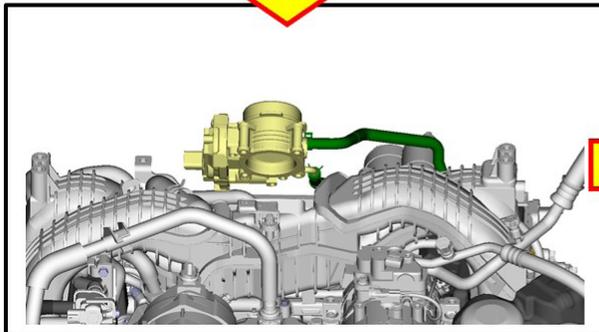
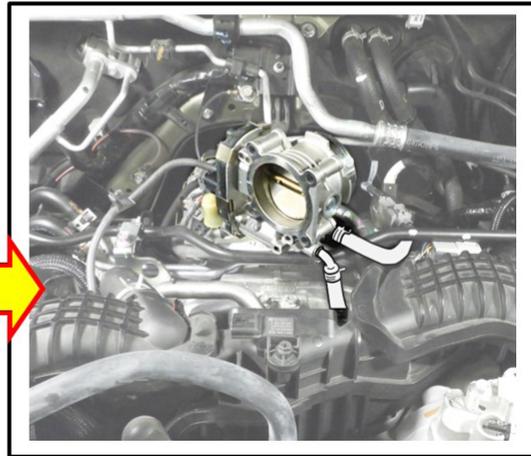
**TIP 4)** The throttle body assembly does not have to be fully removed. Remove the four mounting bolts and disconnect the wiring harness connection. The throttle body assembly can be repositioned with the pre-heater (coolant) hoses attached to gain sufficient access. Use CAUTION to not damage the throttle plate during this procedure.

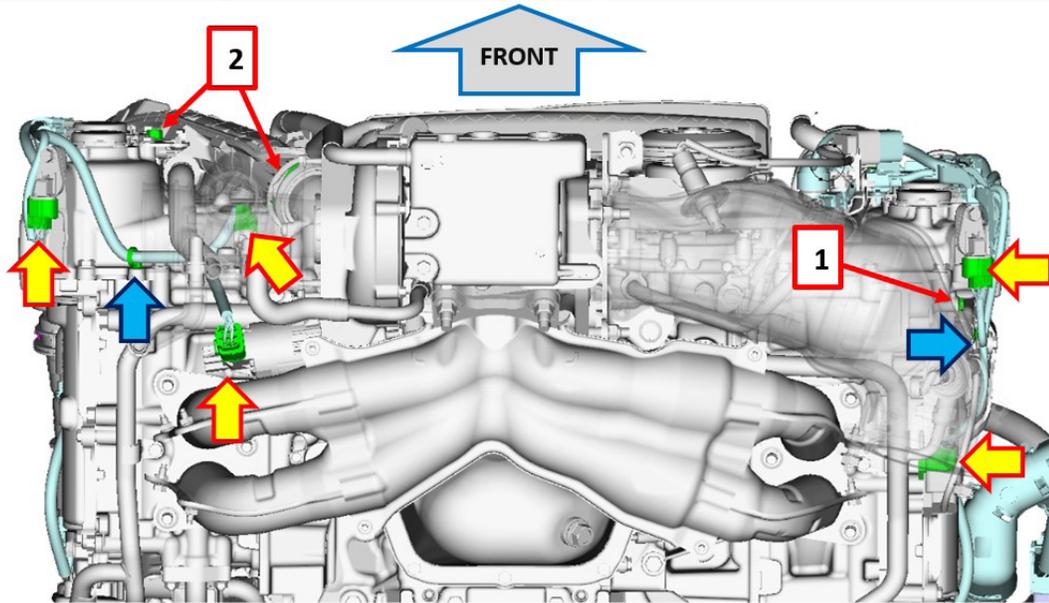
**TIP 5)** CAREFULLY raise the vehicle and disconnect the five electrical connectors and the harness mounting clips. Remove the mounting bolt and the spring lock on the intake duct. Refer to the images below.

- 1** Lower Oil Cooler Pipe Mounting Bolt
- 2** Mounting Bolt and Spring Lock for the Intake Duct
-
