**SERVICE BULLETIN**

**APPLICABILITY:** 2012-21MY Forester  
 2012-21MY Impreza  
 2015-20MY WRX

**NUMBER:** 02-131-12R  
**DATE:** 07/18/12  
**REVISED:** 07/11/22

**SUBJECT:** Oil Seepage Diagnosis and Repair Procedures

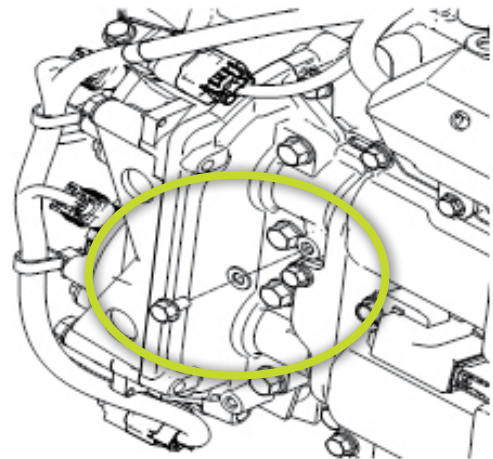
If oil seepage is verified coming from the 6mm threaded hole in the left-hand camshaft cap, install the specified bolt and flat washer.

**Bolt:** Part# 800206180

**Washer:** Part# 031106000

**Tightening Torque:** 6.4 +/- 0.5 Nm  
 (57 +/- 4 inch-pounds)

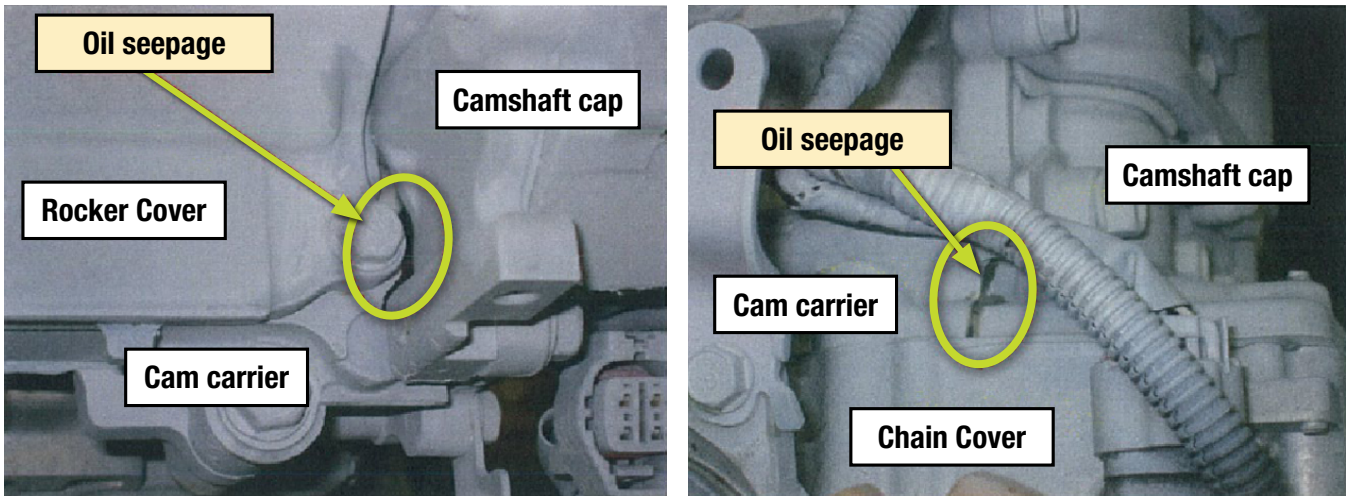
If oil seepage is verified coming from the front camshaft cap or cam carrier as shown in the photos below, remove the cam cap and clean both surfaces thoroughly before applying sealer. **Note:** The 2 o-rings between the camshaft cap and the cam carrier will need to be replaced as they are not re-usable.

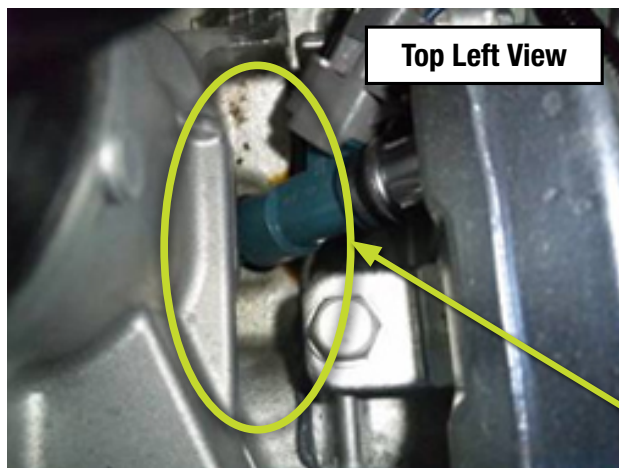
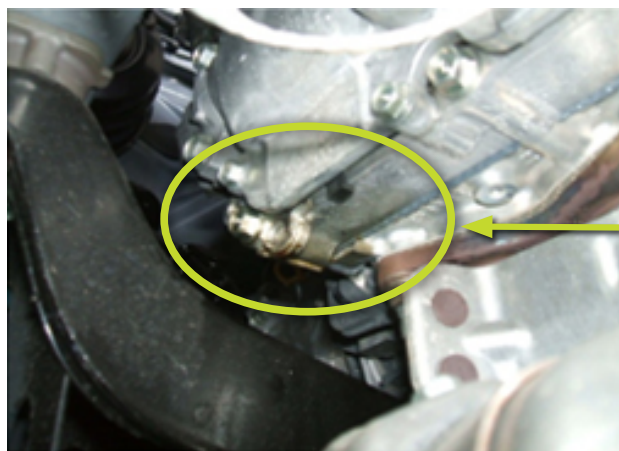
**Cam carrier seepage seen from top left and lower right side of engine**

If oil seepage is verified coming from between the cam carrier and the cylinder head as shown in the photos below, remove the cam carrier. Clean the machined sealing surfaces thoroughly and then re-seal using Liquid Gasket ThreeBond 1217H (SOA868V9610) or equivalent\*. As shown in the photos below, the o-rings between the cam carrier and the cylinder head will need to be replaced as they are not re-usable. This would also be a good time to clean the Active Valve Control System (AVCS) filter screens which are contained in the cam carriers. **NOTE:** The filter screens are one-time use and must be replaced if they need to be removed. The replacement filter part# is 14451AA050.

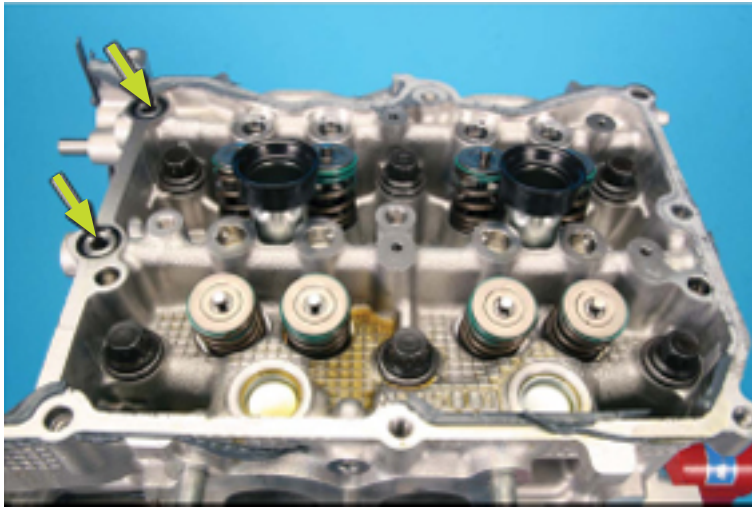
**Cam carrier o-rings requiring replacement**

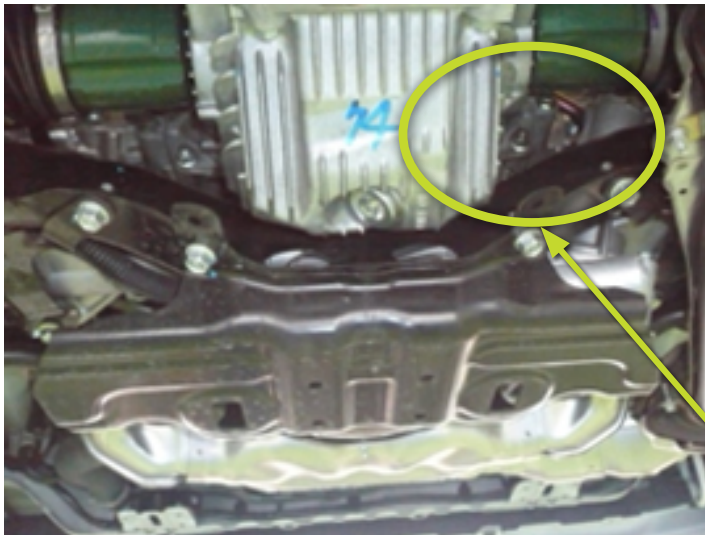
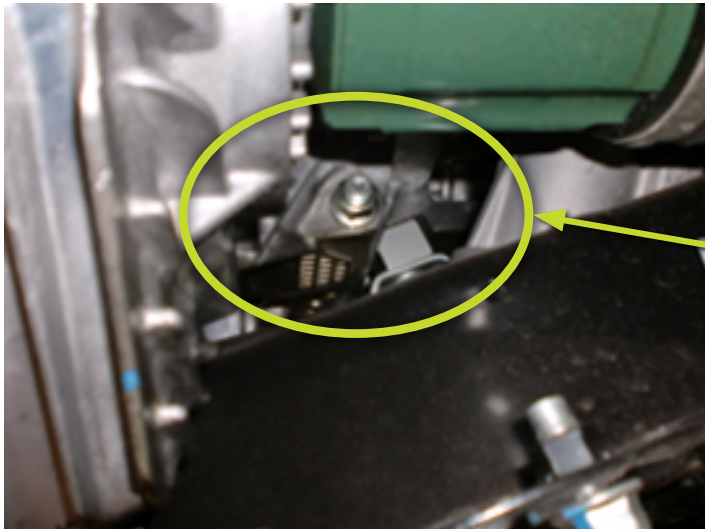
**As viewed from the rear, oil seepage from the upper pan to engine block sealing area may be present in these areas.**

If you find engine oil seepage between the cylinder block and upper oil pan, remove the upper oil pan, clean the machined sealing surfaces thoroughly and then re-seal using Liquid Gasket ThreeBond 1217H (SOA868V9610) or equivalent\*. **Note:** The o-rings between the upper oil pan and the cylinder block along with those between the upper and lower oil pan will need to be replaced as they are not re-usable.

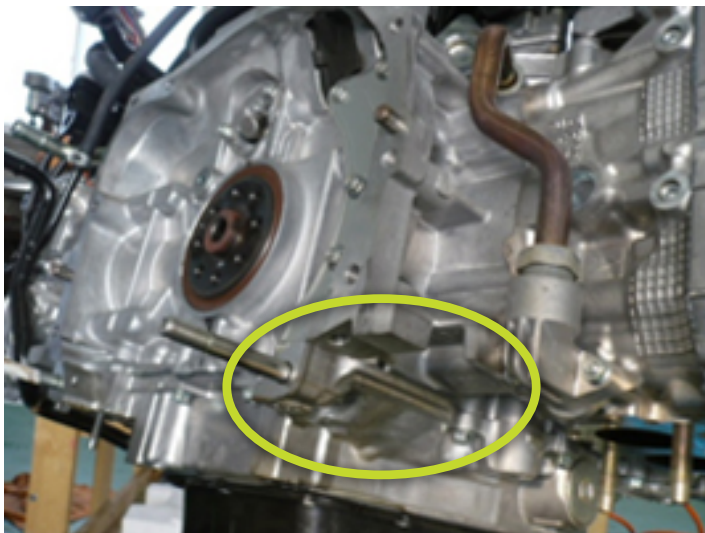
Photo shows seepage from upper oil pan to engine block sealing surfaces.

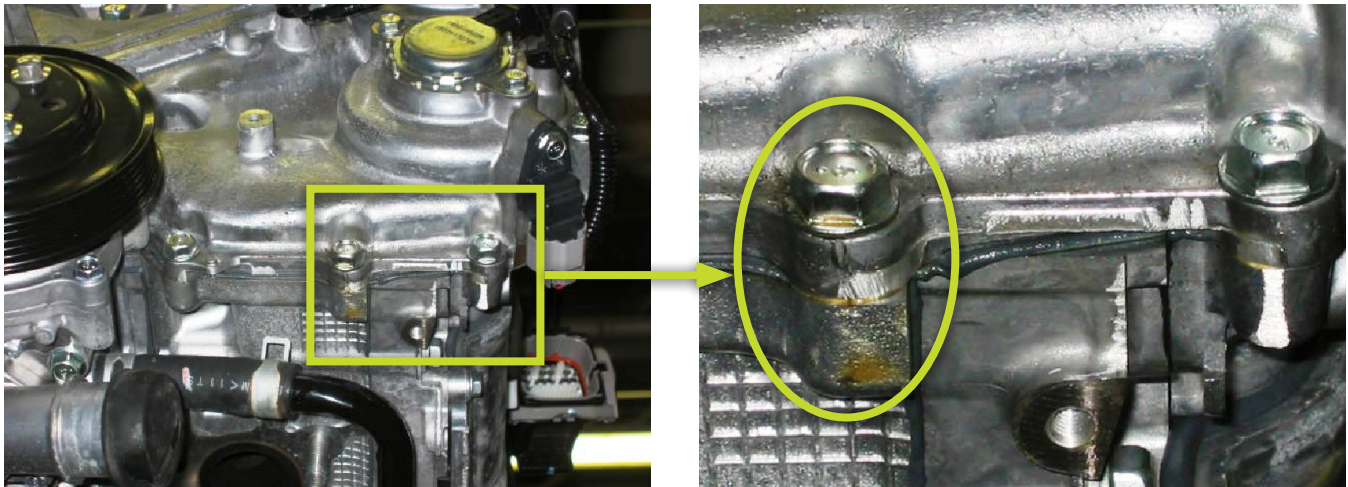
**Note:** Only reseal the front chain cover AFTER confirming there is no oil seepage coming from the cam retainer cap (area 1) as previously described.

1. If there are no oil droplets found on the engine under-cover or the lower radiator hose, thoroughly clean the chain cover sealing area along with the surrounding cylinder head and crankcase areas. Re-check for oil seepage again at the next service interval.
2. If the front chain cover is leaking and needs to be resealed, follow the repair procedure in the applicable Service Manual. Thoroughly clean and inspect the sealing surfaces then re-seal using Liquid Gasket ThreeBond 1217H (SOA868V9610) or equivalent\*.
