GLOBAL SAFETY FIELD INVESTIGATIONS
DCS6228
URGENT - DISTRIBUTE IMMEDIATELY

Subject: N222376590 - Service Update
Transmission Control Module Reprogramming

Models: 2020 Chevrolet Silverado 2500/3500 HD
Equipped with 8-cylinder, 6.6L Diesel Engine (RPO L5P)

N222376590 Transmission Control Module Reprogramming

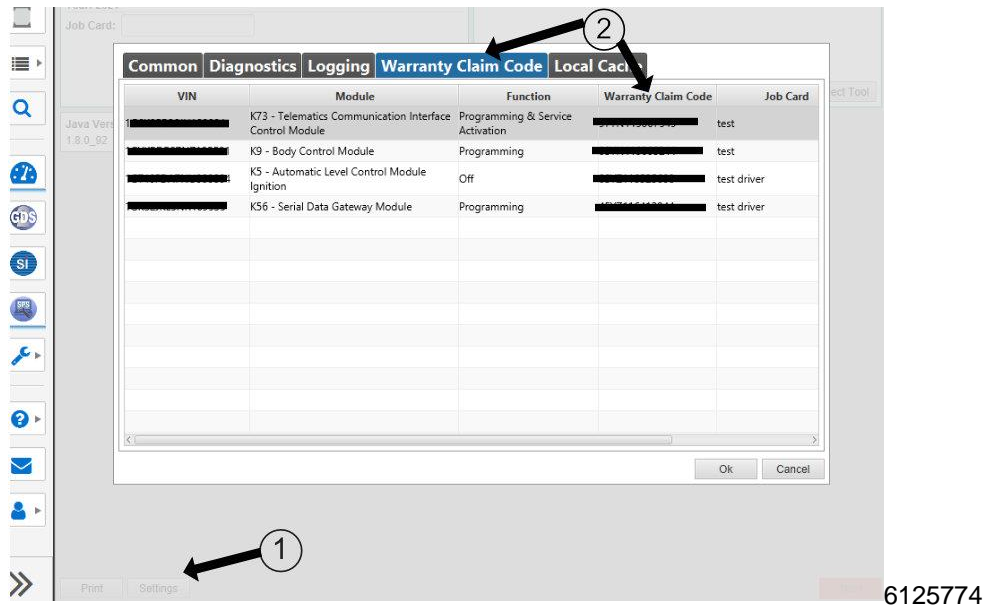
Warranty Claim Code Information Retrieval

1. Open TLC on the computer used to program the vehicle.
2. Select and start SPS2.
3. Select Settings (1).
4. Select the Warranty Claim Code tab (2).

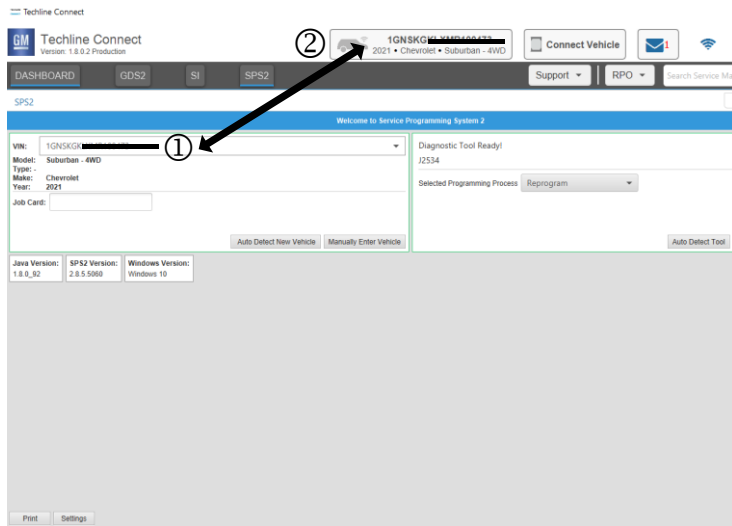
5743643

Caution: Be sure the VIN selected in the drop down menu (1) is the same as the vehicle connected (2) before beginning programming.

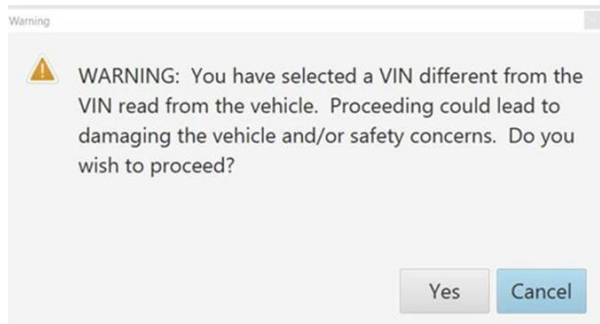
5877000

Important: If the vehicle VIN DOES NOT match, the message below will be shown.

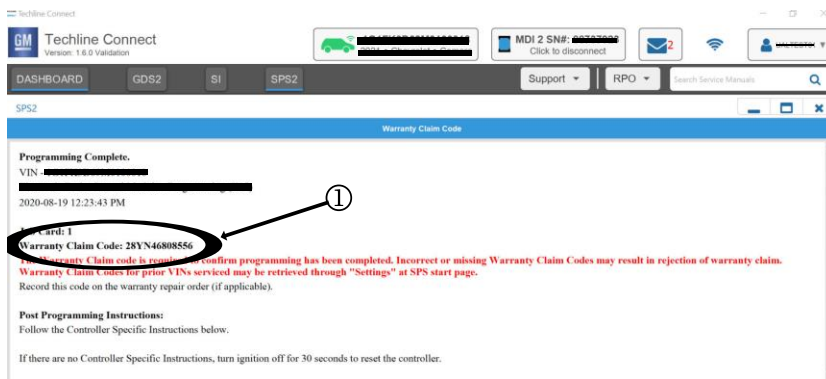
5644478

Important: To avoid warranty transaction rejections, you **MUST** record the warranty claim code provided on the Warranty Claim Code (WCC) screen shown above on the job card. Refer to callout 1 above for the location of the WCC on the screen.

2. Record SPS Warranty Claim Code on job card for warranty transaction submission.
