Front Radar, Reprogramming

V-366-003A

(July 2022)

Volvo trucks equipped with Front Radar (collision avoidance system with adaptive cruise control) and built from 11/11/2013 through 07/01/2016.

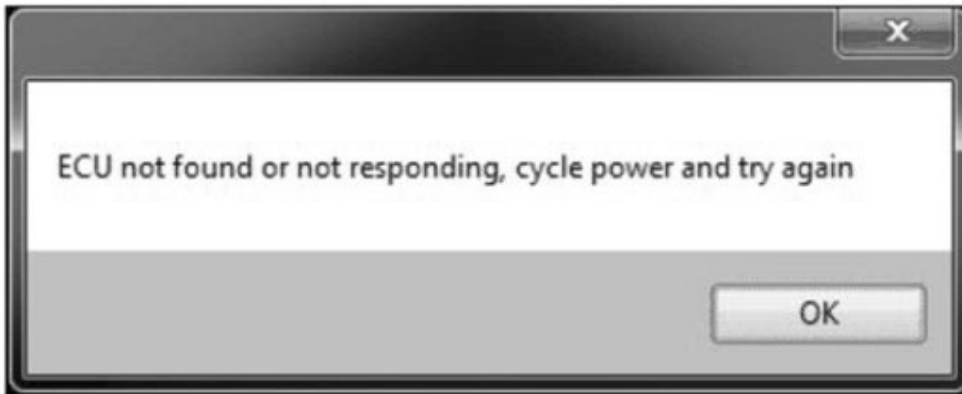
. All other choices will cause the following error message below to display.

. Choose the following settings for the Vocom PN 88890300; then click on **(Save)**.

Settings for Vocom PN 8890300	
i	V3PUWA32
ii	1
iii	J1939:Baud=Auto,Channel=2
<i>Note: All the "Channel=2" choices work EXCEPT the last one.</i>

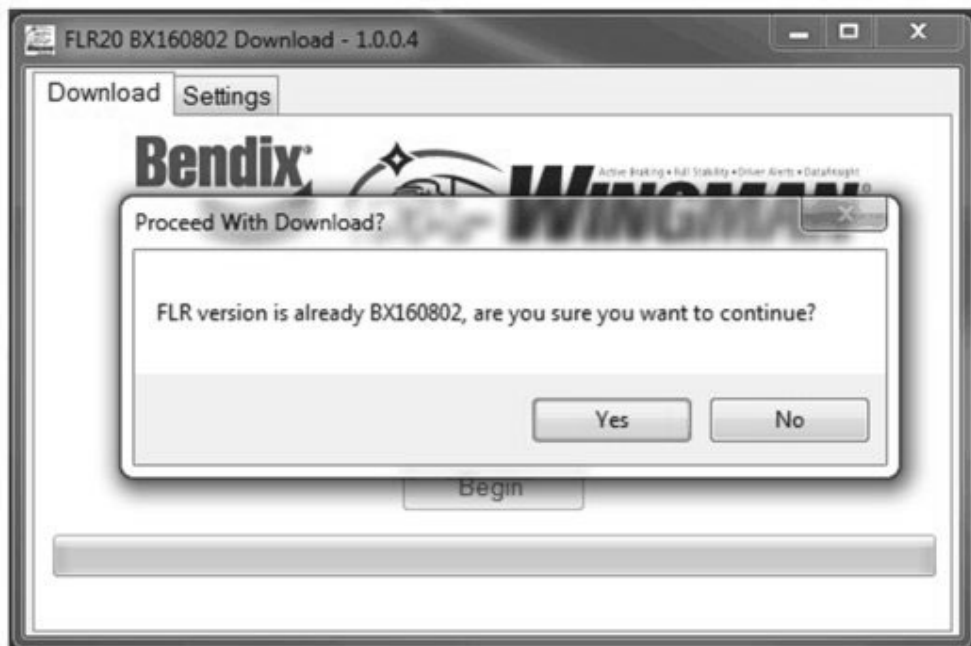
If this reprogramming is completed on a truck that has already been programmed, the following prompt below will display. Select **(No)**, and close the program.

Note: No further action needed.

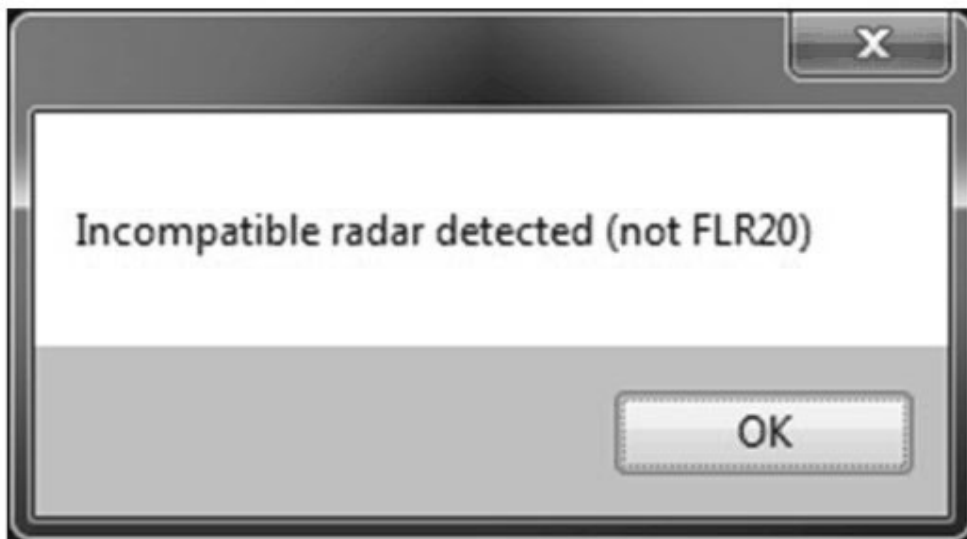
If this reprogramming is completed on a truck built with the incorrect front radar, the following error message below will display.
