# Service Bulletin

Bulletin No.: 19-NA-181

**Subject:** Multiple Electrical Concerns, Intermittent Multiple Instrument Panel Cluster (IPC) Warning Lamps Illuminated, Intermittent Multiple Message on Drivers Information Center (DIC) and Malfunction Indicator Lamp (MIL) Illuminated - DTC P057D, P057E, P0658, P0700, P073D, P07E4, P16F4, P175F, P1778, P1789, P2760, U0073, U0101 and/or U0121

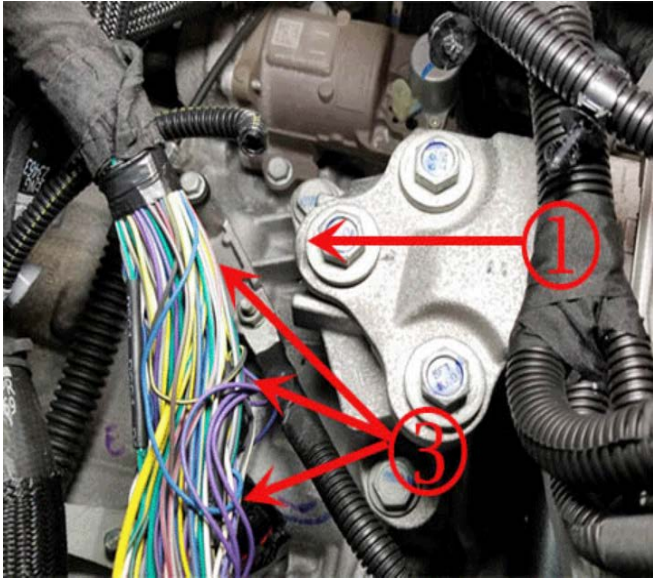
5023193

1. For **M3H/M3U**, inspect engine harness for proper routing and circuit 6387 for damaged wiring.
  - Wrap removed, point of contact (1) and chafed wire.

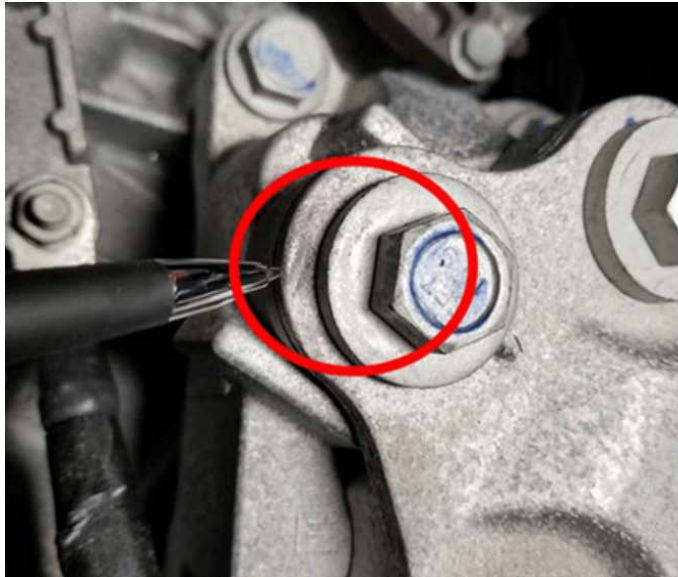
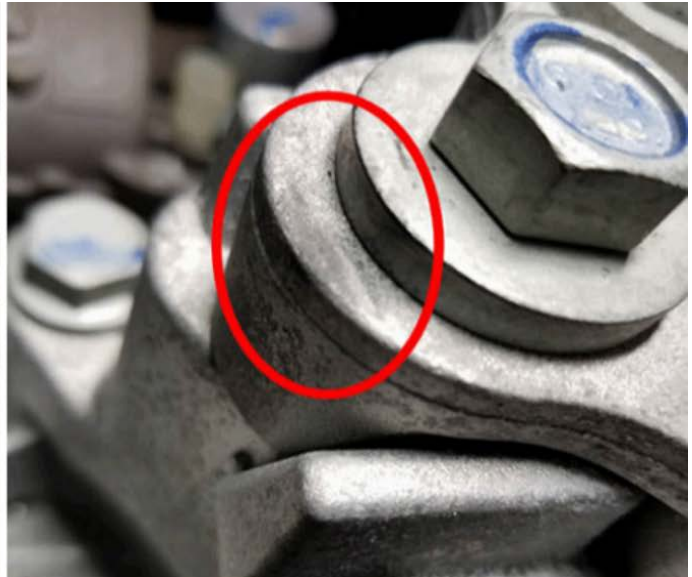
5394518

- Witness mark from point of harness contact.

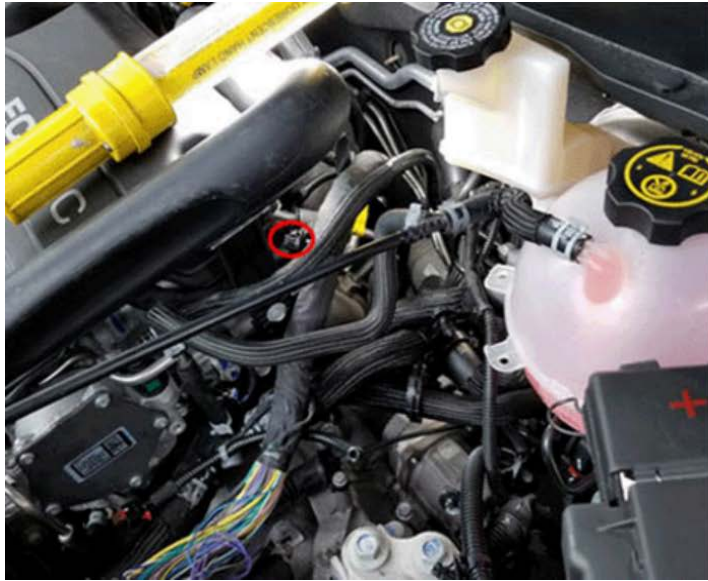
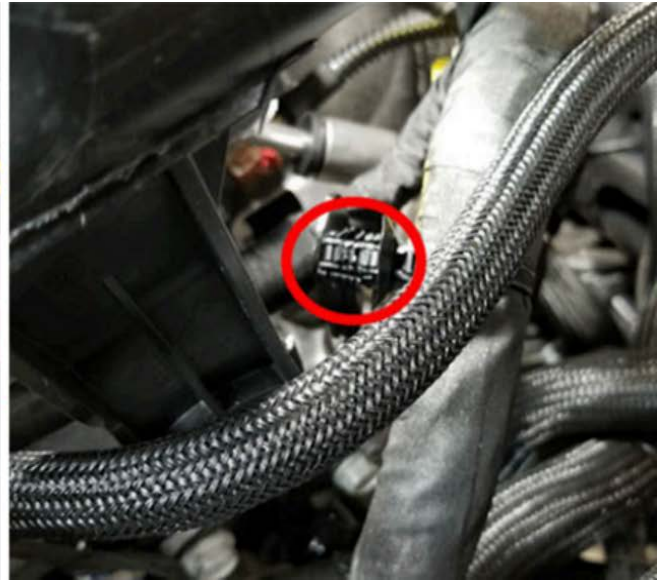
5394519

- Wire harness retainer not installed into bracket.

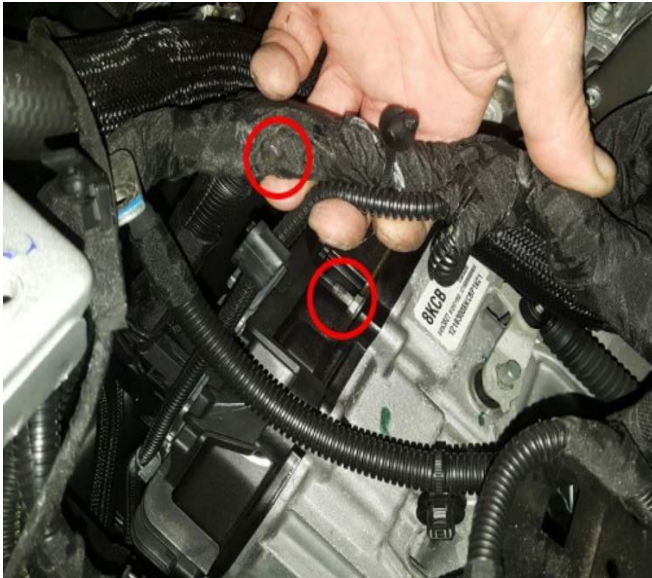
5387842

- Point of contact and chaffed wire.

2. Repair the wires per the *Wiring Repairs* procedure in SI.
3. Using Woven Polyester Electrical Tape (PET), tape all the contact points of the engine harness ensuring that the tape is applied in a double layer extending along the harness past the splice sleeves.
4. Verify all straps are secured and retainers are installed.

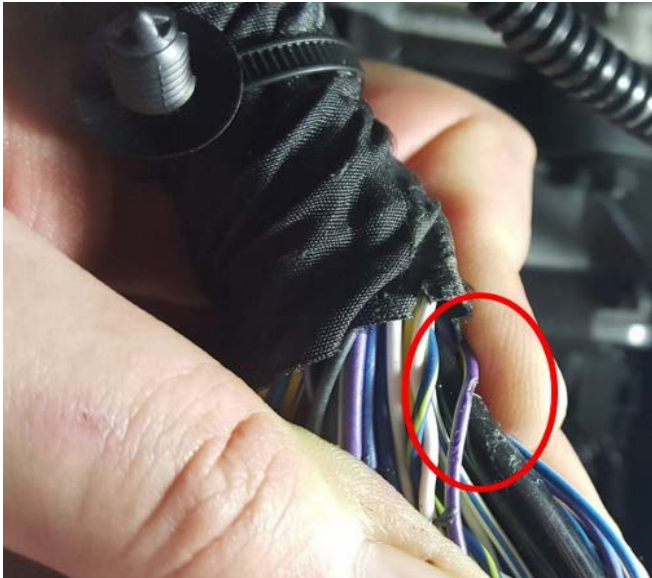
5387909

- Wrap removed, close-up picture.
