Service Bulletin

Subject: Clunking Noise from Rear of Vehicle (Re-torque Leaf Spring Bolts)

5295289

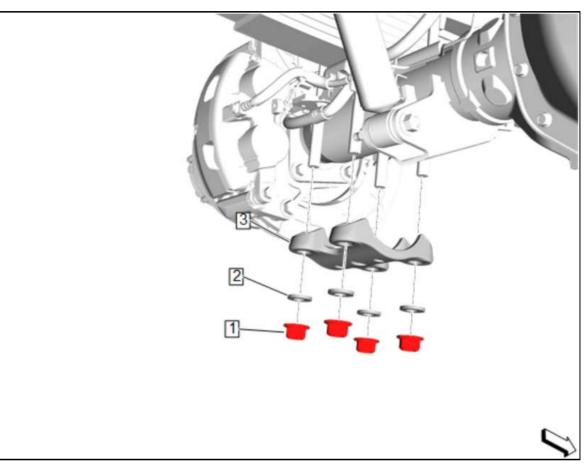
Involved Region or Country	North America, Middle East		
Condition	Some customers may comment about a clunking noise coming from the rear of the vehicle. Upon further investigation, the technician may diagnose the noise coming from the rear suspension leaf spring area.		
Cause	This condition may be caused by movement between the anchor plate and axle assembly.		
Correction	The noise may be resolved by re-torqueing the joints of the leaf spring assembly.

- 2. Loosen the leaf spring U-bolts (1).
- 3. Re-torque the leaf spring U-bolts (1). Refer to SI for torque specifications.
- 4. Repeat steps 2 and 3 for the right side leaf spring.
- 5. Re-test the vehicle for the same clunking noise. If the issue remains, continue diagnosis referring to SI.
