Service Bulletin

Bulletin No.: 20-NA-136

Subject: Diagnostic Tips for DTCs Set at a Low Mileage for 9T65 Transmissions

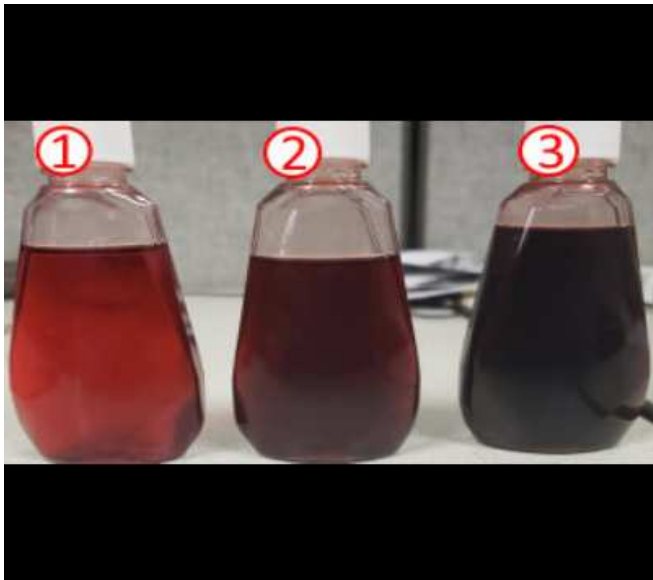
5840393

- The fluid should be red or dark brown.
- It should be transparent so that objects or writing can be seen through it. Sample #1 is an example of acceptable fluid. Sample #2 is an example of very dark fluid. Sample #3 is an example of black fluid.
- In addition to checking the fluid color and transparency, the fluid should be checked for an odor of burnt fluid. If the fluid is very dark, black, or has a burnt odor it would indicate clutch damage has occurred internally in the transmission and it would need to be removed from the vehicle and investigated.
