# Service Bulletin

Bulletin No.: 21-NA-248

**Subject: A/C Blows Warm Intermittently and/or Takes a Long Time to Start Cooling**

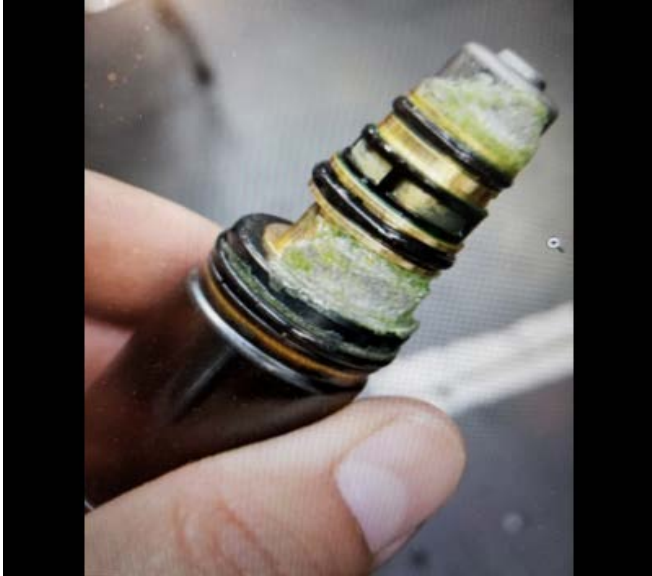
5787215

Shown in the picture above is a contaminated Compressor Solenoid.

If there is solid contamination on just the compressor solenoid you will need to replace just the compressor and receiver/dryer. Note that it is not necessary to replace the condenser, the receiver/dryer is replaceable separately.

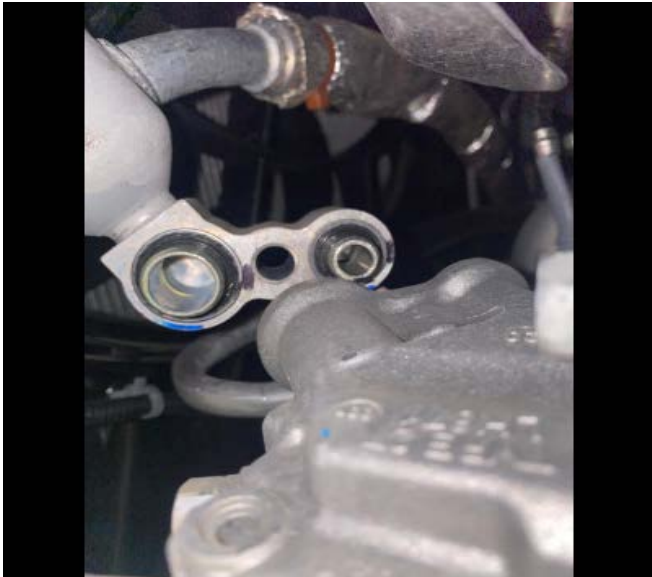
5899621

Shown in the picture above is a clean Compressor Inlet/Outlet (Some oil and greenish dye is normal)

If there is solid contamination in the compressor inlet/ outlet you will need to replace everything EXCEPT the evaporator.

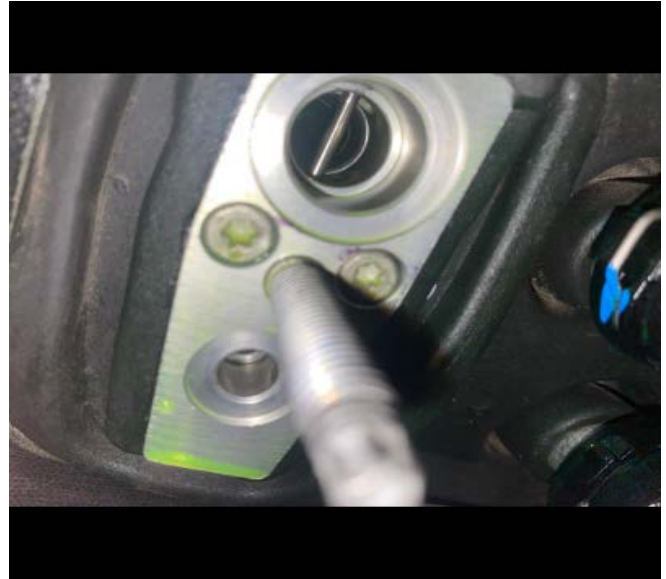
5899622

Shown in the picture above is a clean TXV (Some oil and greenish dye is normal)

If there is solid contamination in the TXV, you will need to replace the entire system. Oil and/or dye present is normal. (See examples below.)
